Dryad, LLC

October 8, 2018

Project name: Humboldt Bay Trail South -Limited Visual Tree Risk Assessment
 Project no.: 715036

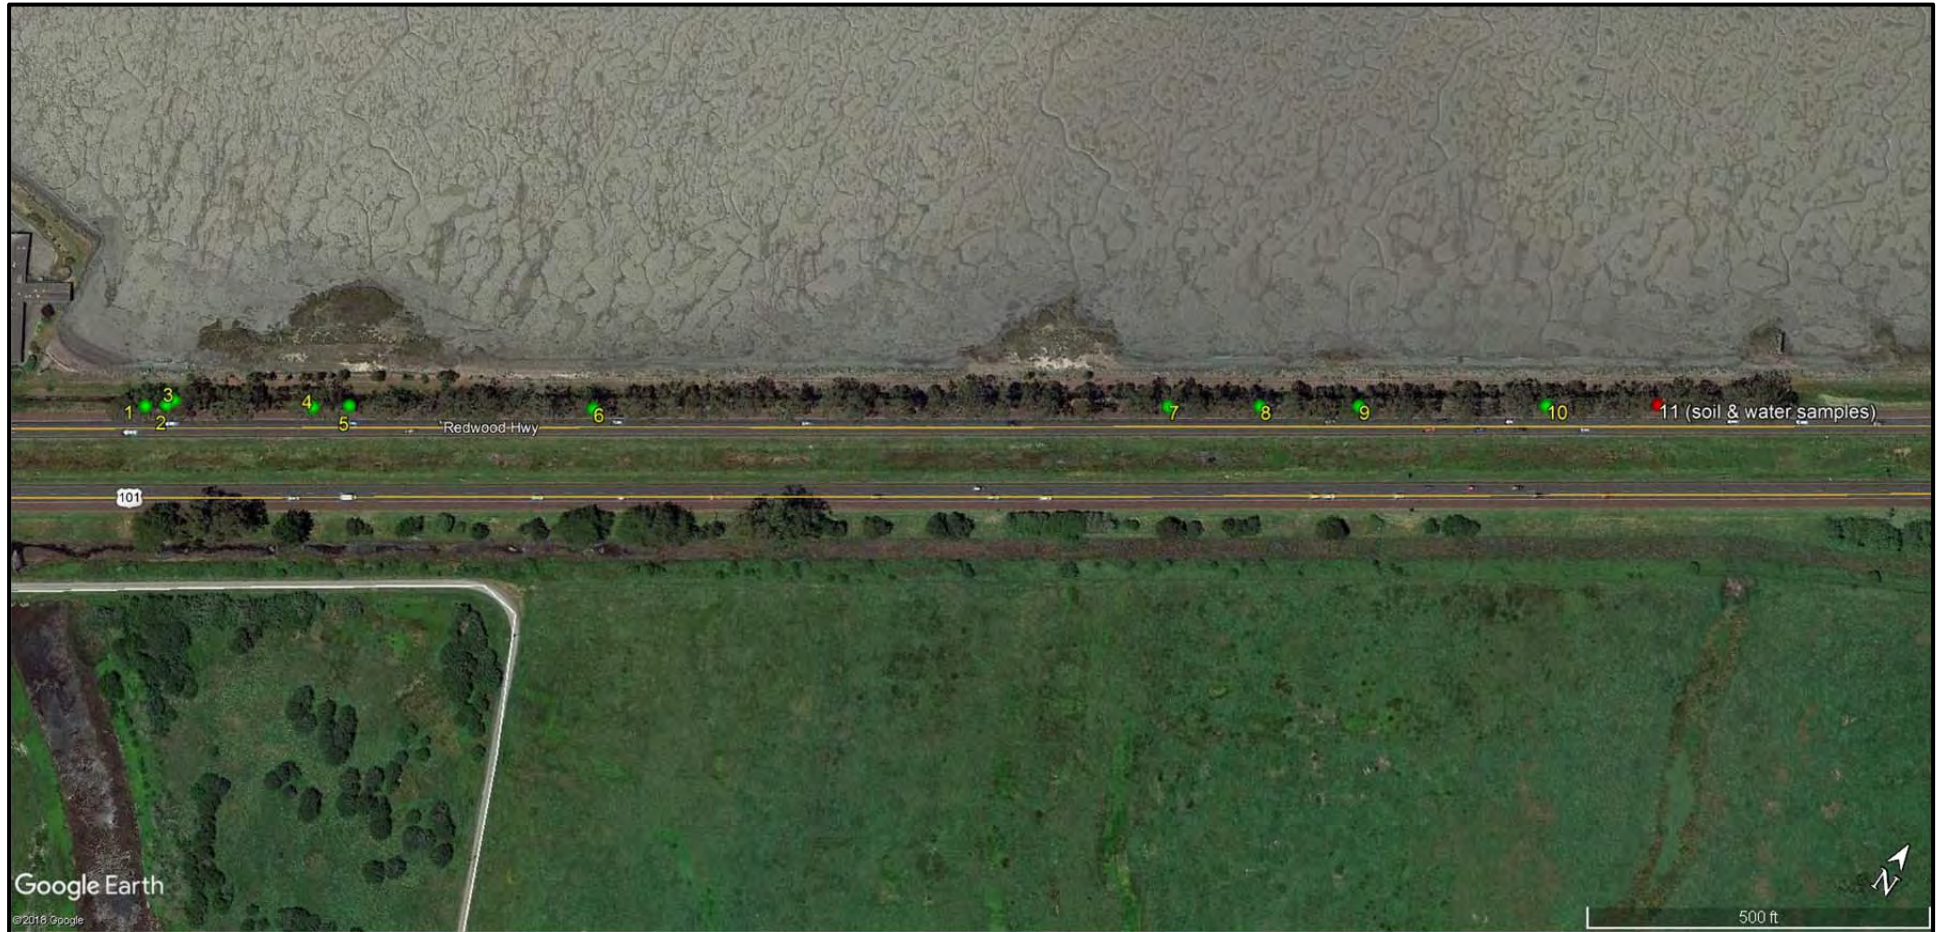
Locations of example trees:

No.	Common name	Genus-species	Trunk diameters (dsh)					Risk rating ⁷ (Tree Part 1)	Residual risk (Tree Part 2)	Observations/Comments	Graph no.	Micro-resistance graph notes ¹⁵
			1	2	3	4	5					
1	Bluegum	<i>Eucalyptus globulus</i>	21					Low	N/A	Decayed pruning wounds on trunk (tension) & base (8-12" diameter) <5% canopy Trunk curvature & lean to east Major decay column at 11" depth	9	E-W (48" hgt.) decay column @ 11"... (w/anomalies)
2	Bluegum	<i>Eucalyptus globulus</i>	26	21				Low	Low	2 codominant stems @ 3' above grade 3 large wounds from stem removals (8-12" diameter) Large wounds on upper trunk (tension side) Lean to west Large dead branches at top <2% canopy	N/A	
3	Bluegum	<i>Eucalyptus globulus</i>	22	19	13			Low	Moderate	Substantially dead 3 codominant stems Large, dead limbs to west Decay at topping cut <2% canopy Excess soil over root flare	8	NE=SW (24" hgt.) sound (minor anomalies)

4	Bluegum	<i>Eucalyptus globulus</i>	42					Moderate	Low	2 codominant stems Decay column to west Lean to west ~20% canopy	N/A	
5	Bluegum	<i>Eucalyptus globulus</i>	25	20				Moderate	Moderate	Substantially dead Codominant stems w/weak attachments <2% canopy Decaying wounds Decay column north side, lower west stem Lean to west	6 & 7	6, East trunk: E-W (36" hgt.); decay @ 4.75-7" & 9-14" 7, West trunk: (N-S) (48" hgt.); decay @ 2-3.5" & 15"...

No.	Common name	Genus-species	Trunk diameters (dsh)					Risk rating ⁷ (Tree Part 1)	Residual risk (Tree Part 2)	Observations/Comments	Graph no.	Micro-resistance graph notes ¹⁵
			1	2	3	4	5					
6	Bluegum	<i>Eucalyptus globulus</i>	25					High	N/A	Substantially dead <2% canopy Leans to east Codominant tops Decaying wound (15" diameter to east) Decaying wound (17" diameter to north) Interior decay column @ ~9" depth	4 & 5	4: N-S (48" hgt.) decay @ 8.5"..." 5: E-W (48" hgt.) decay @ 8.5"-19"
7	Bluegum	<i>Eucalyptus globulus</i>	39					Moderate	Moderate	5 large dead limbs to west 3 codominant stems w/weak attachments ~10% canopy	N/A	
8	Bluegum	<i>Eucalyptus globulus</i>	22	14				Low	High	Substantially dead <1% canopy Codominant stems Large, decaying wounds from stem removals	N/A	
9	Bluegum	<i>Eucalyptus globulus</i>	36					High	N/A	3 codominant stems with weak attachments 3 large wounds at base (stem removals) Lean to east Torsional stress and response growth <10% canopy	2 & 3	2: E-W (36" hgt.) decay @ 7.5"..." 3: NE-SW (24" hgt.) decay @ 16.5"..."

10	Bluegum	<i>Eucalyptus globulus</i>	27	24	20	20	11	Moderate	High	5 codominant stems w/weak attachments Large dead branches to west Excess soil over root flare Large wounds from stem removals to east Decaying stub on trunk to east <5% canopy	1	E-W (60" hgt.) decay @ 5.5"-9.5"; 11"-14"; 17.5"-19"
