**Cultivation Relocation,  
Environmental Superiority Analysis,  
& Site Restoration**

**Denali Farms, LLC - July 2022**

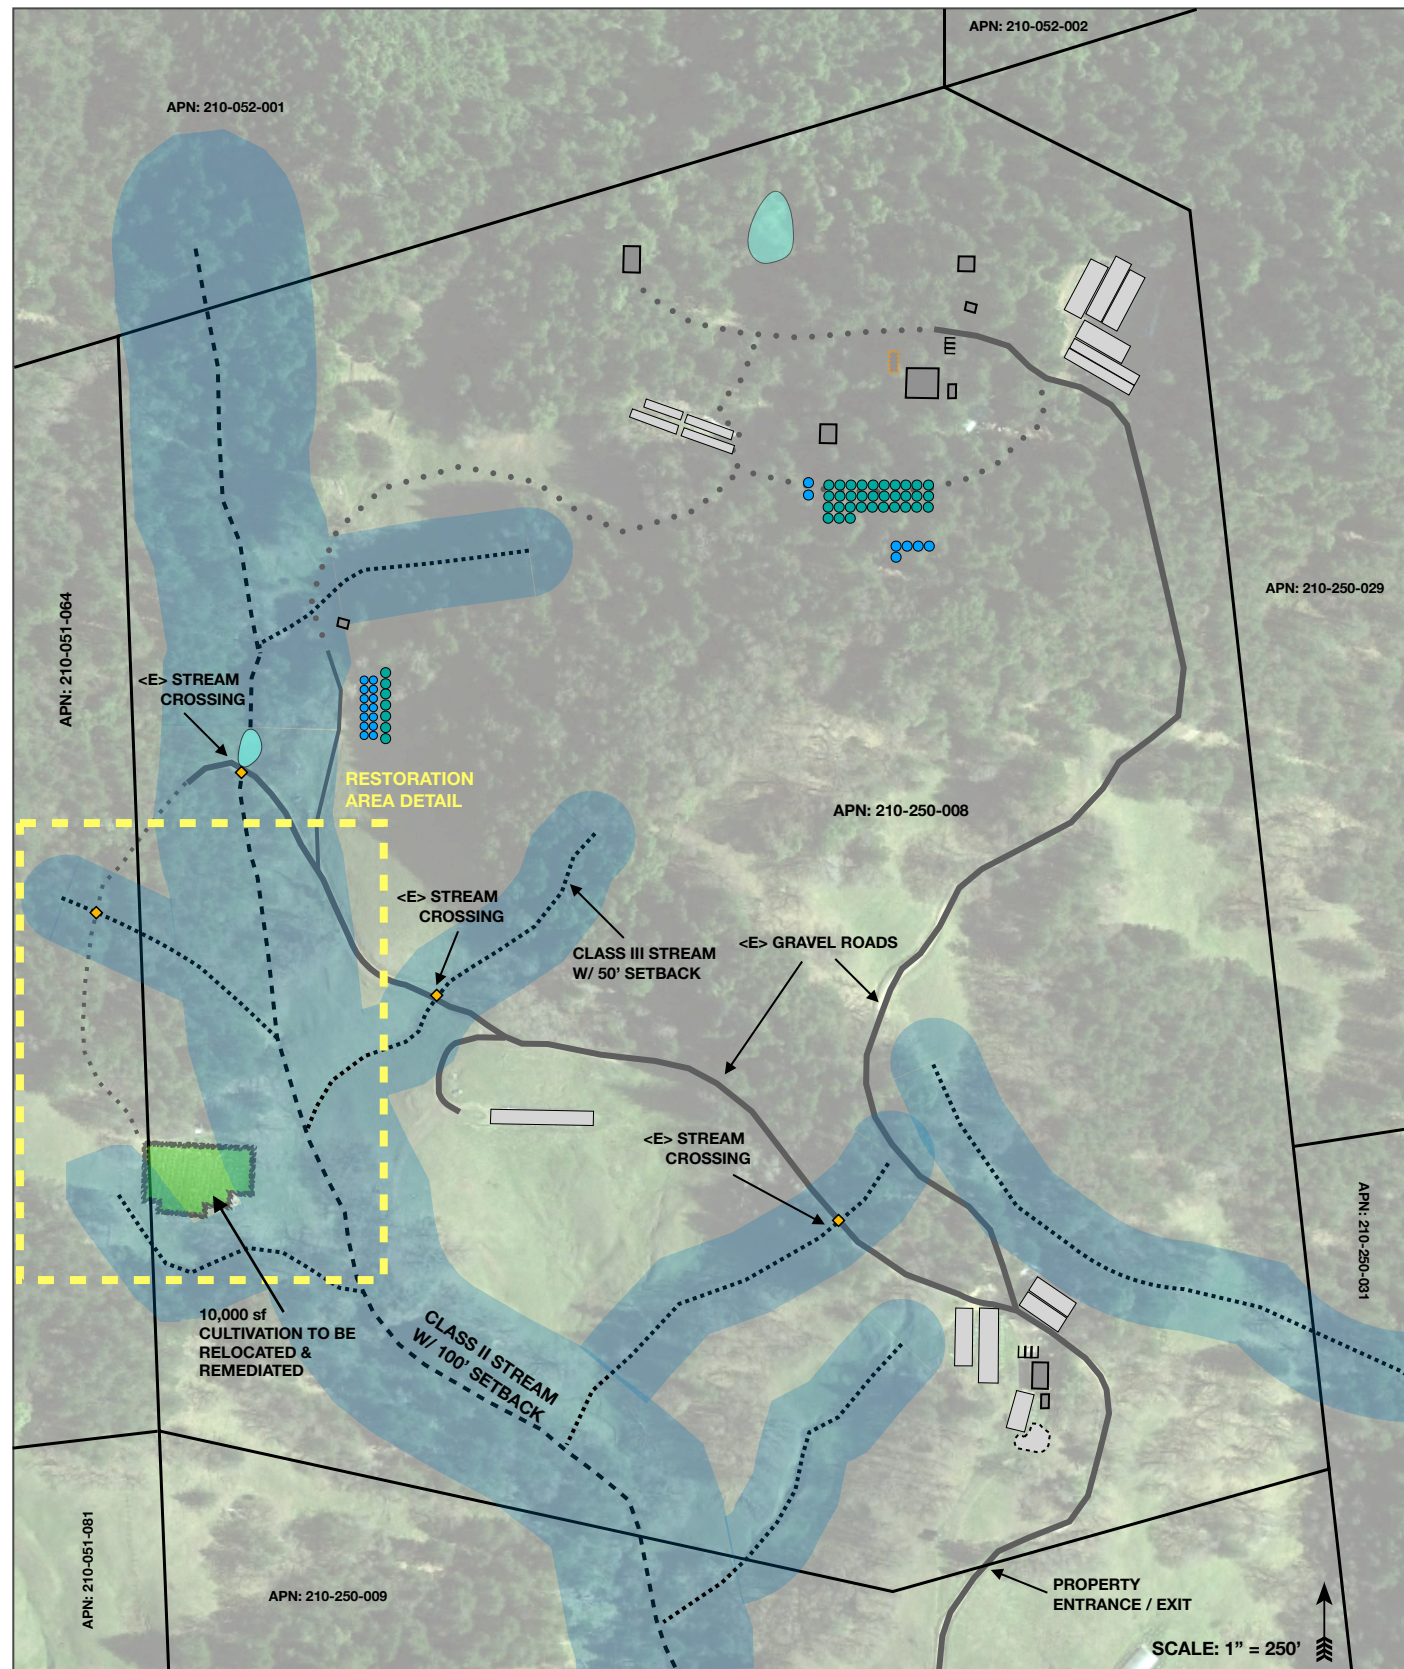
PARCEL OVERVIEW

**DENALI FARM, LLC  
RESTORATION SITE PLAN  
APN: 210-250-008**

rainy season. The ATV trail leading to the site will remain in place for fire access, but will have waterbars installed to prevent erosion. See the restoration site plan for details.
