Water Resource Protection Plan

WDID# - 1B171605CHUM

Timberland Resource Consultants

05-13-2018

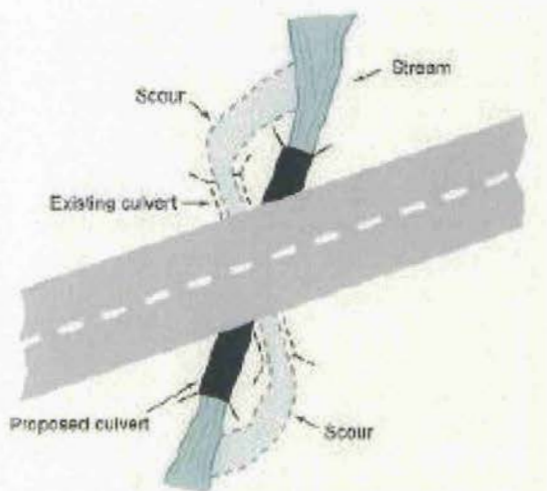
FIGURE 97. *Culvert alignment should be in relation to the stream and not the road. It is important that the stream enters and leaves the culvert in a relatively straight horizontal alignment so streamflow does not have to turn to enter the inlet or discharge into a bank as it exits. This figure shows a redesigned culvert installation that replaces the bending alignment that previously existed. Channel turns at the inlet increase plugging potential because wood going through the turn will not align with the inlet. Similarly, channel turns at the inlet and outlet are often accompanied by scour against the channel banks (Wisconsin Transportation Information Center, 2004).*

- Align culverts with the natural stream channel orientation to ensure proper function, prevent bank erosion and minimize debris plugging. See Figure 97 below.

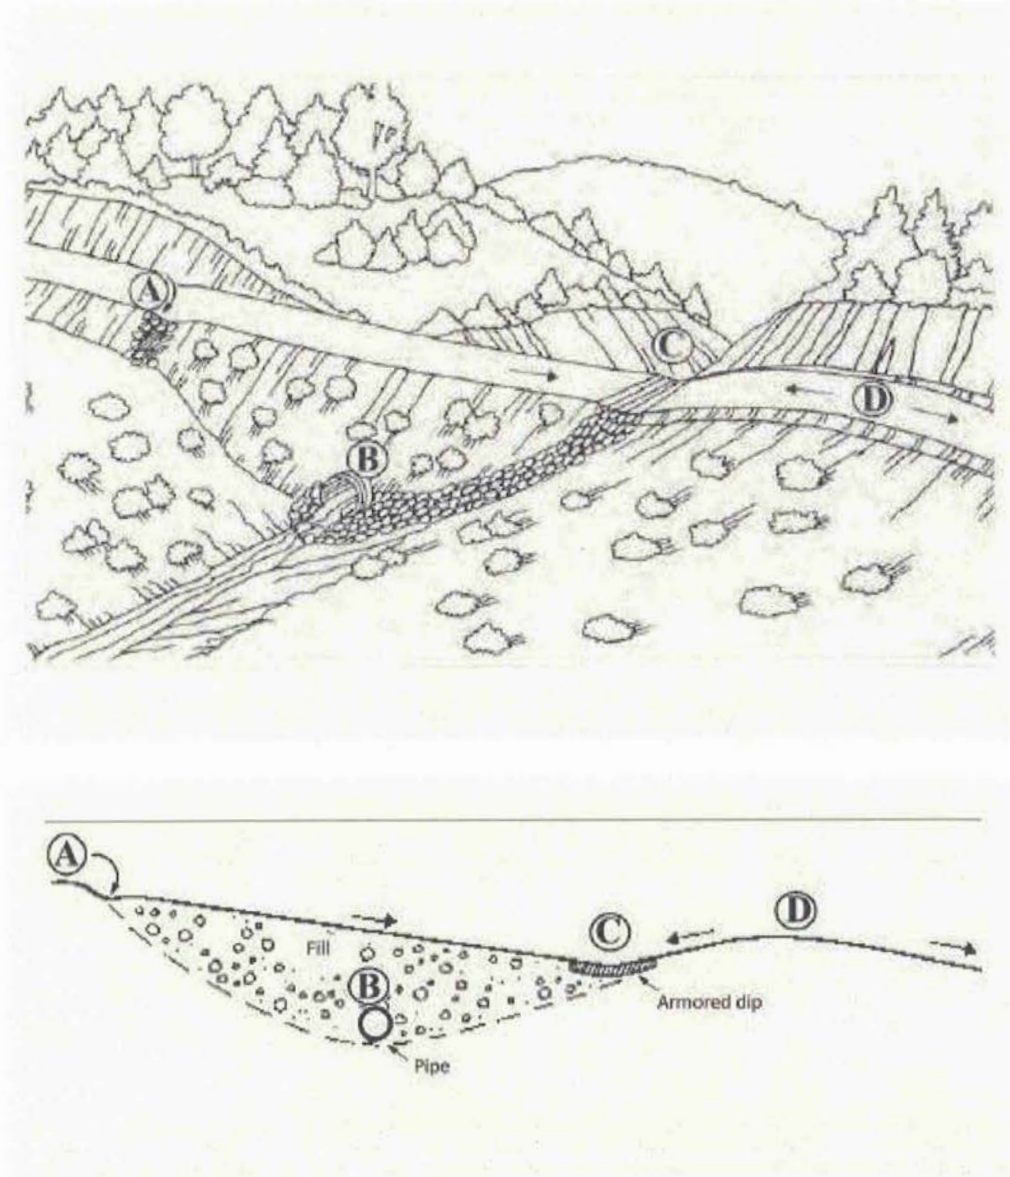
FIGURE 84. Critical dips or dipped crossing fills should be centered near a stream crossing's down-road hinge line, not over the centerline of the crossing where overtopping could cause washout or severe erosion of the fill. If the stream crossing culvert (B) plugs, water will pond behind the fill until reaching the critical dip or low point in the crossing (C) and flowing back down into the natural stream channel. The down-road ditch must be plugged to prevent streamflow from diverting down the ditch line. For extra protection in this sketch, riprap armor has been placed at the critical dip outfall and extending downslope to the stream channel. This is only required or suggested on stream crossings where the culvert is highly likely to plug and the crossing fill overtopped. The dip at the hinge line is usually sufficient to limit erosional damage during an overtopping event. Road surface and ditch runoff is disconnected from the stream crossing by installing a rolling dip and ditch relief culvert just up-road from the crossing (A) (Keller and Sherar, 2003).

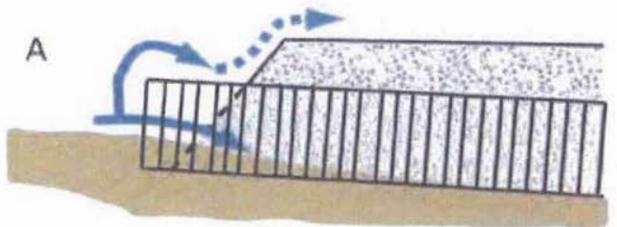
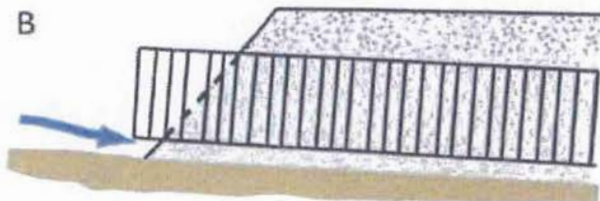
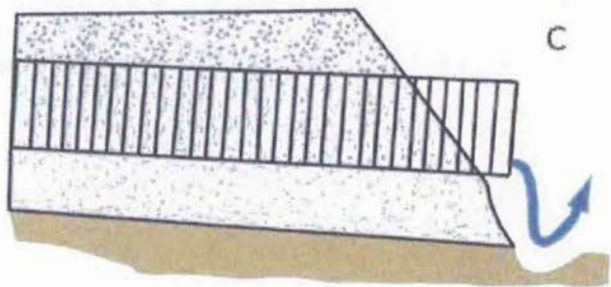
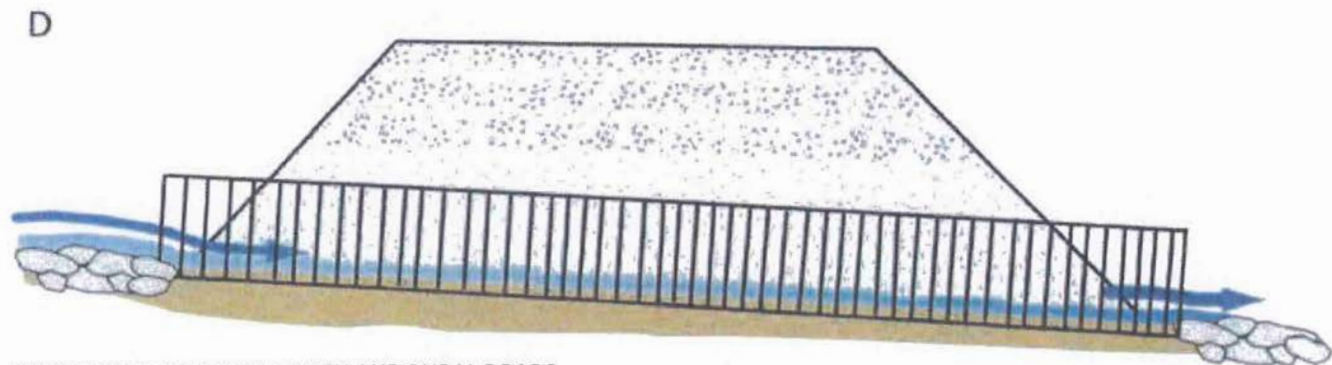
FIGURE 155. Proper culvert installation involves correct culvert orientation, setting the pipe slightly below the bed of the original stream, and backfilling and compacting the fill as it is placed over the culvert. Installing the inlet too low in the stream (A) can lead to culvert plugging, yet if set too high (B) flow can undercut the inlet. If the culvert is placed too high in the fill (C), flow at the outfall will erode the fill. Placed correctly (D), the culvert is set slightly below the original stream grade and protected with armor at the inlet and outlet. Culverts installed in fish-bearing stream channels must be inset into the streambed sufficiently (>25% embedded) to have a natural gravel bottom throughout the culvert (Modified from: MDSL, 1991).

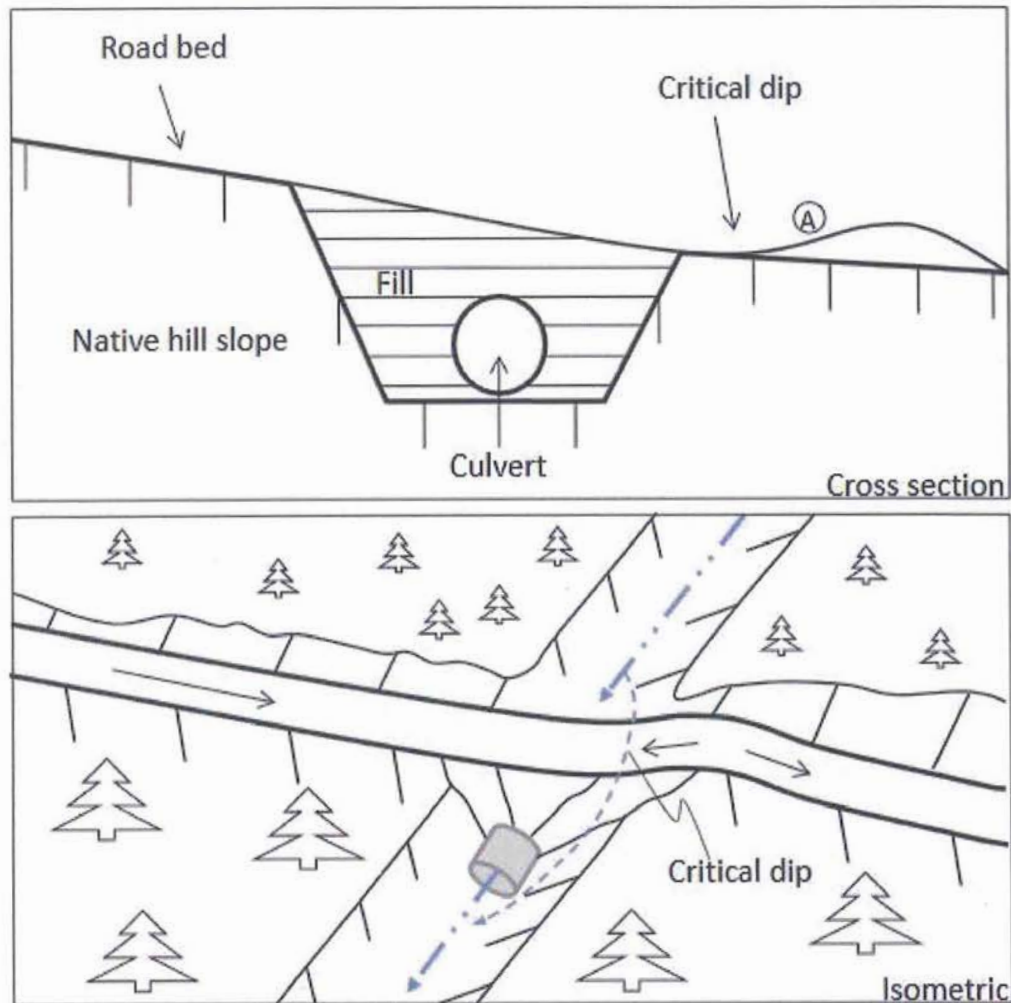
Typical Critical Dip Design for Stream Crossings with Diversion Potential

Critical Dip Construction:

1. Critical dip will be constructed on the lower side of crossing.
2. Critical dip will extend from the cutbank to the outside edge of the road surface. Be sure to fill inboard ditch, if present.
3. Critical dip will have a reverse grade (A) from cutbank to outside edge of road to ensure flow will not divert outside of crossing.
4. The rise in the reverse grade will be carried for about 10 to 20 feet and then return to original slope.
5. The transition from axis of bottom, through rising grade, to falling grade, will be in the road distance of at least 15 to 30 feet.
6. Critical dips are usually built perpendicular to the road surface to ensure that flow is directed back into the stream channel.

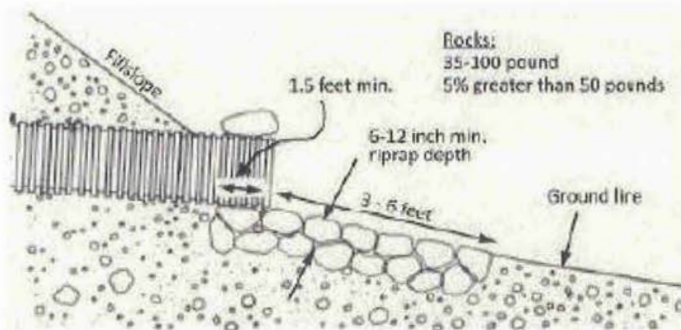
FIGURE 107A. Riprap armor at culvert outlet (Modified from: Kellar et al., 2011).

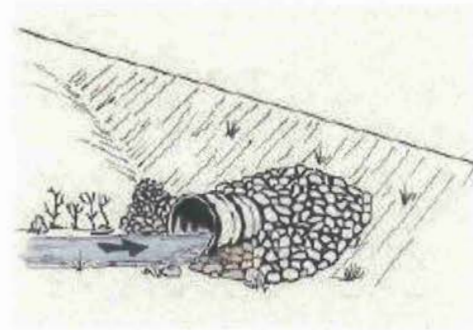
FIGURE 107B. Riprap armor at culvert inlet (Kellar and Sherar, 2003).

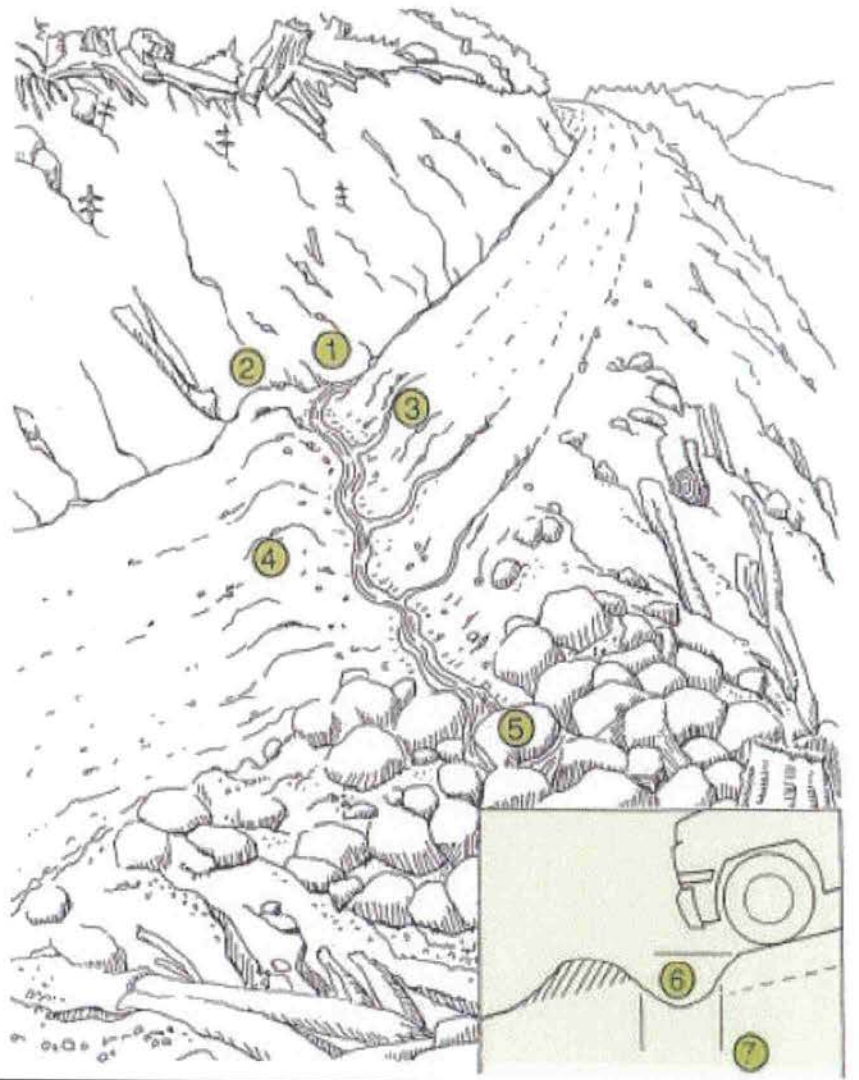
FIGURE 40. Waterbars are constructed on unsurfaced forest and ranch roads that will have little or no traffic during the wet season. The waterbar should be extended to the cutbank to intercept all ditch flow (1) and extend beyond the shoulder of the road. A berm (2) must block and prevent ditch flow from continuing down the road during flood flows. The excavated waterbar (3) should be constructed to be self-cleaning, typically with a 30° skew to the road alignment with the excavated material bermed on the downhill grade of the road (4). Water should always be discharged onto the downhill side on a stable slope protected by vegetation. Rock (shown in the figure) should not be necessary if waterbars are spaced close enough to prevent serious erosion. (5) The cross ditch depth (6) and width (7) must allow vehicle cross-over without destroying the function of the drain. Several alternate types of waterbars are possible, including one that drains only the road surface (not the ditch), and one that drains the road surface into the inside ditch (BCMF, 1991).

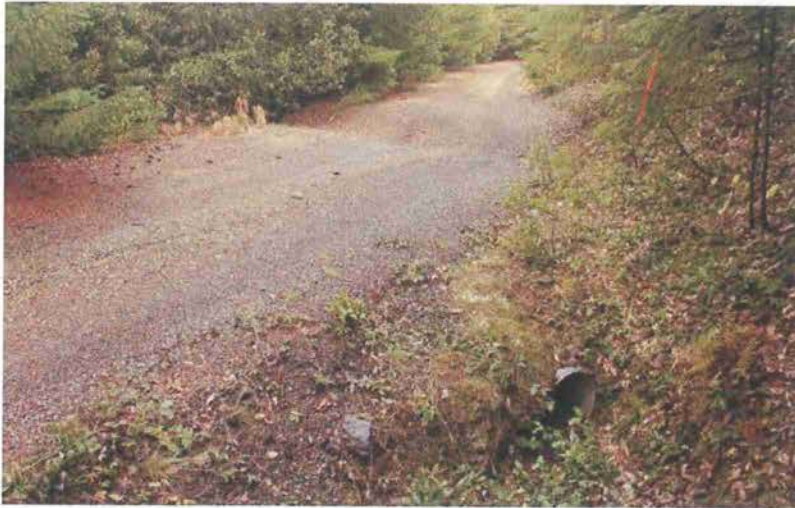
FIGURE 39.

Waterbars are often used to drain surface runoff from seasonal, unsurfaced roads. Because they are easily broken down by vehicles, waterbars are only used on unsurfaced roads where there is little or no wet weather traffic. In this photo, a waterbar and ditch relief culvert are used to drain all road surface and ditch runoff from the insloped road prism.

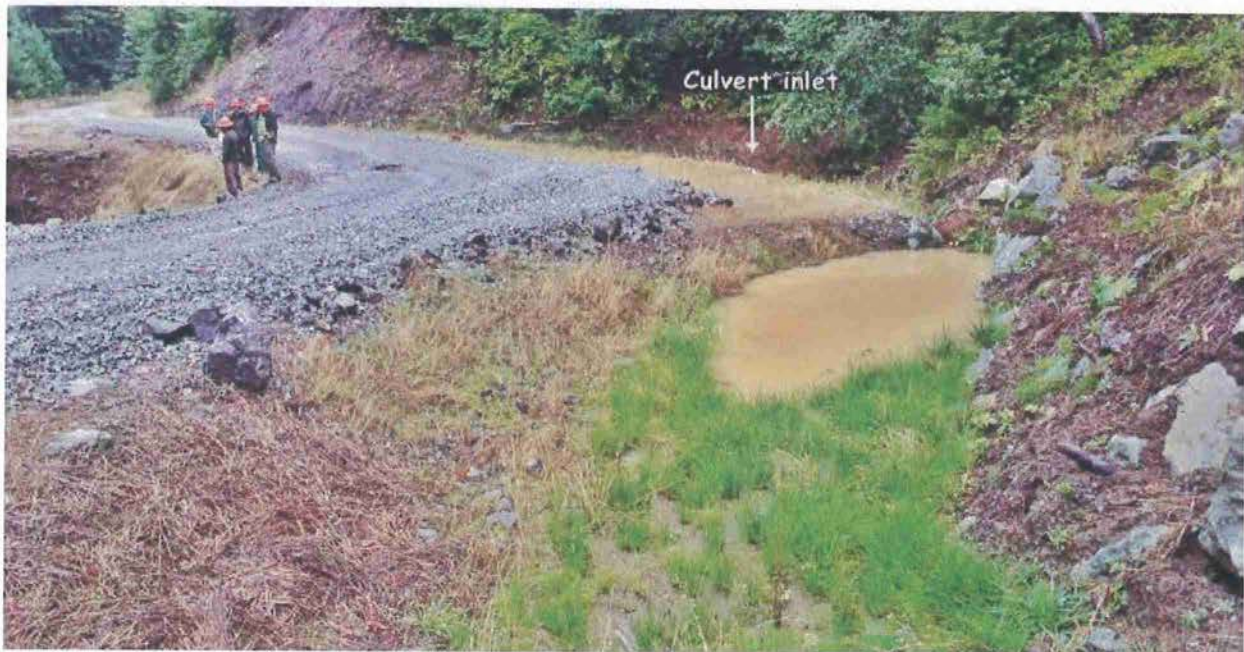
FIGURE 238. *Traffic and surface runoff from graveled roads often produces surface erosion, turbid runoff and fine sediment transport that can be delivered to streams. Where ditches can't be eliminated, sediment traps and roadside settling basins can be installed to capture and remove most of the eroded sediment. This settling basin has been constructed along the inside ditch just before a stream crossing culvert inlet (see arrow). Eroded sediment from the road and ditch are deposited in the basin before flow is released to the stream. Fine sediments have filled about 1/3 of this basin and vegetation is now growing. Sediment basins require periodic maintenance to maintain their storage capacity.*

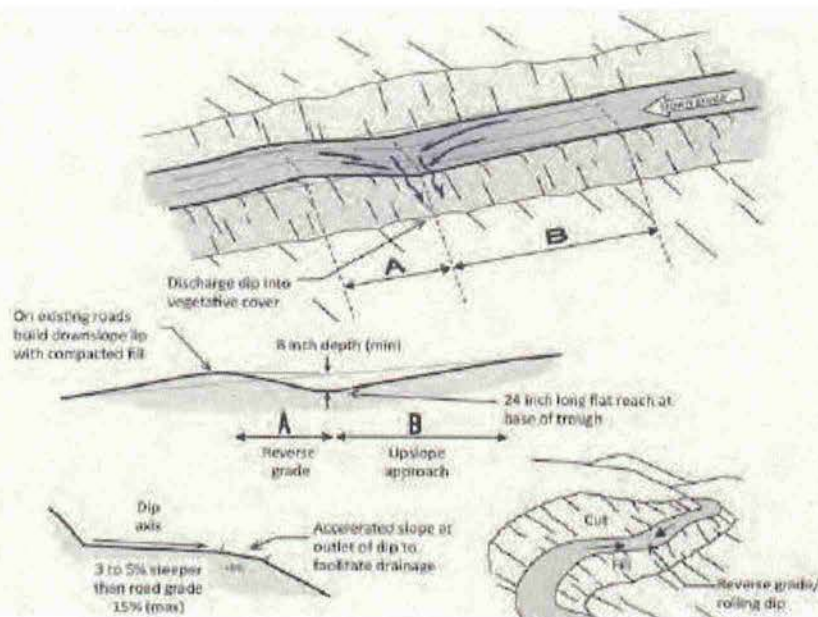
FIGURE 34. A classic Type I rolling dip, where the excavated up-road approach (B) to the rolling dip is several percent steeper than the approaching road and extends for 60 to 80 feet to the dip axis. The lower side of the structure reverses grade (A) over approximately 15 feet or more, and then falls down to rejoin the original road grade. The dip must be deep enough that it is not obliterated by normal grading, but not so deep that it is difficult to negotiate or a hazard to normal traffic. The outward cross-slope of the dip axis should be 3% to 5% greater than the up-road grade (B) so it will drain properly. The dip axis should be out-sloped sufficiently to be self-cleaning, without triggering excessive downcutting or sediment deposition in the dip axis (Modified from: Best, 2013).

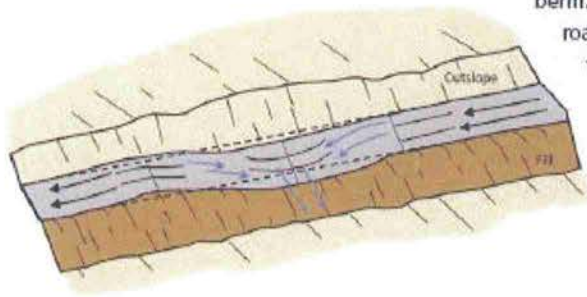
Type 1 Rolling Dip (Standard)

Type 1 rolling dips are used where road grades are less than about 12-14% and road runoff is not confined by a large through cut or berm. The axis of the dip should be perpendicular to the road alignment and sloped at 3-4% across the road tread. Steep roads will have longer and more abrupt dip dimensions to develop reverse grade through the dip axis. The road tread and/or the dip outlet can be rocked to protect against erosion, if needed.

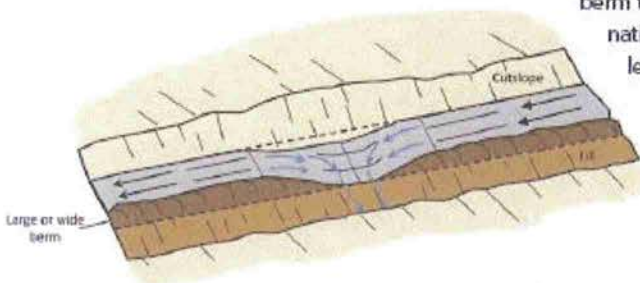
Type 2 Rolling Dip (Through-cut or thick berm road reaches)

Type 2 rolling dips are constructed on roads up to 12-14% grade where there is a through cut up to 3 feet tall, or a wide or tall berm that otherwise blocks road drainage. The berm or native through cut material should be removed for the length of the dip, or at least through the axis of the dip, to the extent needed to provide for uninterrupted drainage onto the adjacent slope. The berm and slope material can be excavated and endhailed, or the material can be sidecast onto native slopes up to 45%, provided it will not enter a stream.

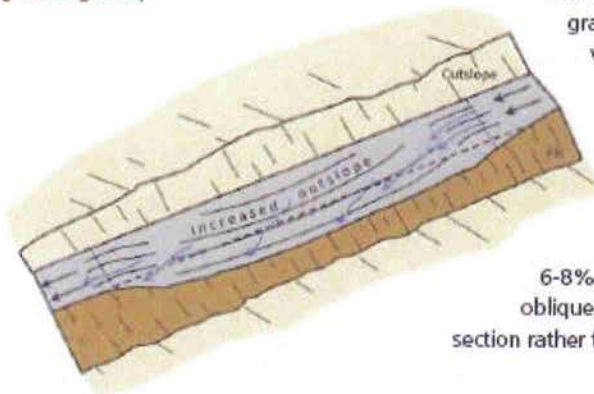
Type 3 Rolling Dip (Steep road grade)

Type 3 rolling dips are utilized where road grades are steeper than about 12% and it is not feasible to develop a reverse grade that will also allow passage of the design vehicle (steep road grades require more abrupt grade reversals that some vehicles may not be able to traverse without bottoming out).

Instead of relying on the dip's grade reversal to turn runoff off the roadbed, the road is built with an exaggerated outslope of 6-8% across the dip axis. Road runoff is deflected obliquely across the dip axis and is shed off the outsloped section rather than continuing down the steep road grade.

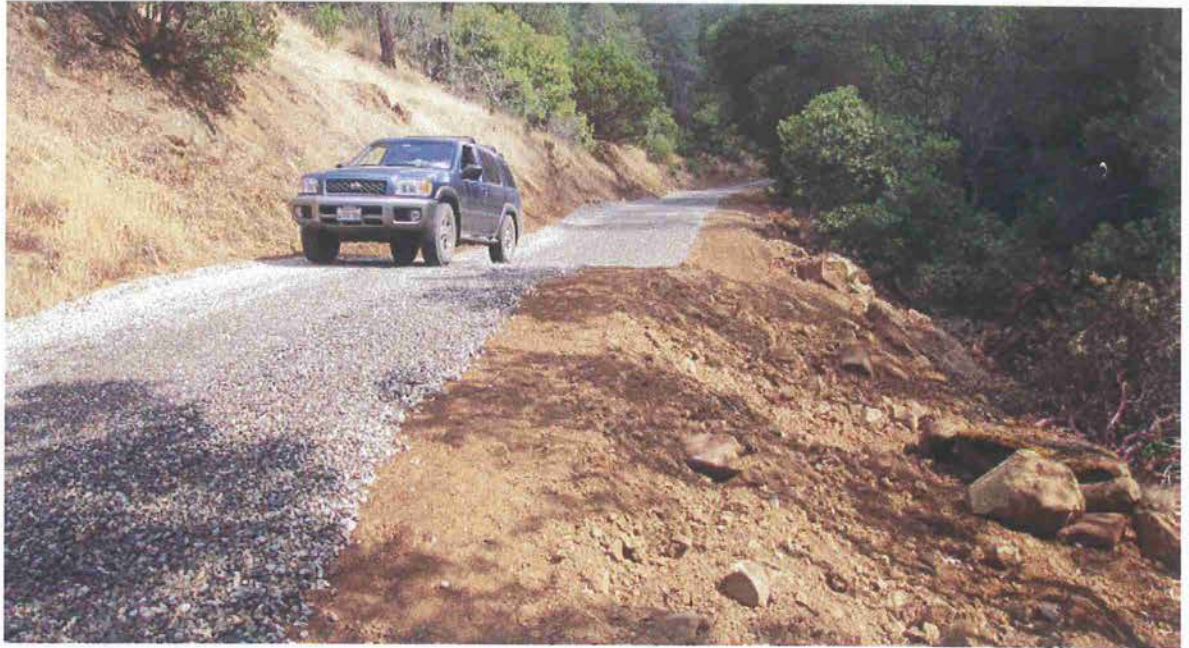
FIGURE 33A.

Rolling dip constructed on a rock surfaced rural road. The rolling dip represents a change-in-grade along the road alignment and acts to discharge water that has collected on, or is flowing down, the road surface. This road was recently converted from a high maintenance, insloped, ditched road to a low maintenance, outsloped road with rolling dips.

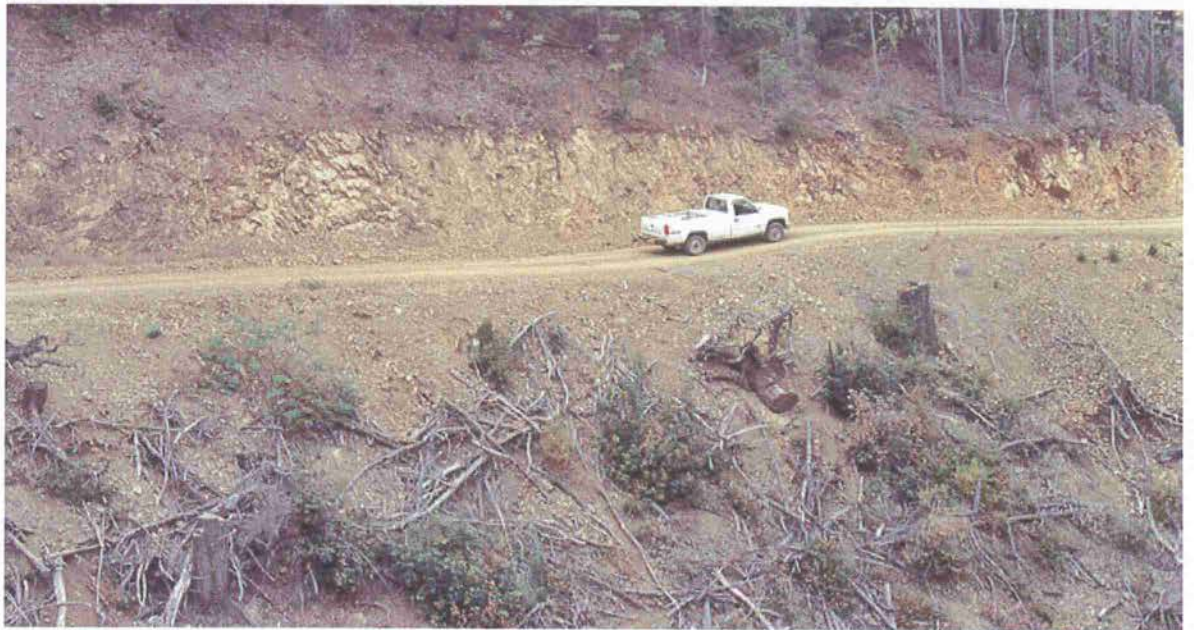
FIGURE 33B.

This side view of an outsloped road shows that the rolling dip does not have to be deep or abrupt to reverse road grade and effectively drain the road surface. This outsloped forest road has rolling dips that allow all traffic types to travel the route without changing speed.

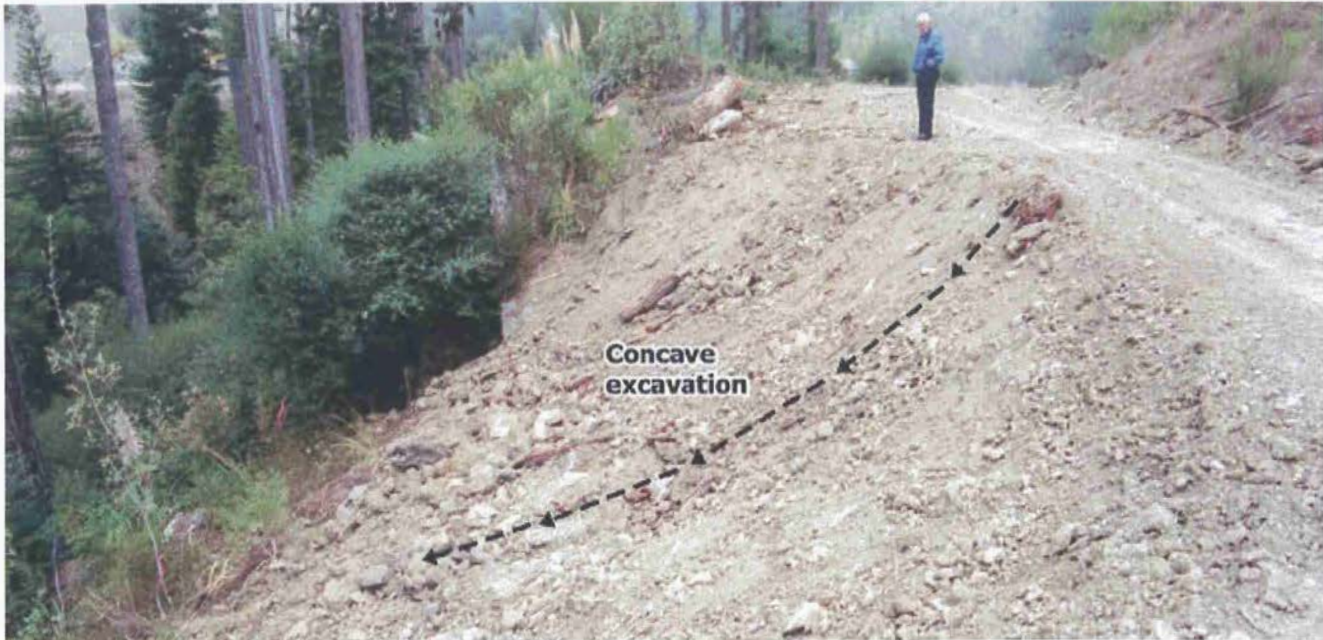
FIGURE 230. *The most cost-effective treatment for unstable fills along the outside of a forest, ranch or rural road is simply the direct excavation of the unstable material. If road width is too narrow, additional width can often be derived from cutting into the bank. The excavation should encompass the unstable fill materials, beginning at the inside crack or scarp, and extending out and down the fill slope as far as possible. For proper surface drainage, and to retrieve most of the unstable fill, the excavation should have a concave profile when completed. Typically, the bulk of the fill is within 20 to 25 feet of the outside edge of the road and is easily reached by a midsized excavator. Any remaining fill is likely to be small enough that it will not fail or travel far enough to reach the stream.*

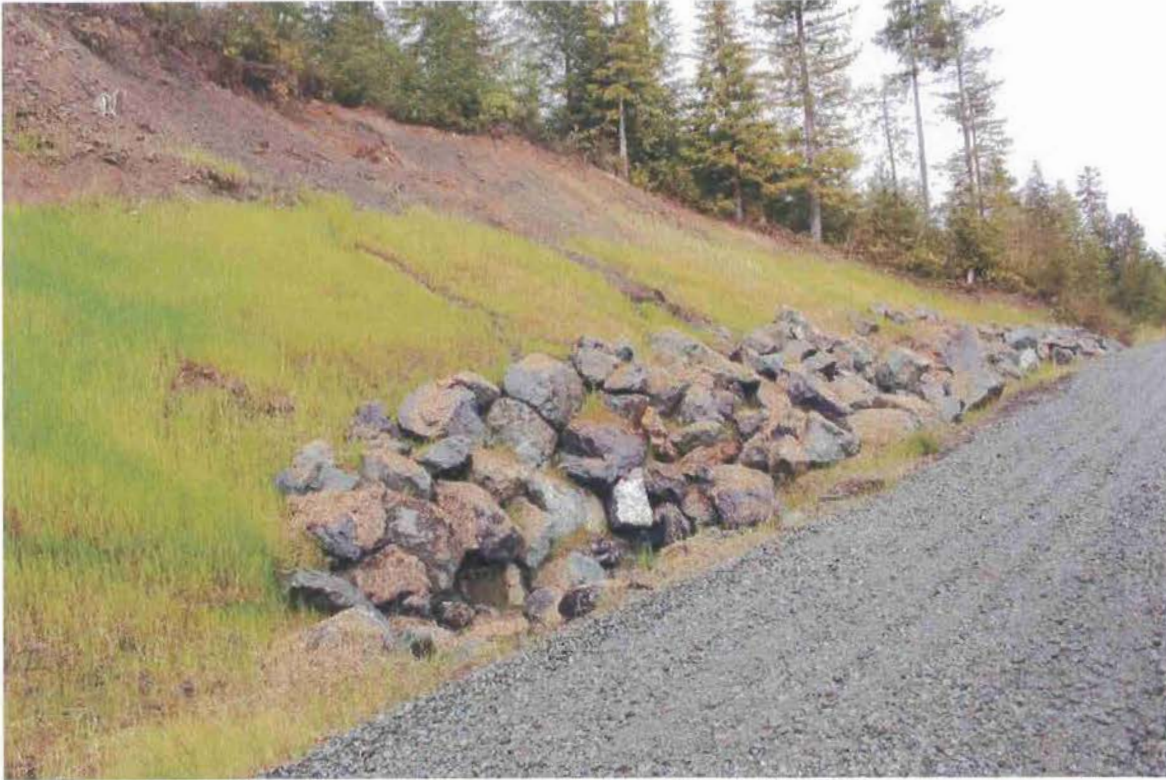
FIGURE 52. *This wet and potentially unstable cut slope on a newly constructed road was stabilized using a buttress of large rock armor. To assure their effectiveness, rock buttresses and other retaining structures should be designed by a qualified engineer or engineering geologist.*
