Site Management Plan

(Tier 1, Low Risk)

WDID - 1_12CC418891

Humboldt County
APN: 211-183-008-000, 211-184-006-000

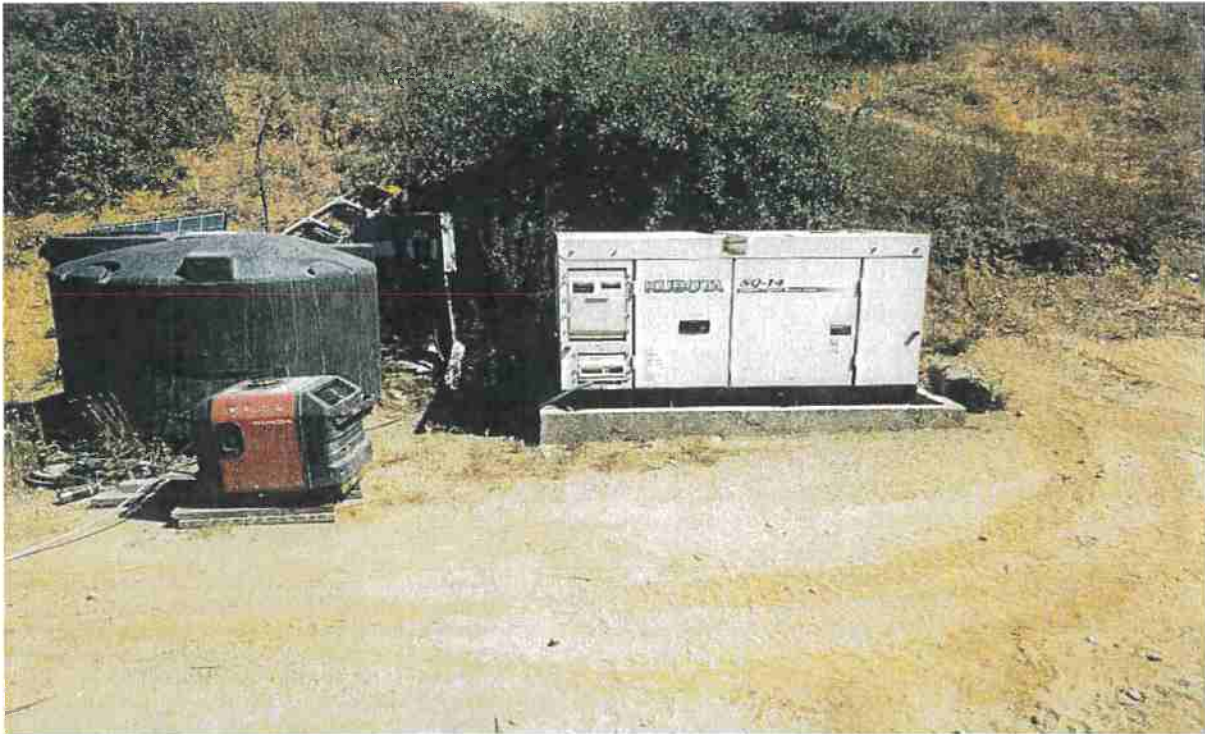
Photo looking at gasoline and diesel generators without proper containment at Site 01.

Unique Point	Lat-Long NAD 83	Road Type	Mitigation Planned	Monitor	1600	Treatment Priority	Date Completed
Site 01	-124.003436 40.254575	Permanent	X	-	-	Prior to 10/15/21	
Current Condition: A diesel and gasoline generator located next to Cultivation Area A does not have proper secondary cover.						Prescribed Action: Provide proper covering for generator and store away in the winter. See attached BMPs: Generator, Fuel, and Oil Management for further details. All petroleum products are required to be used and stored per Cannabis Cultivation Policy, Att. A, Sec. 2, - Term 103 - 110, and 116 - 118 attached.	
Unique Point	Lat-Long NAD 83	Road Type	Mitigation Planned	Monitor	1600	Treatment Priority	Date Completed
Site 02	-124.002989 40.254733	Permanent	X	-	-	Prior to 10/15/22	
Current Condition: Permanent road leading down to Cultivation Area A contains an erosional gully that extends up to the parking lot of the residence. The road is currently outsloted with dirt surfaces.						Prescribed Action: Regrade the road with gentle outsloting from Site 01 to Site 03 then install a waterbar per the specifications outlined in the attached BMPs: Waterbar Construction, General Operations BMPs, and General Erosion Control specifications. Maintain as needed per Cannabis Cultivation Policy, Att. A, Sec. 2, - Term 1 - 29.

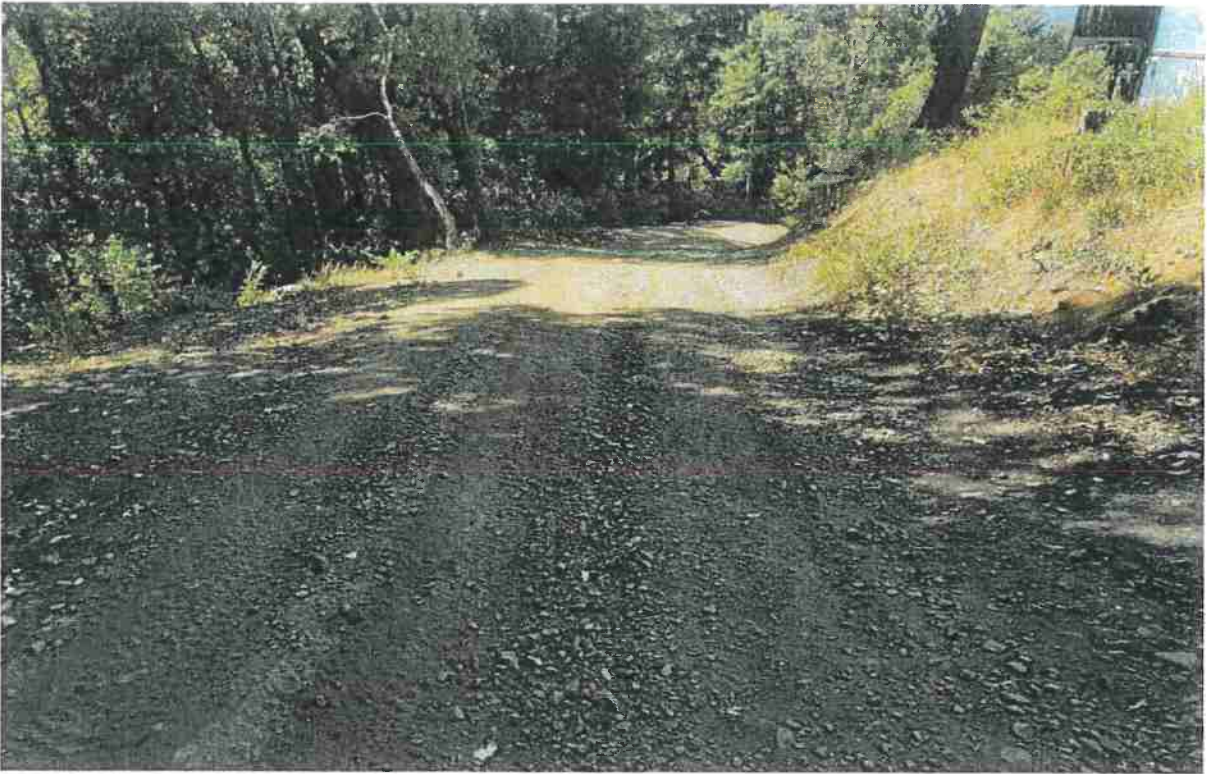
Photo looking up grade at the erosional gully at Site 03.

Photo looking down grade at the erosional gully at Site 03.

Unique Point	Lat-Long NAD 83	Road Type	Mitigation Planned	Monitor	1600	Treatment Priority	Date Completed
Site 03	-124.002912 40.254908	Permanent	X	-	-	Prior to 10/15/22	
Current Condition: Permanent road leading down to Cultivation Area A contains an erosional gully that extends up to the parking lot of the residence. The road is currently outsloted with dirt surfaces.						Prescribed Action: Regrade the road with gentle outsloting from Site 01 to Site 03 then install a waterbar per the specifications outlined in the attached BMPs: Waterbar Construction, General Operations BMPs, and General Erosion Control specifications. Maintain as needed per Cannabis Cultivation Policy, Att. A, Sec. 2, - Term 1 - 29.	
Unique Point	Lat-Long NAD 83	Road Type	Mitigation Planned	Monitor	1600	Treatment Priority	Date Completed
Site 04	-124.002689 40.255078	Permanent	X	-	X	Prior to 10/15/22 pending the approval of any required permits

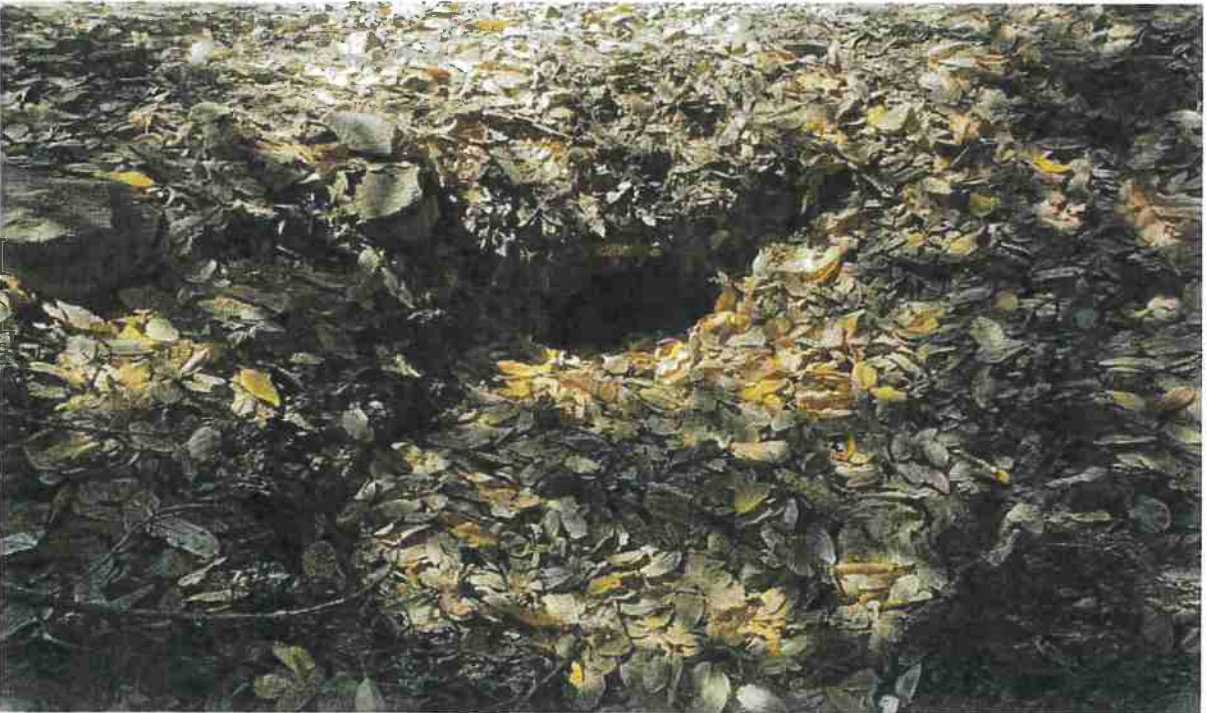
Current Condition: Existing 18-inch diameter corrugated metal culvert on a Class III watercourse. Culvert is undersized, shot-gunned, and partially plugged with forest litter at the inlet.						Prescribed Action: Clean-out inlet then upgrade culvert to minimum 36-inch diameter culvert that is installed to grade, aligned with the natural stream channel, and long enough that it extends lengthwise completely beyond the toe of fill. The crossing upgrade will require the excavation and temporary displacement of approximately 44 cubic yards of fill (30 feet long by 10 feet deep by 4 feet wide) and 120 ft ² of overall disturbance (30 feet length and 4 feet width) per the LSAA #1600-2019-0447-R1.

Photo looking at the inlet of the culvert at Site 04.

Photo looking at the outlet of the culvert at Site 04.

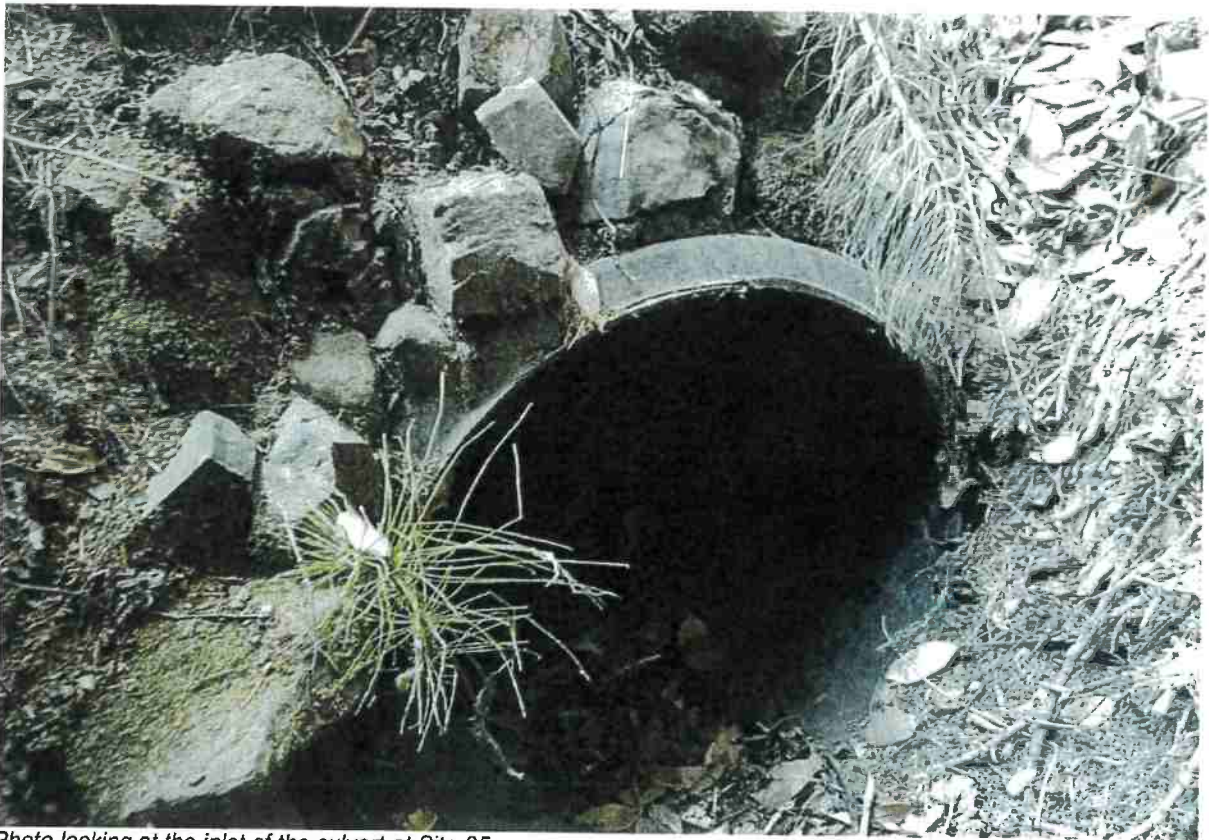
Photo looking at the inlet of the culvert at Site 05.

Photo looking at the outlet of the culvert at Site 05.

Unique Point	Lat-Long NAD 83	Road Type	Mitigation Planned	Monitor	1600	Treatment Priority	Date Completed
Site 05	-124.002172 40.25481	Permanent	X	-	X	Prior to 10/15/22 pending the approval of any required permits	
Current Condition: Existing 24-inch diameter corrugated plastic culvert on a Class III watercourse. The culvert is undersized, too short, and shot-gunned.						Prescribed Action: Upgraded to a 30-inch diameter culvert to grade, aligned with the natural stream channel, and long enough that it extends lengthwise completely beyond the toe of fill. The crossing upgrade will require the excavation and temporary displacement of approximately 41 cubic yards of fill (35 feet long by 8 feet deep by 4 feet wide) and 140 ft ² of overall disturbance (30 feet length and 4 feet wide) per the LSAA #1600-2019-0447-R1.	
Unique Point	Lat-Long NAD 83	Road Type	Mitigation Planned	Monitor	1600	Treatment Priority	Date Completed

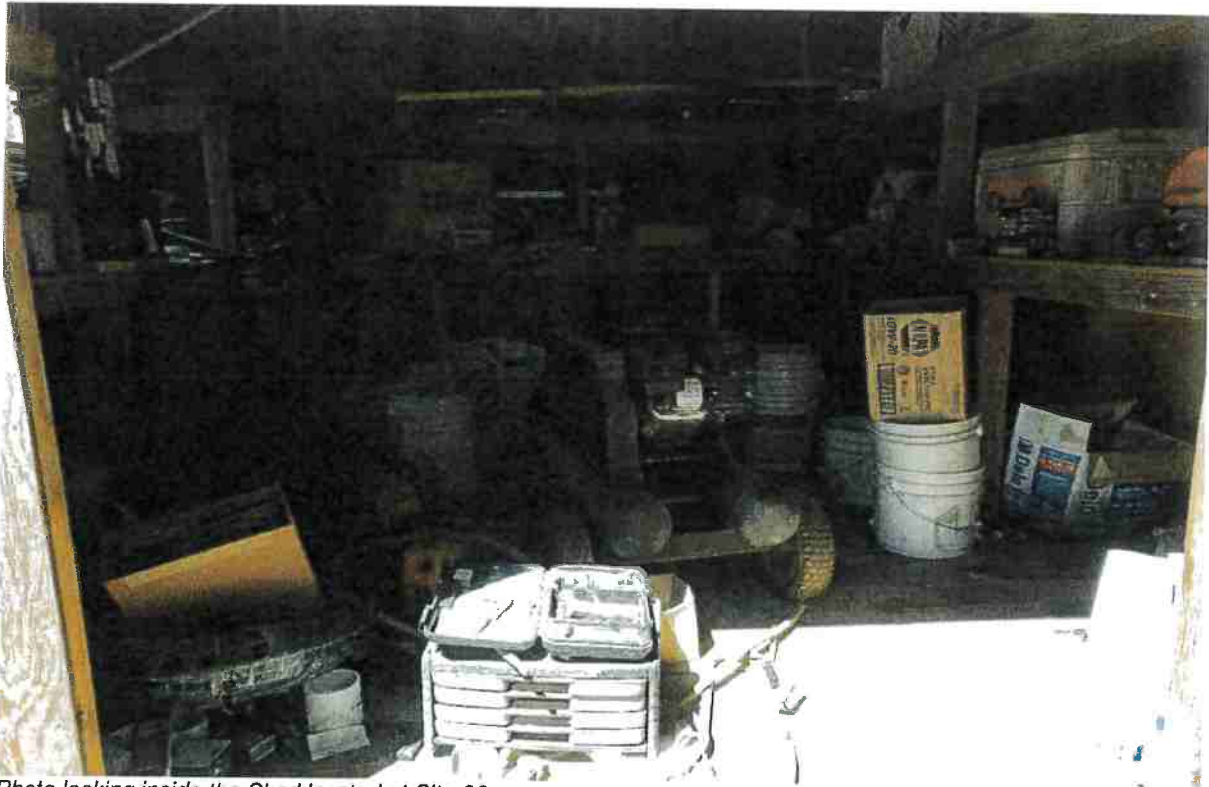
Photo looking at the outside of the Shed at Site 06.

Photo looking inside the Shed located at Site 06.

Site 06	-124.002108 40.254772	Permanent	X	-	-	Prior to 10/15/21	
Current Condition: Shed used for storage of petroleum products is located within the riparian setback of a Class III watercourse. The shed has wooden floors and adequate cover, but petroleum products are not in proper secondary containment.						Prescribed Action: Put all petroleum products in proper secondary containment. See attached BMPs: Generator, Fuel, and Oil Management for further details. All petroleum products are required to be used and stored per Cannabis Cultivation Policy, Att. A, Sec. 2, - Term 103 - 110, and 116 - 118 attached.	
Unique Point	Lat-Long NAD 83	Road Type	Mitigation Planned	Monitor	1600	Treatment Priority	Date Completed
Site 07	-124.001691 40.254495	Permanent	X	-	X	Prior to 10/15/22 pending the approval of any required permits	
Current Condition: Existing 24-inch diameter corrugated plastic culvert on a Class III watercourse. The culvert is adequately sized, slightly shot-gunned, and the inlet is partially buried.						Prescribed Action: Replace 24-inch diameter corrugated plastic culvert with 24-inch diameter corrugated metal culvert that is set to grade and aligned correctly. Rock armor the inlet and outlet with appropriately sized rock per the LSAA #1600-2019-0447-R1.

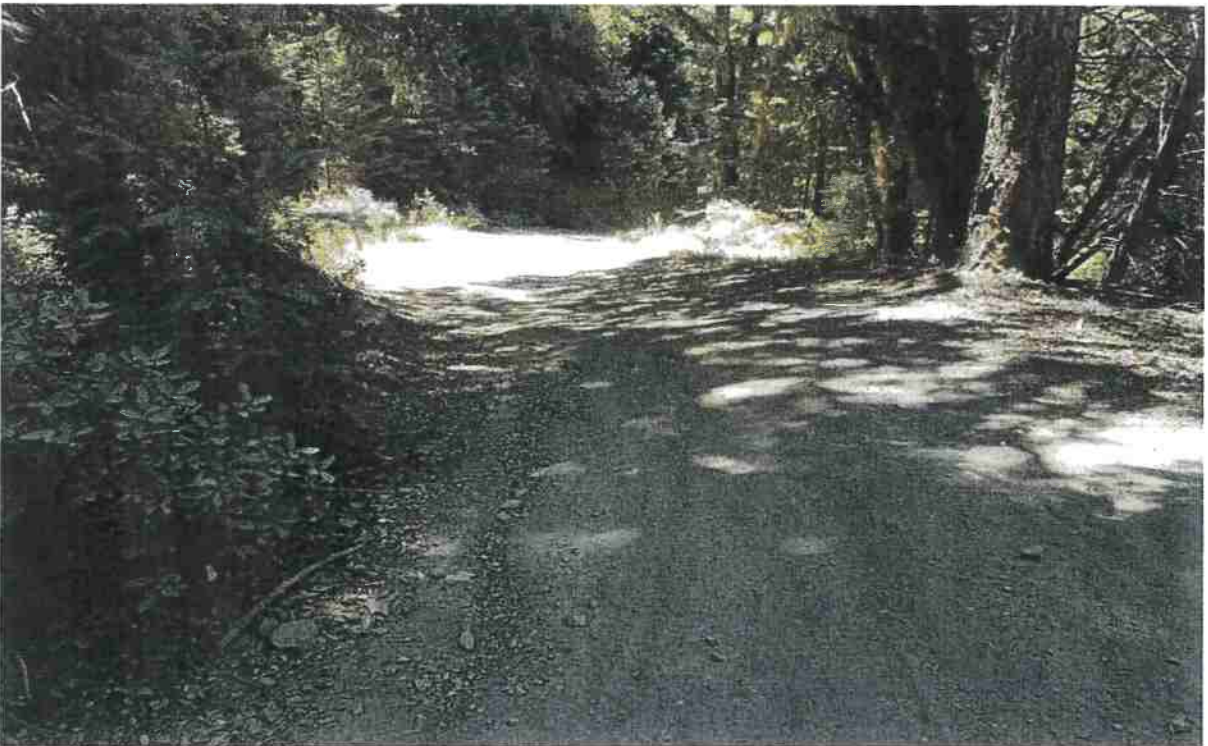
Photo looking up grade at the erosion at Site 11.

Photo looking down grade at the erosion at Site 11.

Photo looking at where the proposed rock armored lead out will be at Site 11.

Unique Point	Lat-Long NAD 83	Road Type	Mitigation Planned	Monitor	1600	Treatment Priority	Date Completed
Site 11	-124.001157 40.255205	Permanent	X	-	-	Prior to 10/15/22	
Current Condition: Erosional gully exists on a permanent road downhill of Cultivation Area B. The section of road with erosion occurring is located within riparian setbacks of two separate Class III watercourses and has the potential of becoming hydrologically connected to both watercourses.						Prescribed Action: Regrade the road from Site 11 to Site 13 with gentle outsloping then install a rolling dip along with a 8' x 8' leadout that is rock armored with adequate sized rock. See "Rolling Dip Design and Placement" in the attached BMP's. See Cannabis Cultivation Policy, Att. A, Sec. 2, - Term 1 - 29 that is attached for specifications.	
Unique Point	Lat-Long NAD 83	Road Type	Mitigation Planned	Monitor	1600	Treatment Priority	Date Completed

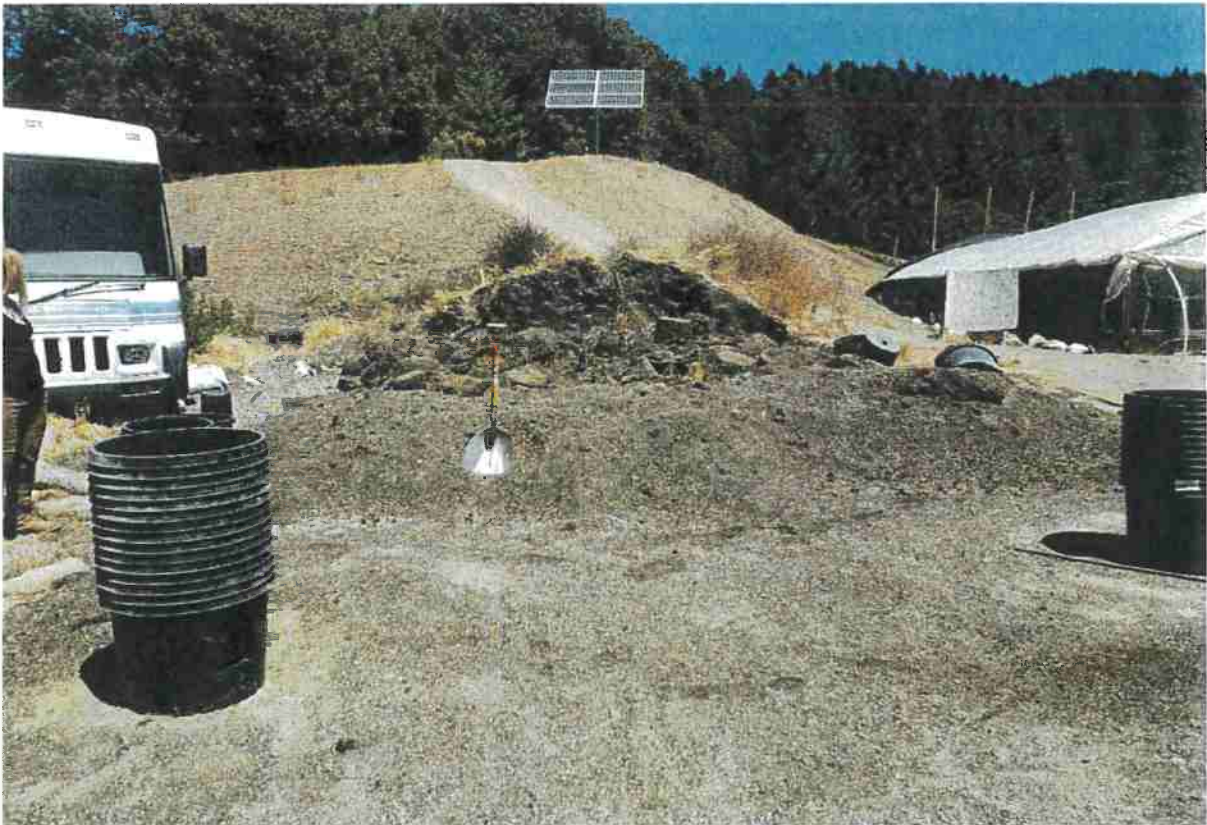
Photo looking at the uncovered soil pile at Site 22.
