# Water Resource Protection Plan

**WDID: 1B171721CHUM**

**APN(s): 208-111-029 (Humboldt)**

**Timberland Resource Consultants**

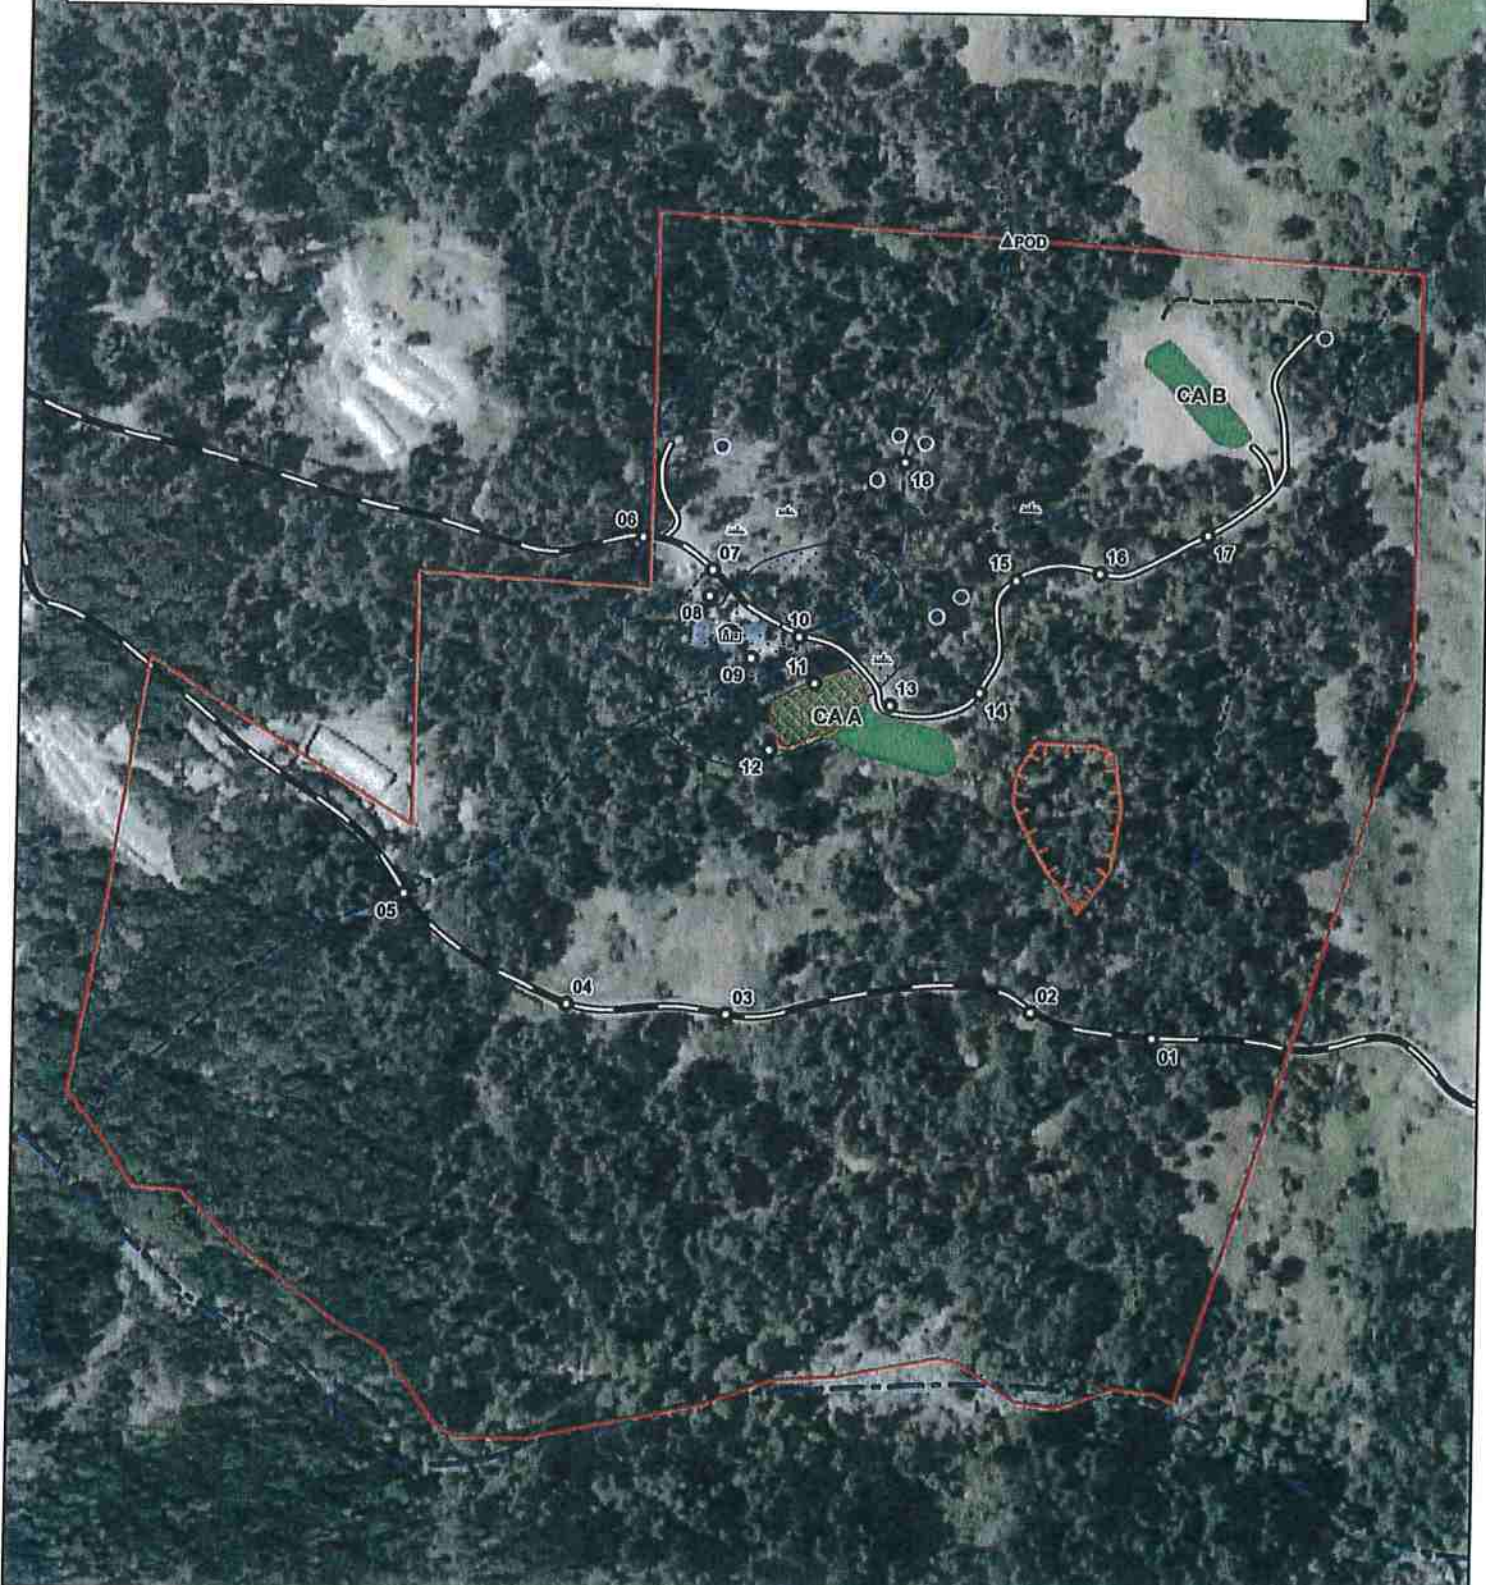
2016 NAIP DOQ  
Map Scale 1" = 225'  
Map Date 3/2/2018

Unique Point	Lat-Long NAD 83	Road Type	Mitigation Planned	Monitor	1600	Standard Conditions	Treatment Priority	Date Completed
1	-123.760481 40.472664	Permanent	X	X	X	A.2.	Interim measures immediately; Mitigation measures prior to 10/15/18 pending the approval of any required permits	
<p><b>Current Condition:</b> Class III watercourse crossing consisting of an 12-inch square steel pipe. The crossing is undersized and has plugged with debris, resulting in the diversion of the watercourse down the road to the outlet of the ditch relief culvert at Site 02.</p>						<p><b>Prescribed Action:</b> Interim measures: Clear the plugged inlet of the pipe of debris. Permanent measures: Replace existing pipe with a 36-inch culvert per attached specifications.</p>		
Unique Point	Lat-Long NAD 83	Road Type	Mitigation Planned	Monitor	1600	Standard Conditions	Treatment Priority	Date Completed
2	-123.761028 40.472741	Permanent	X	X	-	A.1.	Prior to 10/15/19

<p><b>Current Condition:</b> Ditch relief culvert consisting of a 13-inch steel pipe. The pipe is undersized, exposed in the road pad, installed at too sharp of an angle, shot-gunned, and eroding the fillslope at the outlet. Also, the inside ditch drained by the ditch relief culvert has become filled in and is no longer adequately capturing and draining road runoff. The road also is not insloped for approximately 75-feet up grade, preventing the inside ditch from adequately capturing road runoff.</p>						<p><b>Prescribed Action:</b> Replace the existing pipe with an 18-inch diameter ditch relief culvert per attached specifications. Clear and re-establish the inside ditch for 100-feet up grade. Grade and inslope the road into the inside ditch.</p>		
Unique Point	Lat-Long NAD 83	Road Type	Mitigation Planned	Monitor	1600	Standard Conditions	Treatment Priority	Date Completed
3	-123.762372 40.472712	Permanent	X	X	-	A.1.	Prior to 10/15/19

<p><b>Current Condition:</b> Ditch relief culvert consisting of a 13-inch steel pipe that is undersized and installed at too sharp of an angle. Also, the inside ditch drained by the ditch relief culvert has become filled in and is no longer adequately capturing and draining road runoff.</p>						<p><b>Prescribed Action:</b> Replace the existing pipe with an 18-inch diameter ditch relief culvert per attached specifications. Clear approximately 50-feet of the inside ditch up grade.</p>		
Unique Point	Lat-Long NAD 83	Road Type	Mitigation Planned	Monitor	1600	Standard Conditions	Treatment Priority	Date Completed
4	-123.763478 40.472857	Permanent	X	X	-	A.1.	Prior to 10/15/18	
<p><b>Current Condition:</b> Road surface runoff is eroding the road pad and draining to the watercourse crossing at Site 05.</p>						<p><b>Prescribed Action:</b> Install a rocked rolling dip per attached specifications.</p>

Unique Point	Lat-Long NAD 83	Road Type	Mitigation Planned	Monitor	1600	Standard Conditions	Treatment Priority	Date Completed
5	-123.763829 40.4731	Permanent	X	X	X	A.2.	Prior to 10/15/20 pending the approval of any required permits	
<p><b>Current Condition:</b> Class II watercourse crossing consisting of two 12-inch diameter square pipes stacked on top of each other. The crossing is undersized, too short, and lacks rock armoring of the inlet and outlet. Two inside ditches also drain into the inlet of the crossing.</p>						<p><b>Prescribed Action:</b> Replace the existing pipe with a 42-inch diameter culvert per attached specifications. Grade, inslope, and rock the road above the crossing for the entire length of the crossing road fill prism, approximately 30-feet in either direction.</p>

Unique Point	Lat-Long NAD 83	Road Type	Mitigation Planned	Monitor	1600	Standard Conditions	Treatment Priority	Date Completed
6	-123.762792 40.474323	Permanent	-	X	-	A.2.		
Current Condition: Class III watercourse crossing consisting of a 36-inch diameter corrugated metal pipe. The crossing is adequately sized and functioning properly.						Prescribed Action: None. Monitor.		
Unique Point	Lat-Long NAD 83	Road Type	Mitigation Planned	Monitor	1600	Standard Conditions	Treatment Priority	Date Completed
7	-123.762481 40.474217	Permanent	X	X	-	A.1.	Prior to 10/15/20	
Current Condition: Low spot drainage pipe consisting of a 12-inch diameter steel pipe. The pipe is plugging with debris and misaligned with the low spot. A Class III watercourse begins at the outlet of the drainage pipe.						Prescribed Action: Replace the existing culvert with a 15 or 18-inch diameter culvert per attached specifications. Install an inside ditch along the road pad to better drain the low spot.

Unique Point	Lat-Long NAD 83	Road Type	Mitigation Planned	Monitor	1600	Standard Conditions	Treatment Priority	Date Completed
8	-123.762491 40.47413	-	X	X	-	A.3.	Prior to 10/15/18	
Current Condition: A potted tomato garden is located directly above a Class III watercourse at this site.						Prescribed Action: Remove all cultivation soils and materials from this site. Discontinue use of this location as a veggie garden.		
Unique Point	Lat-Long NAD 83	Road Type	Mitigation Planned	Monitor	1600	Standard Conditions	Treatment Priority	Date Completed
9	-123.762308 40.473922	-	X	X	-	A.11.	Prior to 10/15/19	
Current Condition: Multiple grey-water pipes are draining onto the bank of a watercourse.						Prescribed Action: Install a greywater seepage pit and install the outlets of the pipes a minimum of 6-inches beneath the surface of the ground into the pit. See attached specifications for further details.

Unique Point	Lat-Long NAD 83	Road Type	Mitigation Planned	Monitor	1600	Standard Conditions	Treatment Priority	Date Completed
10	-123.762103 40.473998	Permanent	X	X	X	A.2.	Interim measures Immediately; Mitigation measures prior to 10/15/20 pending the approval of any required permits	
Current Condition: Class II watercourse crossing consisting of two 12-inch diameter square steel pipes stacked on top of each other. The crossing is undersized, too short, and lacks rock armoring of the inlet and outlet. The crossing has completely plugged in the past with the lower pipe still plugged. The diversion of the watercourse across the road and back into its channel has also occurred in the past. Construction debris is also on the banks of the outlet as well.						Prescribed Action: Interim measures: Clear the plugged inlet of the lower pipe of debris. Remove construction debris from the outlet area of the culvert. Permanent measures: Replace the existing pipe with a 36-inch diameter culvert per attached specifications.

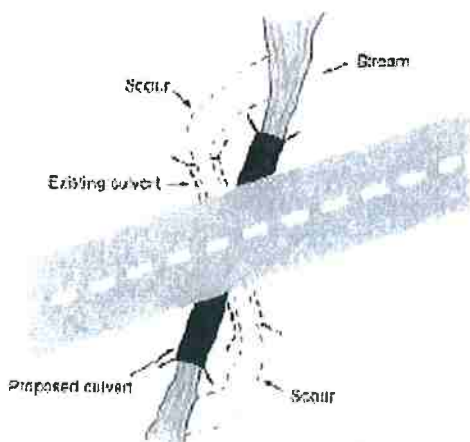
**FIGURE 97.** Culvert alignment should be in relation to the stream and not the road. It is important that the stream enters and leaves the culvert in a relatively straight horizontal alignment so streamflow does not have to turn to enter the inlet or discharge into a bank as it exits. This figure shows a redesigned culvert installation that replaces the bending alignment that previously existed. Channel turns at the inlet increase plugging potential because wood going through the turn will not align with the inlet. Similarly, channel turns at the inlet and outlet are often accompanied by scour against the channel banks (Wisconsin Transportation Information Center, 2004).

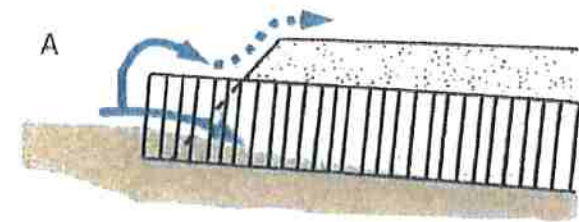
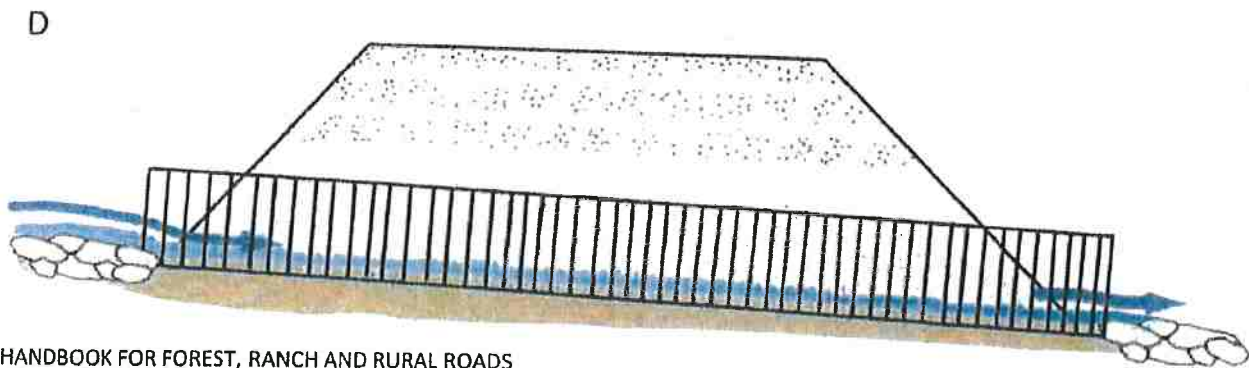
**FIGURE 155.** Proper culvert installation involves correct culvert orientation, setting the pipe slightly below the bed of the original stream, and backfilling and compacting the fill as it is placed over the culvert. Installing the inlet too low in the stream (A) can lead to culvert plugging, yet if set too high (B) flow can undercut the inlet. If the culvert is placed too high in the fill (C), flow at the outfall will erode the fill. Placed correctly (D), the culvert is set slightly below the original stream grade and protected with armor at the inlet and outlet. Culverts installed in fish-bearing stream channels must be inset into the streambed sufficiently (>25% embedded) to have a natural gravel bottom throughout the culvert (Modified from: MDSL, 1991).

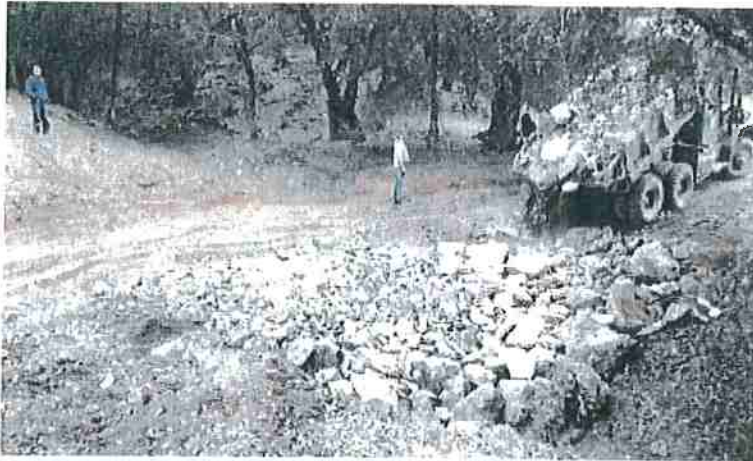
**FIGURE 121D.** Well graded rock armor is then backfilled into the structure and spread across the breadth of the U-shaped stream crossing, and about one-third the way up the roadbed, so that streamflow will only flow over or come in contact with resistant armor material. The armor must be spread and compacted across the design width of the expected flood flow channel width so peak flows will not flank the armored structure.

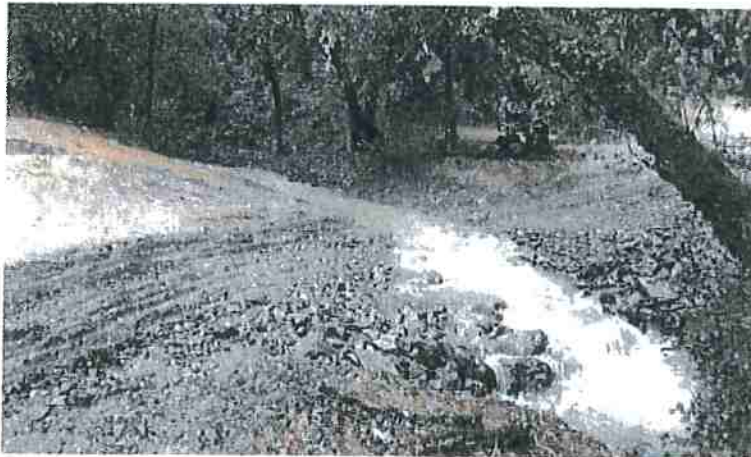
**FIGURE 121E.** Two weeks after this armored fill was constructed, a storm flow event occurred and the structure maintained its function and integrity. The road approaches had not yet been compacted or surfaced with road rock.

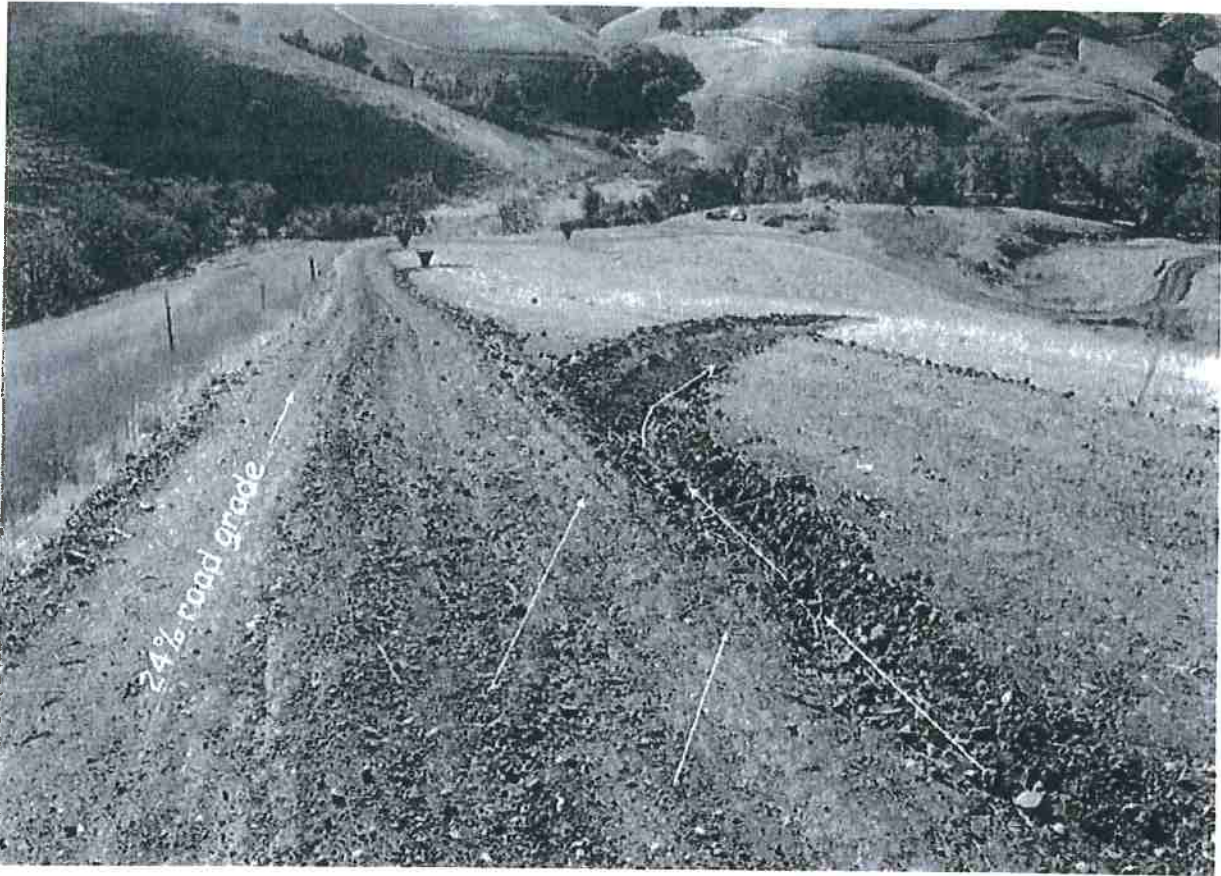
**FIGURE 55.** Steep roads that go straight up or down a hillside are very difficult to drain. This steep, fall line road developed a through cut cross section that was drained using lead out ditches to direct runoff off the road and onto the adjacent, vegetated hillside. The road was "outsloped" to drain runoff to the right side, and the lead out ditch was built slightly steeper than the road grade, to be self-cleaning. Four lead out ditches have been constructed at 100-foot intervals to the bottom of the hillside.

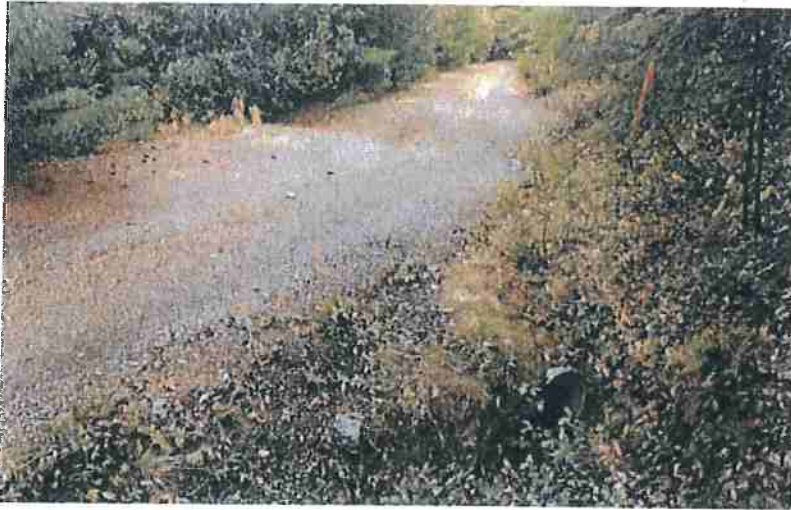
**FIGURE 39.**

*Waterbars are often used to drain surface runoff from seasonal, unsurfaced roads. Because they are easily broken down by vehicles, waterbars are only used on unsurfaced roads where there is little or no wet weather traffic. In this photo, a waterbar and ditch relief culvert are used to drain all road surface and ditch runoff from the insloped road prism.*

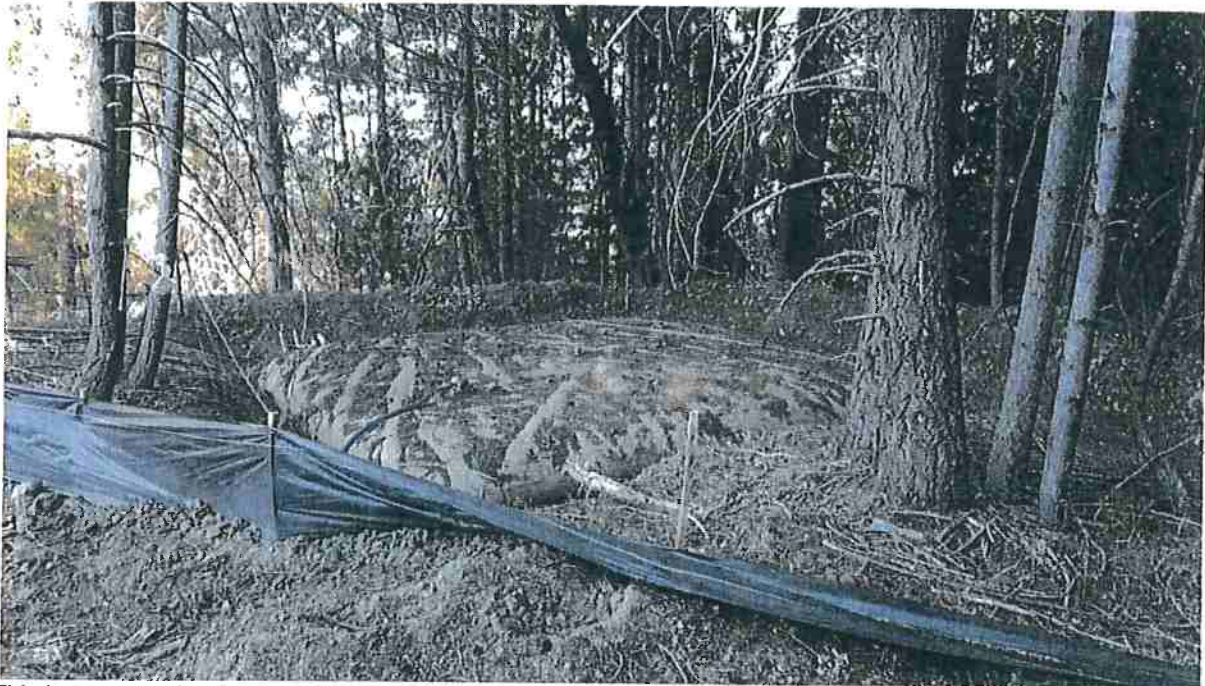
*This is an example of a containment pit which will assist in mitigating the impacts if this storage bladder failed.*
