### HUMBOLDT COUNTY DEPARTMENT OF PUBLIC WORKS ROAD EVALUATION REPORT

Applicant Name: Lost Creek Farms APN: 211-184-006

# TECHNICAL MEMORANDUM

Subject: Road Evaluation for APN: 211-184-006

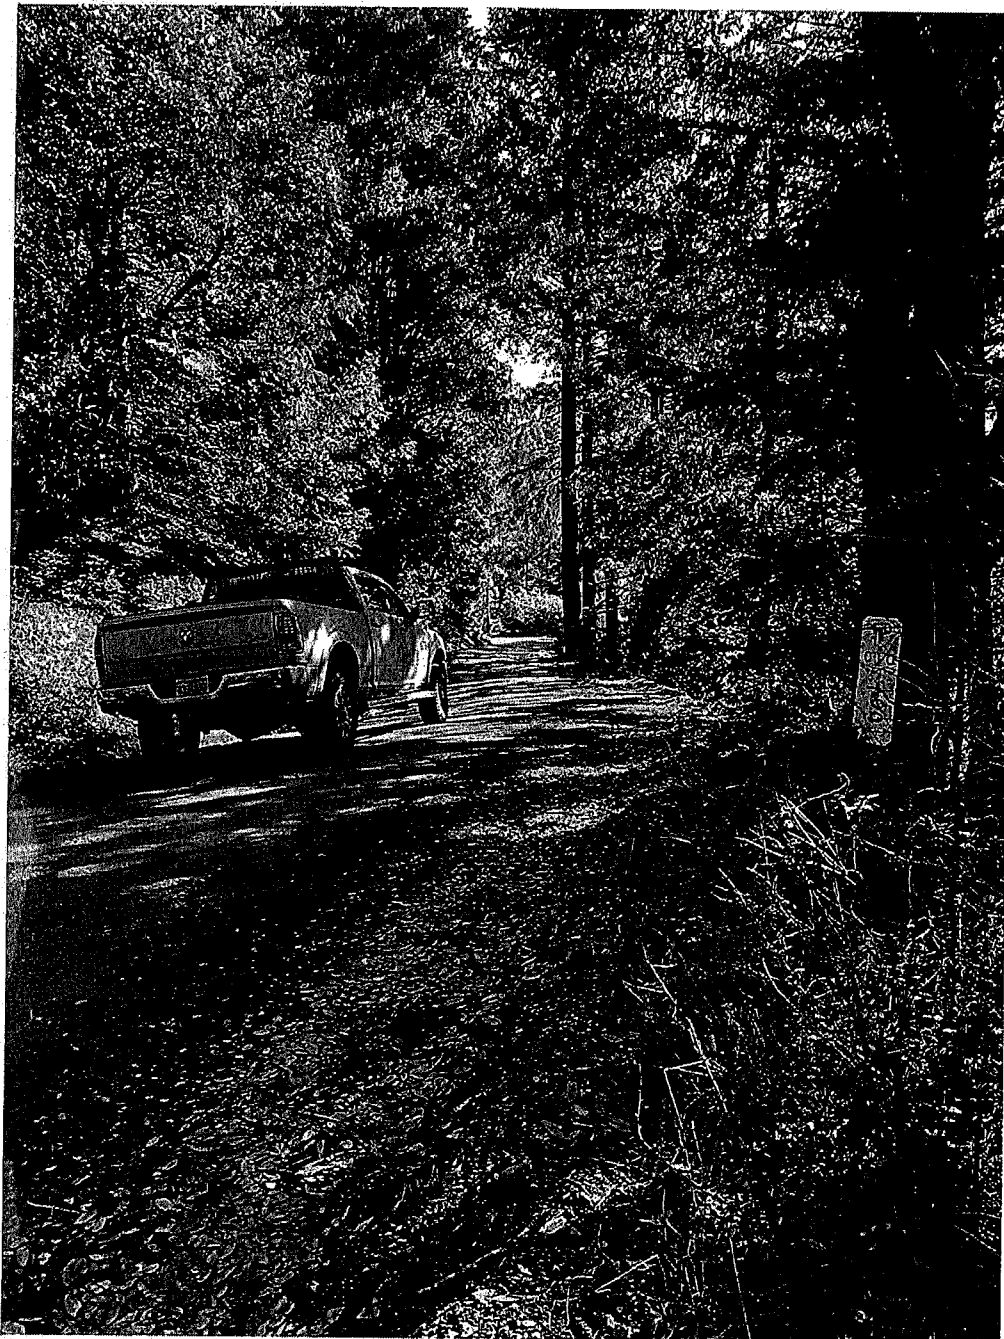
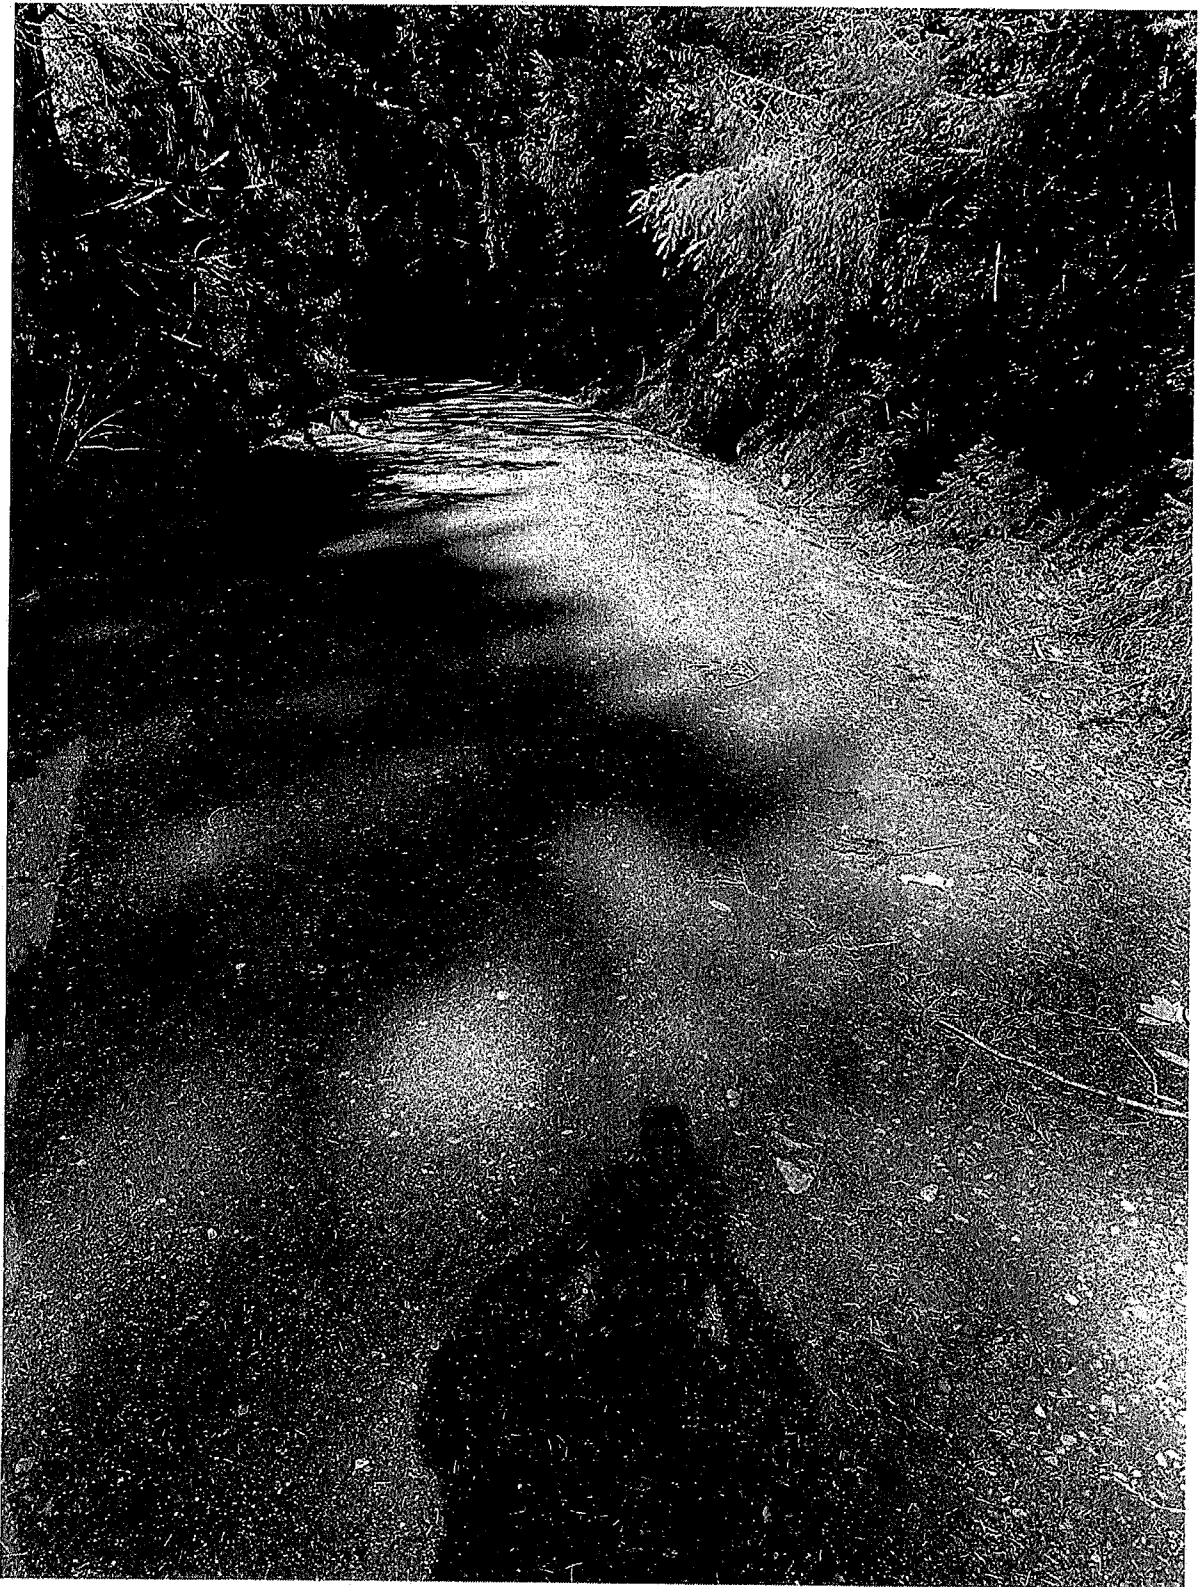
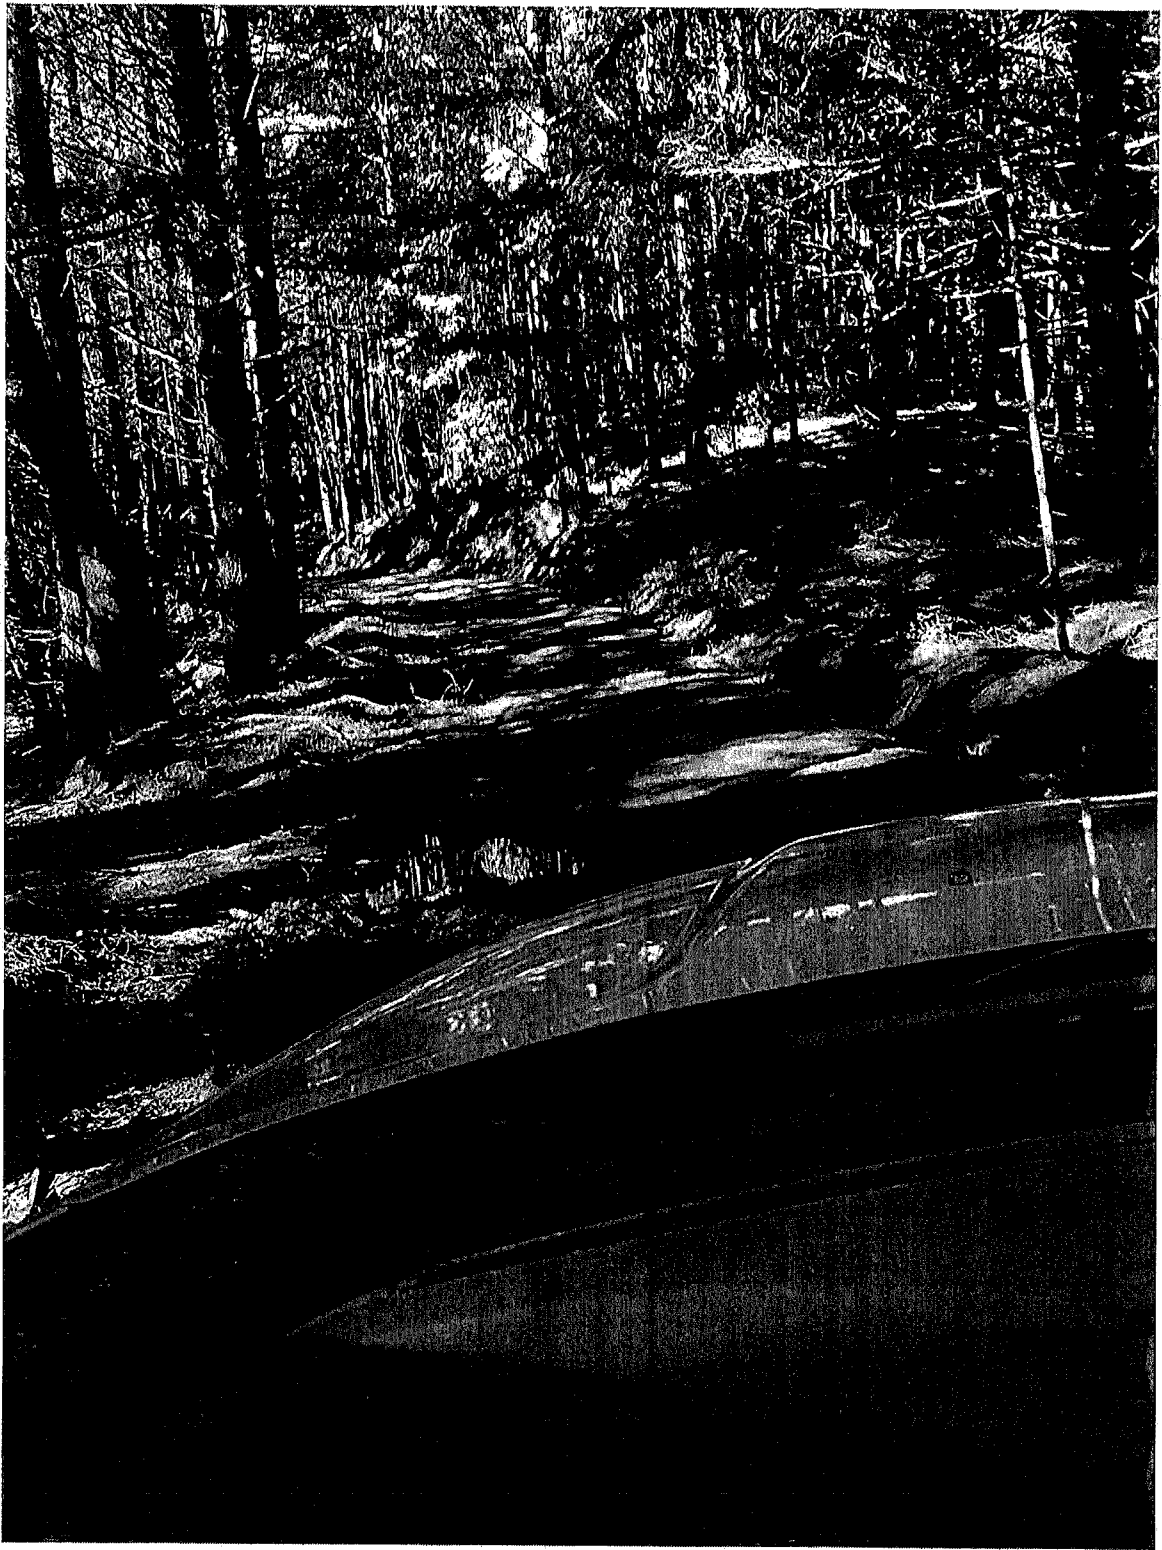
Appendix A  
Photos

Overall, the 1.7 mile segment of Private Drive is in relatively good condition. The road has been blocked off due to a slide and is unusable until the county repairs the road. There is no evidence of skid marks along the segment. The road is fairly narrow, but it only serves \_\_\_\_\_ property(s) so the width is adequate.

Brush Trimming to improve visibility, County repair for road-slide needed
