JOURNEY AQUARIAN – HUMBOLDT KINGZ, LLC
RESTORATION PLAN
APN: 216-136-004 / 216-135-008

COMMERCIAL CANNABIS CULTIVATION FACILITIES

**Restoration Plan
Journey Aquarian of Humboldt Kingz, LLC
APN # 216-135-008 / 216-136-004
Apps # 12125
CUP16-539**

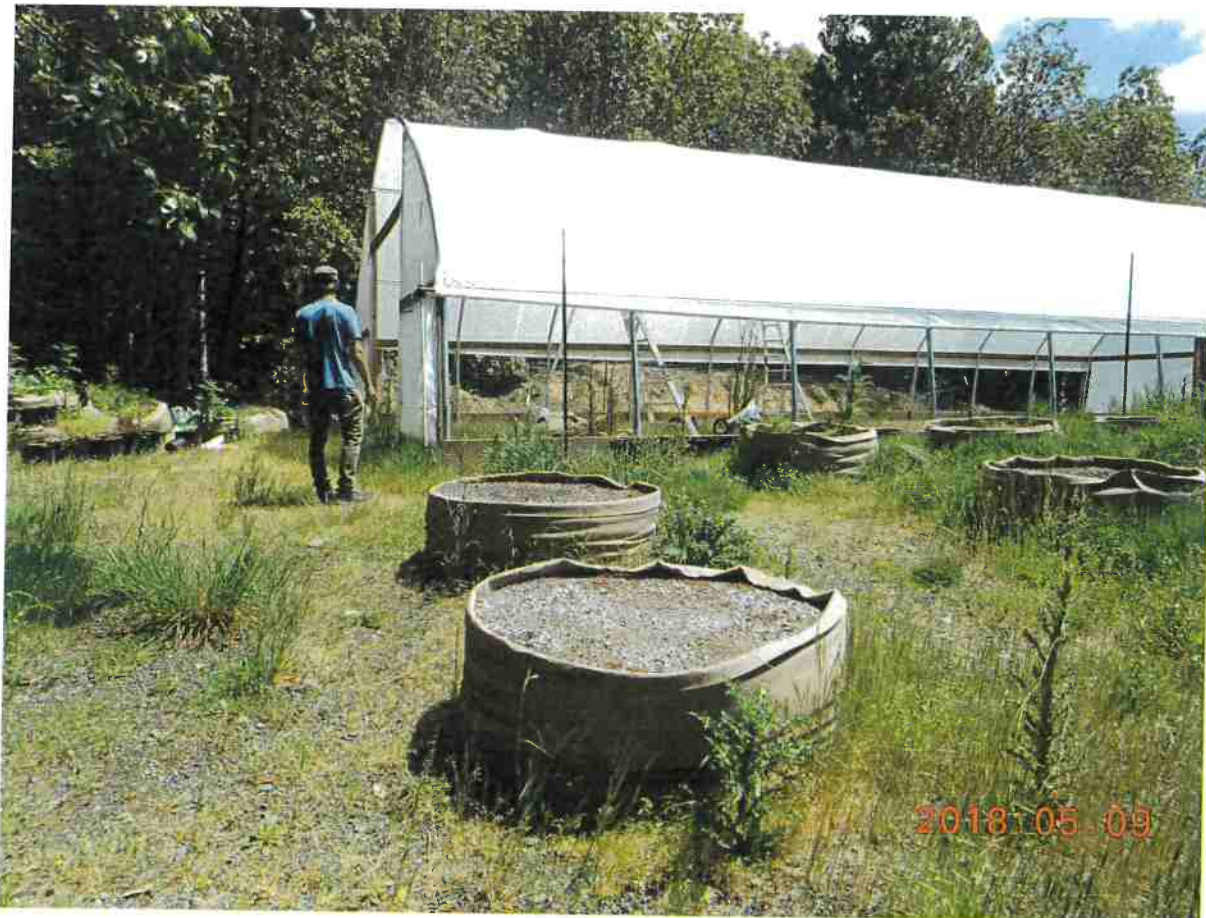
Cultivation Area A – Greenhouse proposed to be relocated

- Area A historically had approximately 7,000 sq. ft. of outdoor cultivation and light-deprivation cultivation in a 30' x 50' greenhouse. This greenhouse may be relocated to Area H or I due to proximity to the property boundary (boundary survey pending).
