Water Resource Protection Plan

APN 522-026-007

Timberland Resource Consultants

08-3-2016

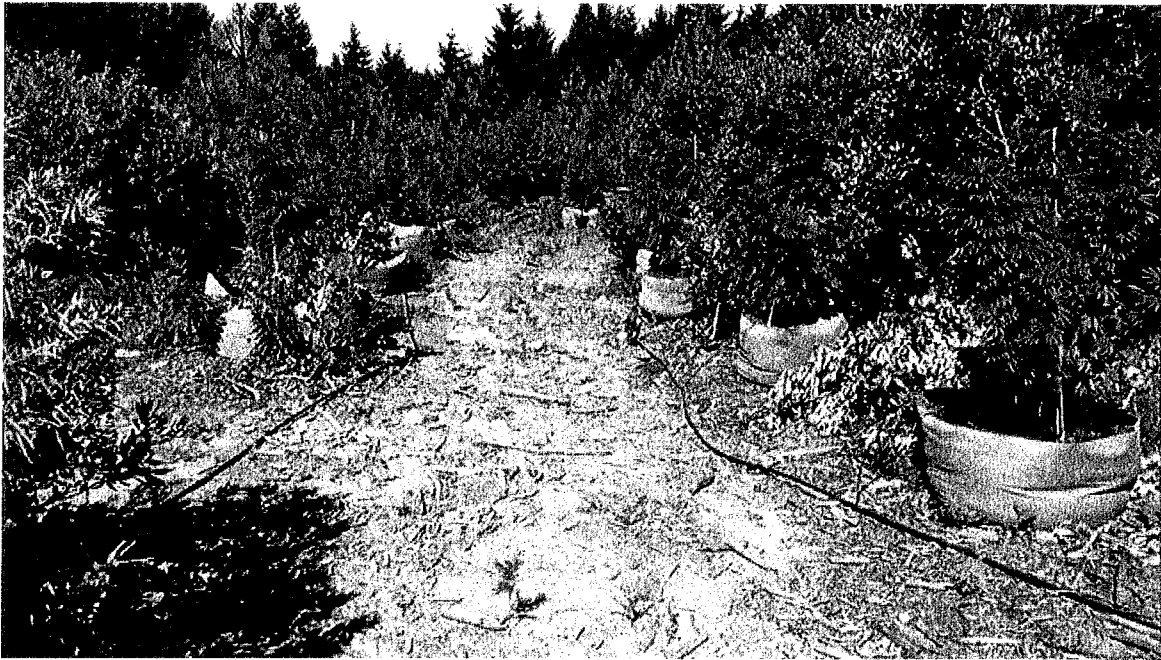
Figure 1: Cultivation site #1 July 25th 2016

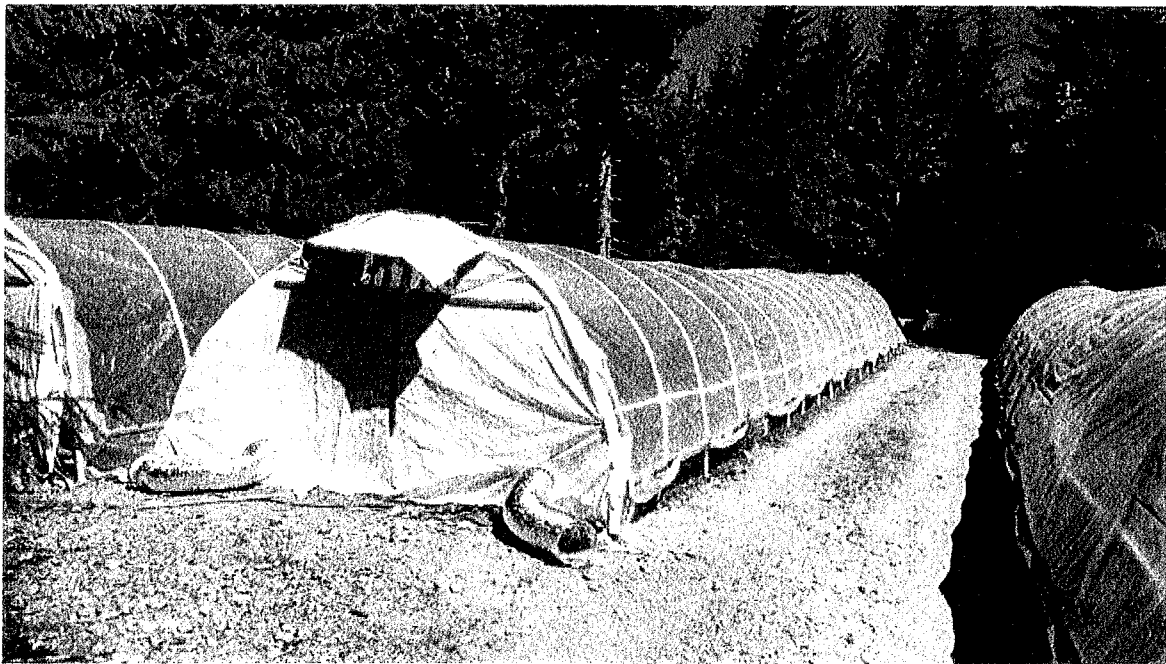
Figure 2: Cultivation Site #2 July 25th 2016

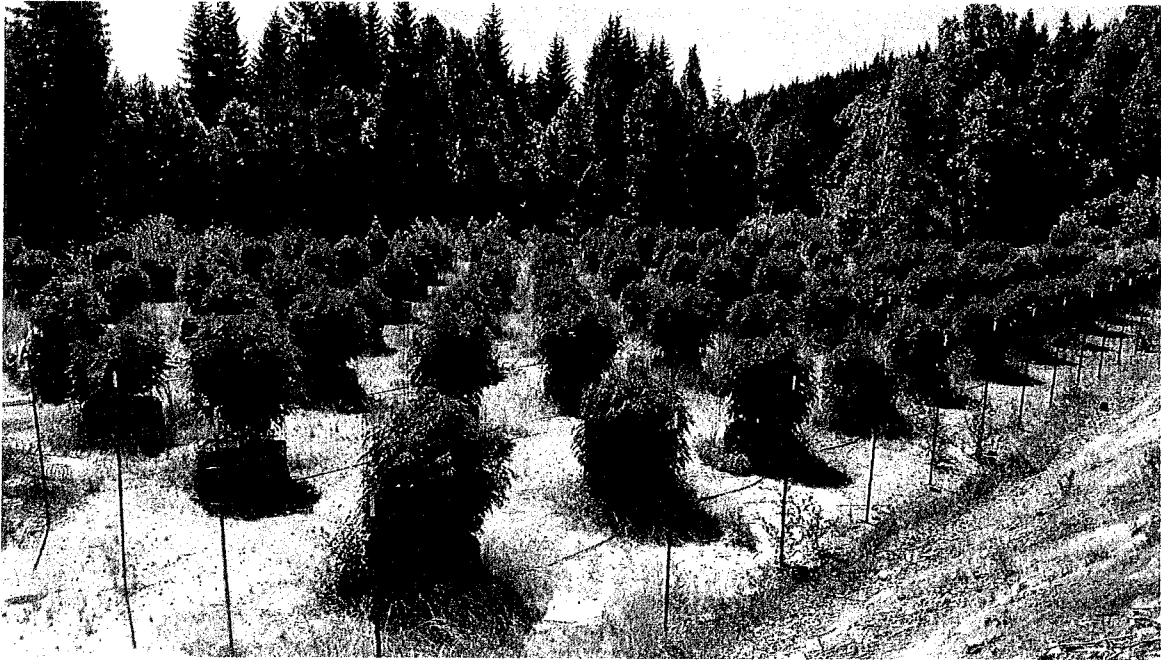
Figure 3: Cultivation Site #3 July 25th 2016

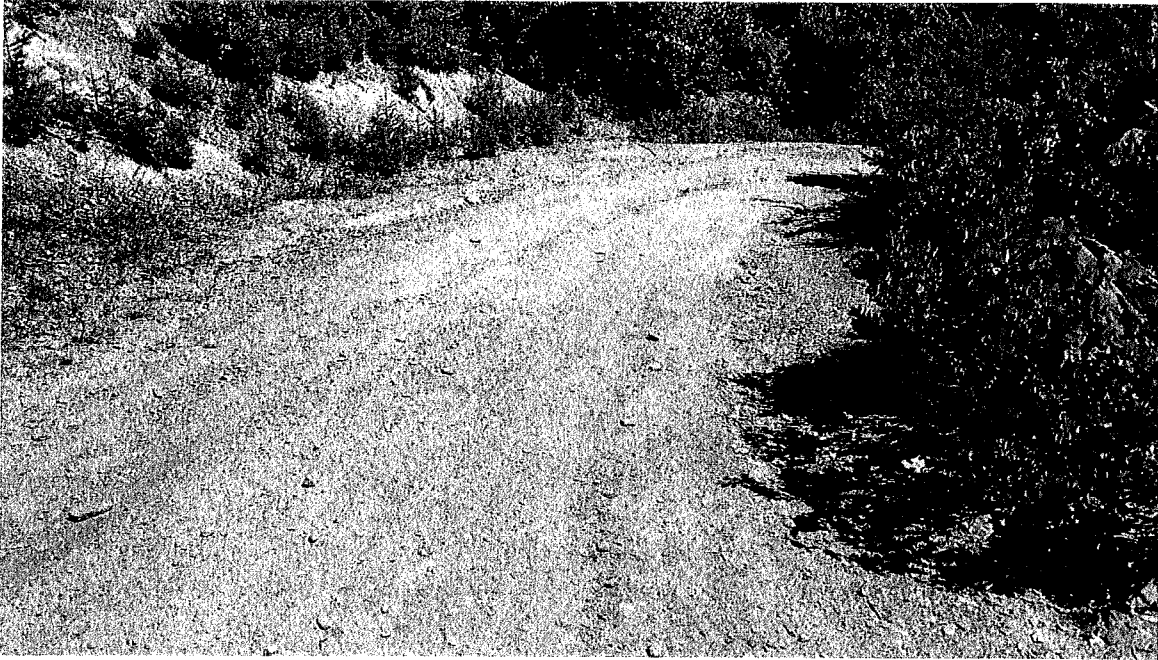
Road Point 2: Alternate view of road erosion. Water is running down the middle of the road. The mitigation measures will improve the longevity of the road and reduce sediment delivery

Road point 2: Alternate view of road erosion. Water is running down the middle of the road. We recommend a water bar or rolling dip be implemented to divert surface water off the roadway. The mitigation measures will improve the longevity of the road and reduce sediment delivery in heavy storm events.(See figure 36 & 40) July 25th 2016

in heavy storm events. We recommend a drainage feature between road point 1 and 2. The drainage feature recommended would be a rolling dip or water bar to get water off the road then a small ditch to direct the flow to the adjacent woodlands.

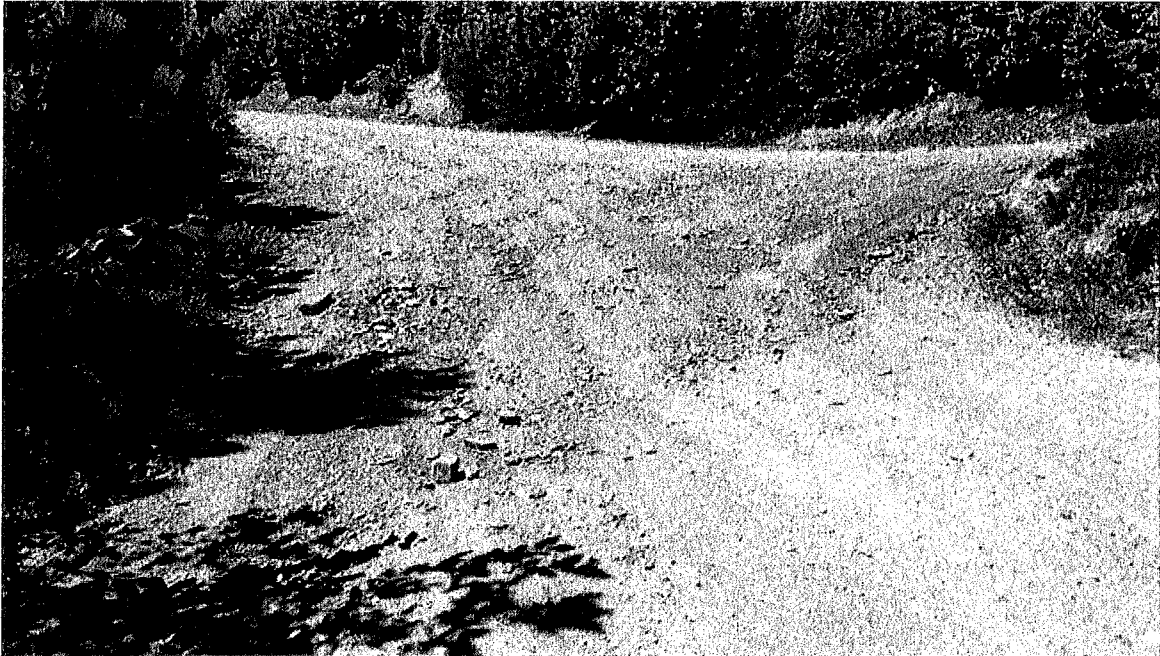
Road Point 3: A rolling dip is installed at this location to direct road runoff off of the road. Owner will monitor and maintain the rolling dip so that road runoff is adequately diverted.

Unique Point	UTM 10 NAD 83	Road Type	Mitigation Planned	Monitor	1600	Standard Conditions	Treatment Priority	Date Completed
RP 3	436028 4537287	Seasonal		X		A.1.a.; A.1.b	Prior to 11/15/17 pending approval of applicable permits	
Current Condition: A water bar is installed at this location to direct road runoff off of the road.						Prescribed BMP: Owner will monitor and maintain the water bar so that road runoff is adequately diverted.		
Unique Point	UTM 10 NAD 83	Road Type	Mitigation Planned	Monitor	1600	Standard Conditions	Treatment Priority	Date Completed
MP 1	436056 4536254	Seasonal	X	X		A.11.c	Prior to 11/15/16 pending approval of applicable permits	
Current Condition: Trash is being collected in one area and is not adequately contained. Owner assured us he regularly takes trash to the dump. No immediate threat to any waterway.						Prescribed BMP: We recommend that this collection of trash be properly disposed of and that future piles of trash be contained better to minimize the chance of it being blown away,

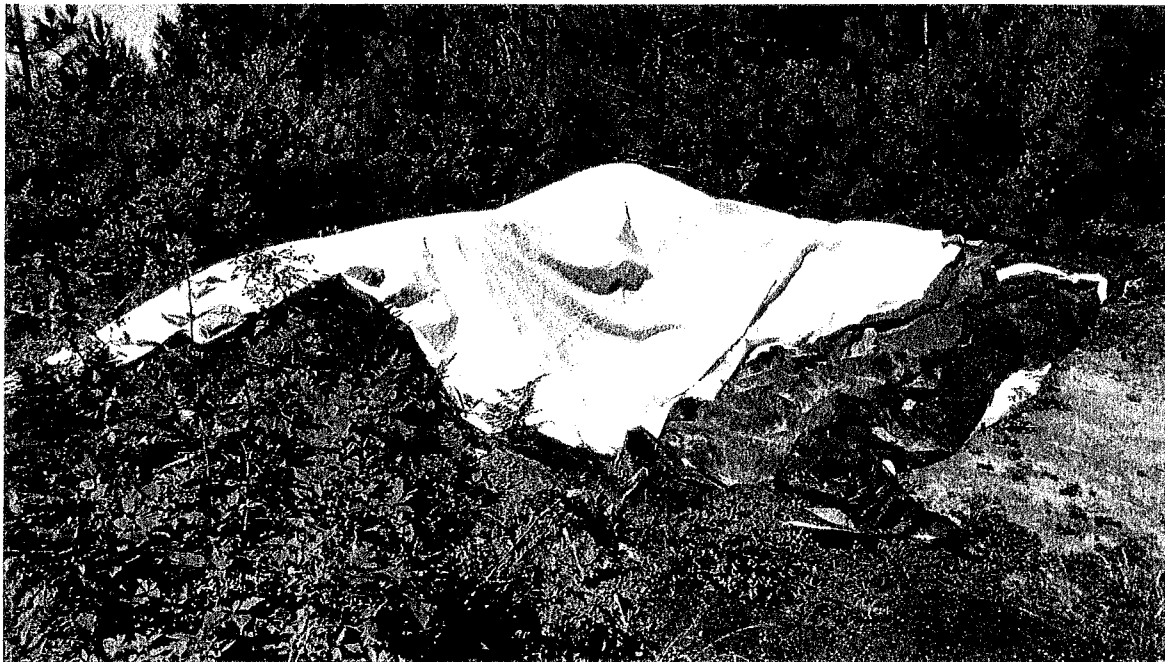
There was one small spoils pile. Current status is, no immediate threat to waterway infiltration. Soils that were found are appropriately covered by tarps, top and bottom, and will be used this season. This standard condition is being met at this time.

Figure 4: Evidence of compliant spoils storage. July 25th 2016

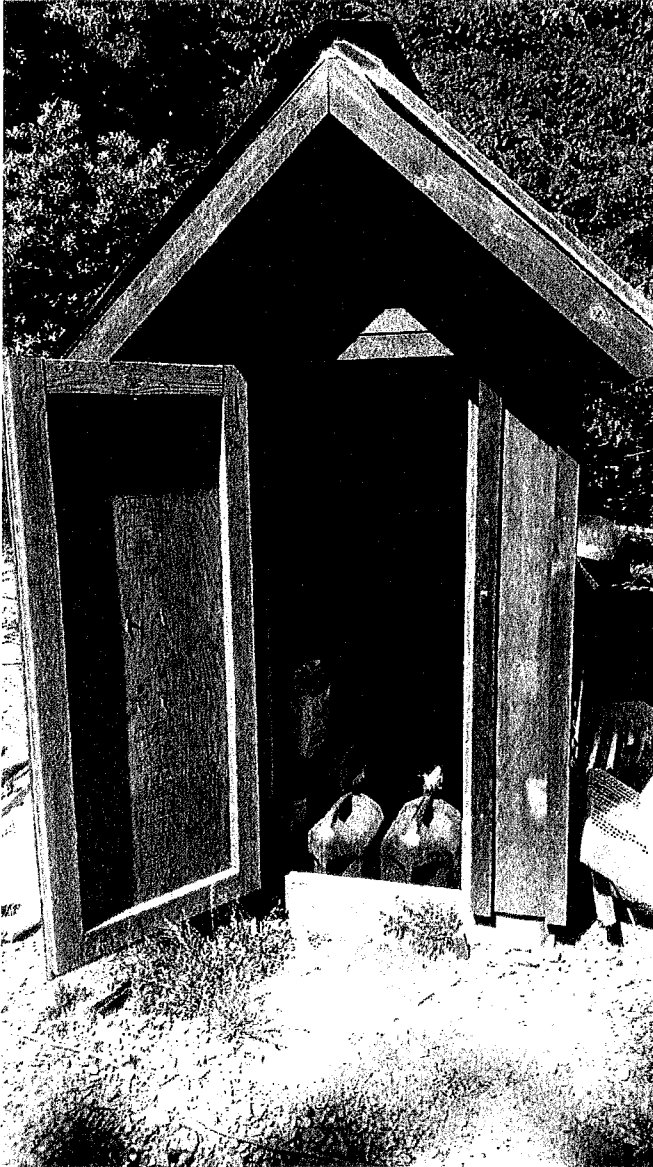
The landowner uses multiple fertilizers and amendments. Fertilizers and amendments are stored appropriately inside the generator shed at the second cultivation site and in the living or storage trailers. Fertilizers used are Age Old Bloom (5-10-5), Age Old Grow (12-6-6), Maxsea Grow (16-16-16). Amendments used are Greensand (0-0-3), Oyster shells, and Bone meal (1-13-0). Fertilizers and amendments are used at manufacturers recommended rates or half that amount. The soil medium used is Royal Gold Mendo Mix. Fertilizers and soil amendments are stored in locations and in a manner in which they cannot enter or be transported into surface waters and such that nutrients or other pollutants cannot be leached into groundwater. This standard condition is being met at this time.

Fuel is stored onsite in portable fuel containers. These containers are stored in the shed on the second cultivation site. This is the extent of all fuels and chemicals on the property. This standard condition is being met at this time.

Figure 5: Evidence of compliant fuel and fertilizer storage. July 25th 2016

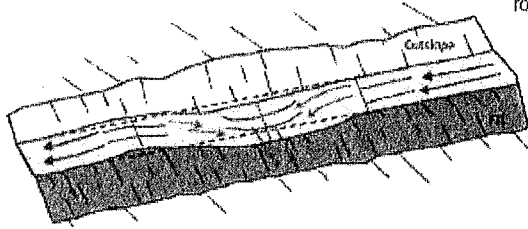
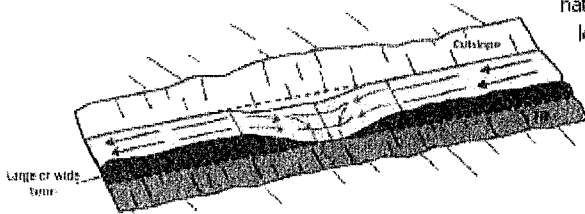
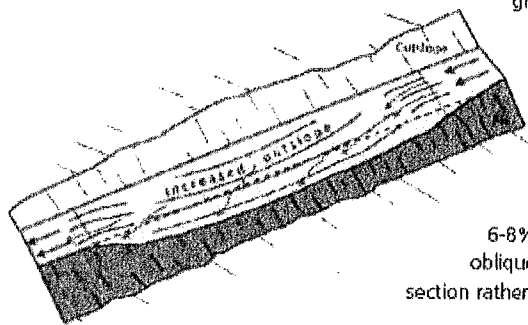
FIGURE 36. Rolling dip types

Type 1 Rolling Dip
(Standard)

Type 1 rolling dips are used where road grades are less than about 12-14% and road runoff is not confined by a large through cut or berm. The axis of the dip should be perpendicular to the road alignment and sloped at 3-4% across the road tread. Steep roads will have longer and more abrupt dip dimensions to develop reverse grade through the dip axis. The road tread and/or the dip outlet can be rocked to protect against erosion, if needed.

Type 2 Rolling Dip
(Through-cut or thick berm road reaches)

Type 2 rolling dips are constructed on roads up to 12-14% grade where there is a through cut up to 3 feet tall, or a wide or tall berm that otherwise blocks road drainage. The berm or native through cut material should be removed for the length of the dip, or at least through the axis of the dip, to the extent needed to provide for uninterrupted drainage onto the adjacent slope. The berm and slope material can be excavated and endhauled, or the material can be sidecast onto native slopes up to 45%, provided it will not enter a stream.

Type 3 Rolling Dip
(Steep road grade)

Type 3 rolling dips are utilized where road grades are steeper than about 12% and it is not feasible to develop a reverse grade that will also allow passage of the design vehicle (steep road grades require more abrupt grade reversals that some vehicles may not be able to traverse without bottoming out).

Instead of relying on the dip's grade reversal to turn runoff off the roadbed, the road is built with an exaggerated outslope of 6-8% across the dip axis. Road runoff is deflected obliquely across the dip axis and is shed off the outsloped section rather than continuing down the steep road grade.

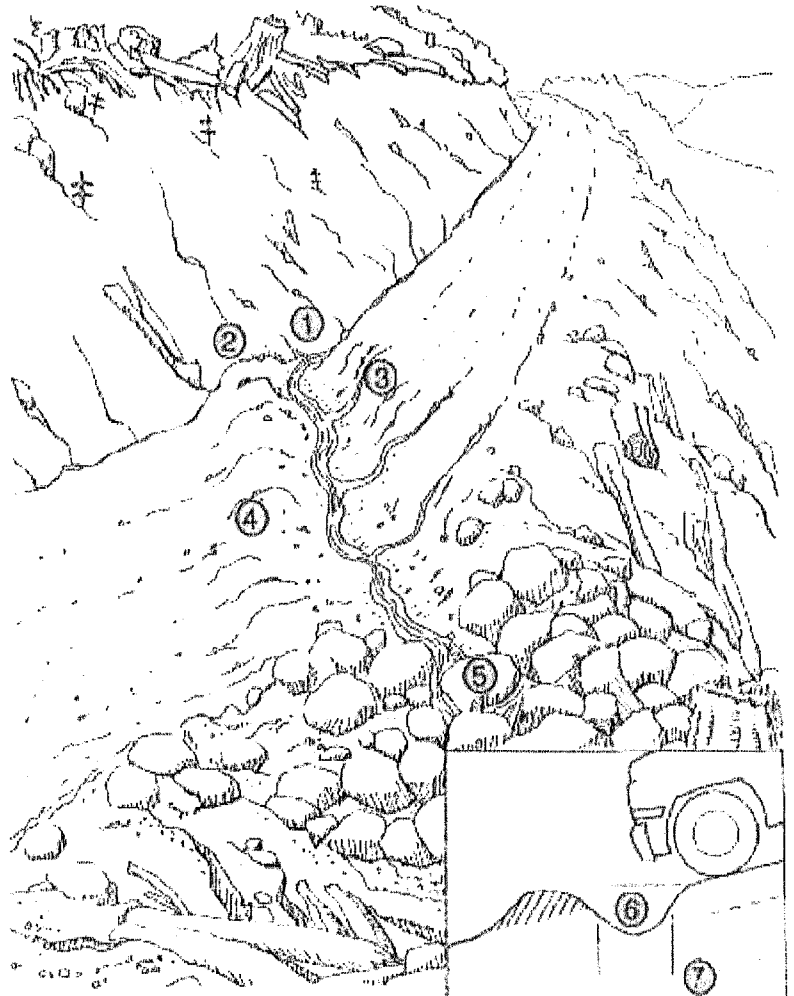
FIGURE 40. Waterbars are constructed on unsurfaced forest and ranch roads that will have little or no traffic during the wet season. The waterbar should be extended to the cutbank to intercept all ditch flow (1) and extend beyond the shoulder of the road. A berm (2) must block and prevent ditch flow from continuing down the road during flood flows. The excavated waterbar (3) should be constructed to be self-cleaning, typically with a 30° skew to the road alignment with the excavated material bermed on the downhill grade of the road (4). Water should always be discharged onto the downhill side on a stable slope protected by vegetation. Rock (shown in the figure) should not be necessary if waterbars are spaced close enough to prevent serious erosion. (5) The cross ditch depth (6) and width (7) must allow vehicle cross-over without destroying the function of the drain. Several alternate types of waterbars are possible, including one that drains only the road surface (not the ditch), and one that drains the road surface into the inside ditch (BCMF, 1991).
