Water Resource Protection Plan

WDID: 1B171720CHUM

APN: 212-311-002

Prepared by:
Timberland Resource Consultants
165 South Fortuna Blvd
Fortuna, California 95540

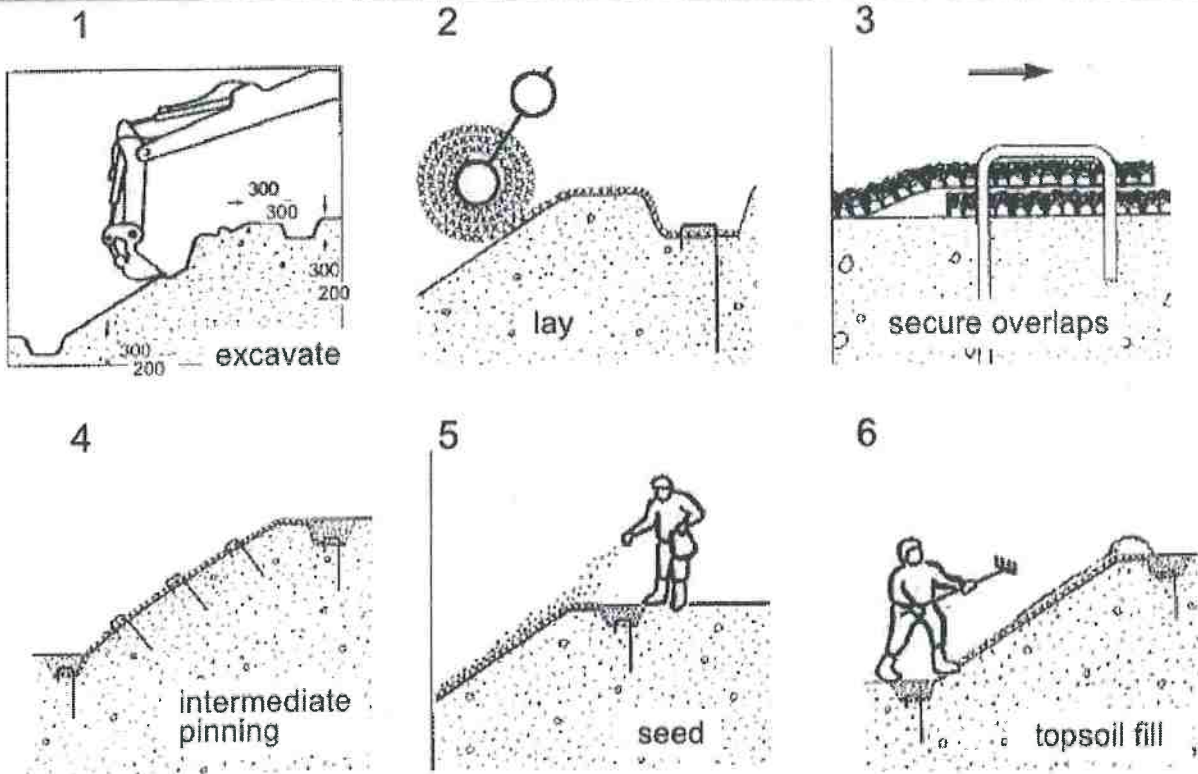
Installation of a geosynthetics mat - Enkamat

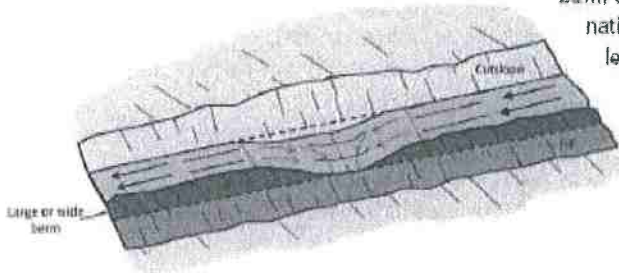
Type 2 Rolling Dip (Through-cut or thick berm road reaches)

Type 2 rolling dips are constructed on roads up to 12-14% grade where there is a through cut up to 3 feet tall, or a wide or tall berm that otherwise blocks road drainage. The berm or native through cut material should be removed for the length of the dip, or at least through the axis of the dip, to the extent needed to provide for uninterrupted drainage onto the adjacent slope. The berm and slope material can be excavated and endhailed, or the material can be sidecast onto native slopes up to 45%, provided it will not enter a stream.

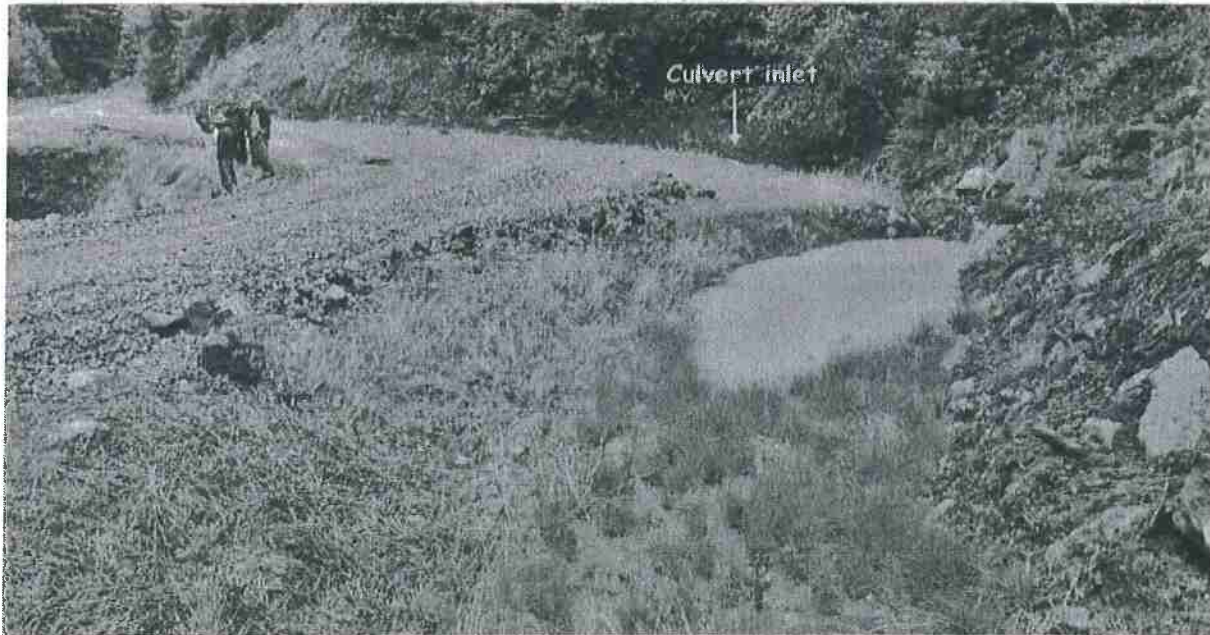
FIGURE 238. Traffic and surface runoff from graveled roads often produces surface erosion, turbid runoff and fine sediment transport that can be delivered to streams. Where ditches can't be eliminated, sediment traps and roadside settling basins can be installed to capture and remove most of the eroded sediment. This settling basin has been constructed along the inside ditch just before a stream crossing culvert inlet (see arrow). Eroded sediment from the road and ditch are deposited in the basin before flow is released to the stream. Fine sediments have filled about 1/3 of this basin and vegetation is now growing. Sediment basins require periodic maintenance to maintain their storage capacity.
