Water Resource Protection Plan

WDID: 1B170612CHUM

APN(s): 220-071-008 (Humboldt)

Timberland Resource Consultants

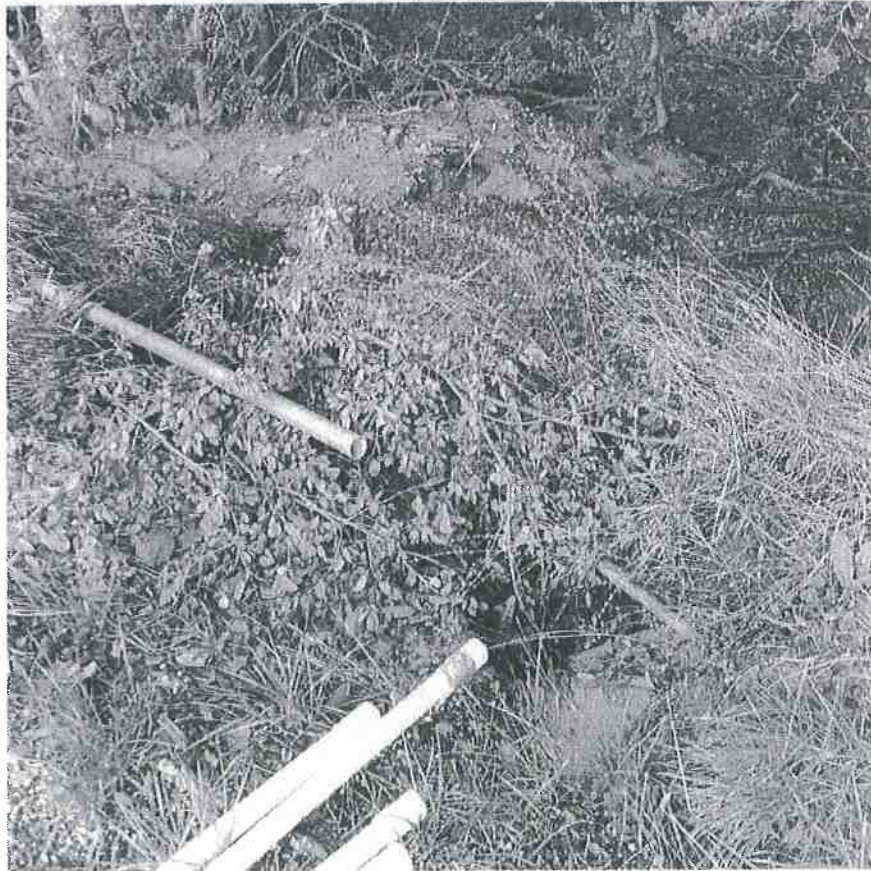
Site 22 – Runoff from the cultivation area is being concentrated and drained into the brush to the north of the landing and is discharging into the watercourse to the north.

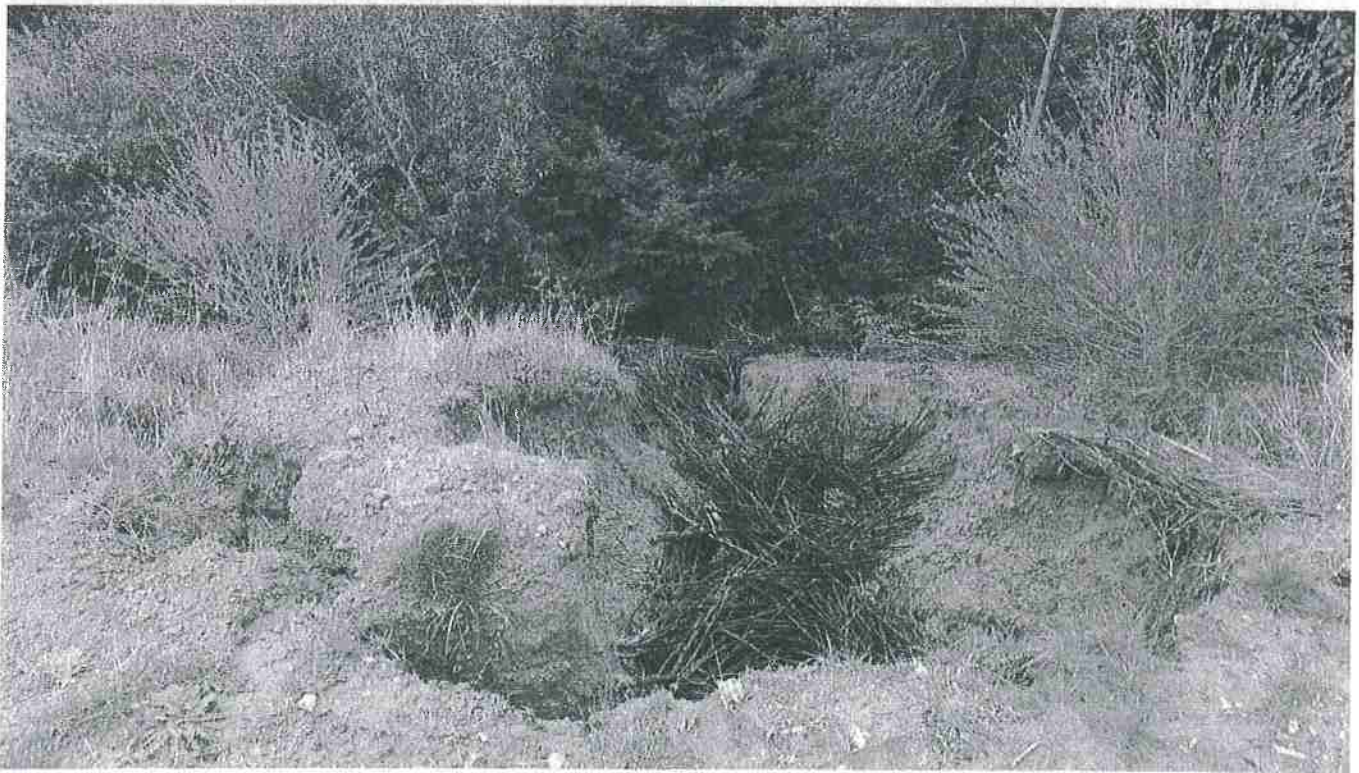
Site 25 – Runoff from the cultivation area is being concentrated and drained onto the landing pads fillslope, resulting in the gulying and caving of the fillslope. Concentrated runoff continues down the hillside to the Mattole River.

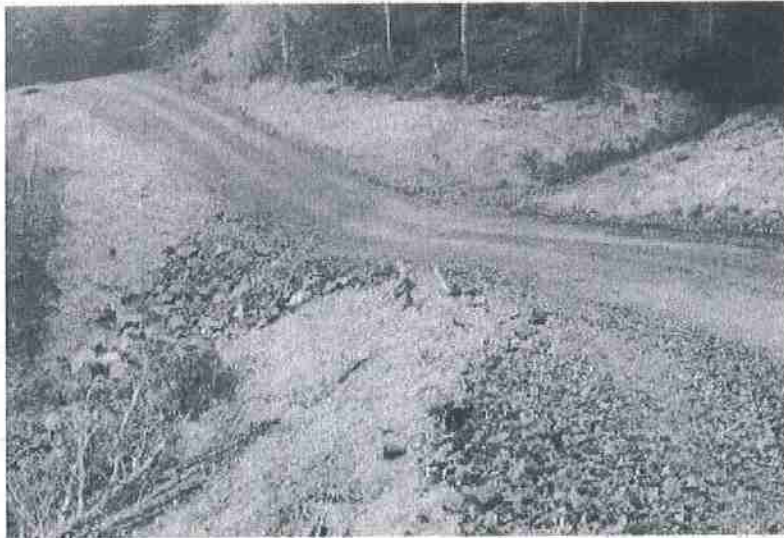
FIGURE 120. *This armored fill crossing of a steep, ephemeral stream was constructed to provide a low maintenance crossing. The crossing has been deeply dipped to reduce the volume of road fill and to eliminate the potential for stream diversion. The fill slope has been heavily armored through the axis of the crossing to contain flood flows and prevent downcutting. Armored fills cannot be used on fish bearing streams.*

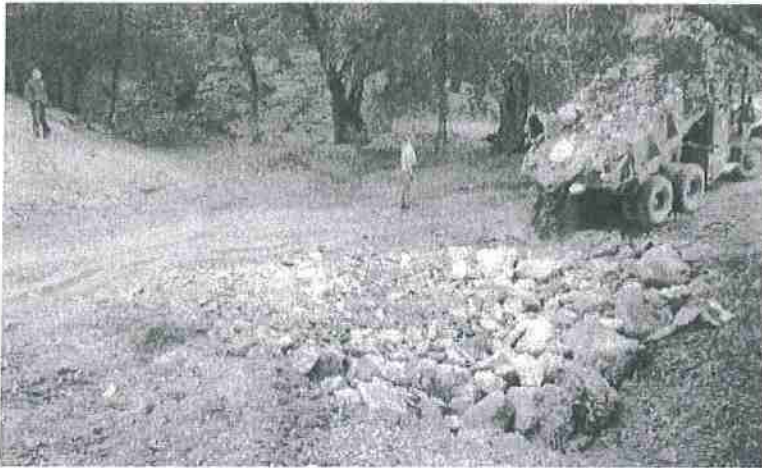
FIGURE 121D. Well graded rock armor is then tumbled into the structure and spread across the breadth of the U-shaped stream crossing, and about one-third the way up the roadbed, so that streamflow will only flow over or come in contact with resistant armor material. The armor must be spread and compacted across the design width of the expected flood flow channel width so peak flows will not flank the armored structure.

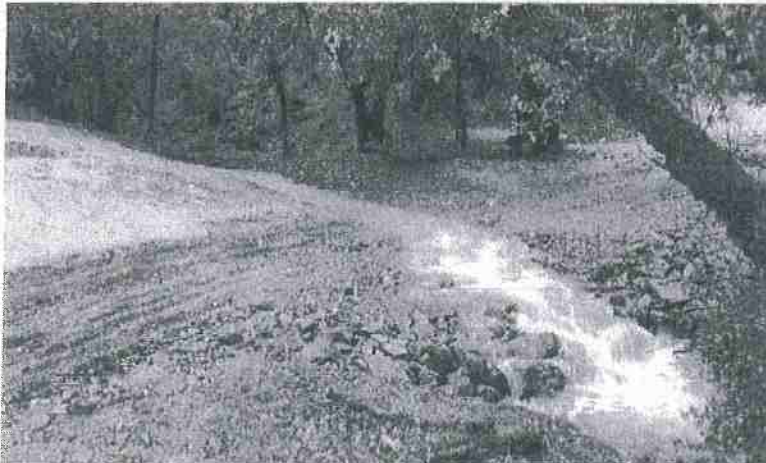
FIGURE 121E. Two weeks after this armored fill was constructed, a storm flow event occurred and the structure maintained its function and integrity. The road approaches had not yet been compacted or surfaced with road rock.

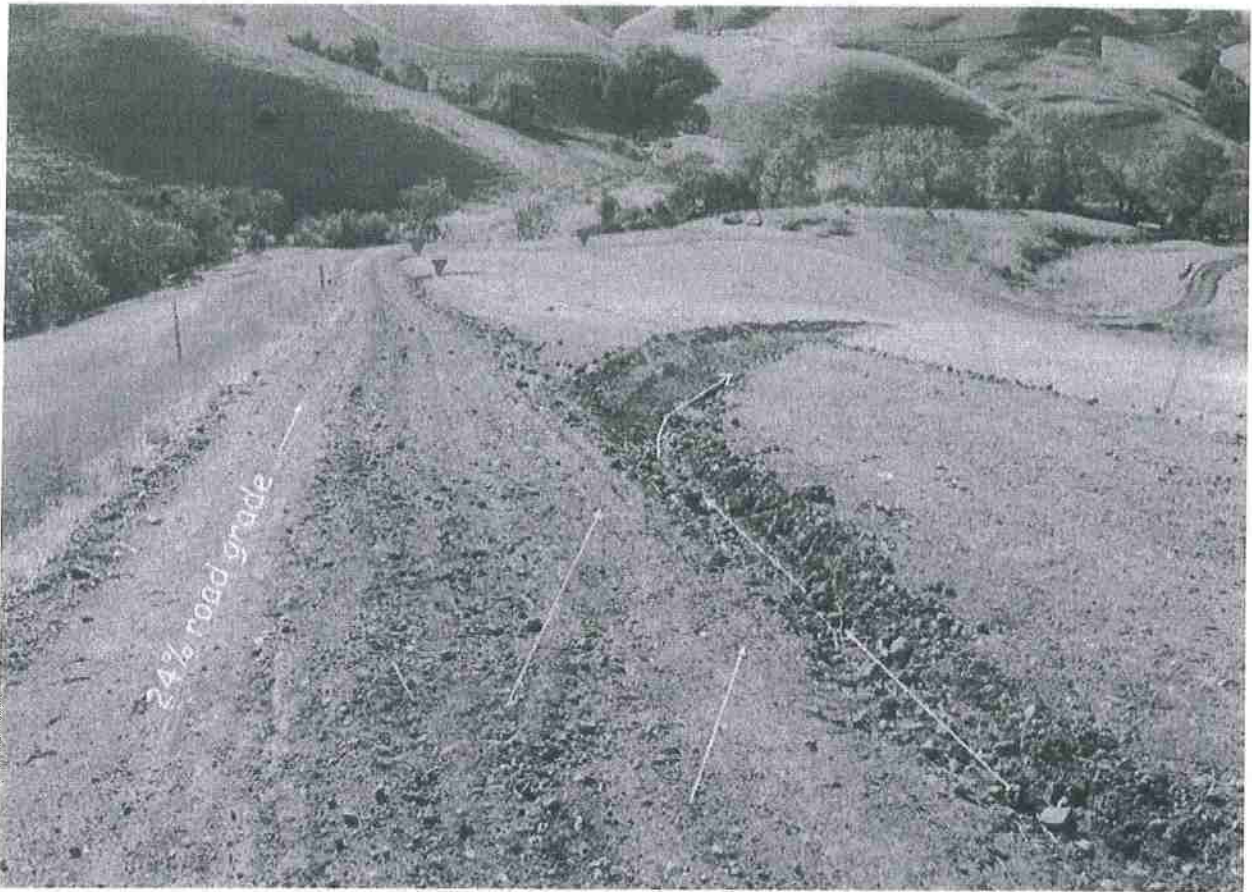
FIGURE 55. Steep roads that go straight up or down a hillside are very difficult to drain. This steep, fall line road developed a through cut cross section that was drained using lead out ditches to direct runoff off the road and onto the adjacent, vegetated hillside. The road was "outsloped" to drain runoff to the right side, and the lead out ditch was built slightly steeper than the road grade, to be self-cleaning. Four lead out ditches have been constructed at 100-foot intervals to the bottom of the hillside.

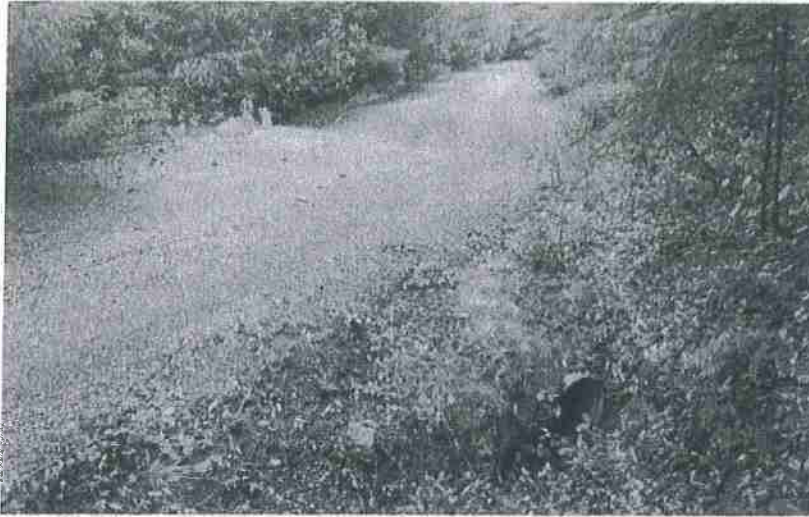
**FIGURE 39.**

Waterbars are often used to drain surface runoff from seasonal, unsurfaced roads. Because they are easily broken down by vehicles, waterbars are only used on unsurfaced roads where there is little or no wet weather traffic. In this photo, a waterbar and ditch relief culvert are used to drain all road surface and ditch runoff from the insloped road prism.
