From: David Nicoletti PE QSD\QSP
DTN Engineering & Consulting
2731 K Street Unit A
Eureka, CA 95501
Email: dnicoletti@dtngineering.com

Subject: Roadway Evaluation for Cobb Road from Rattlesnake Bridge to APN 208-341-016

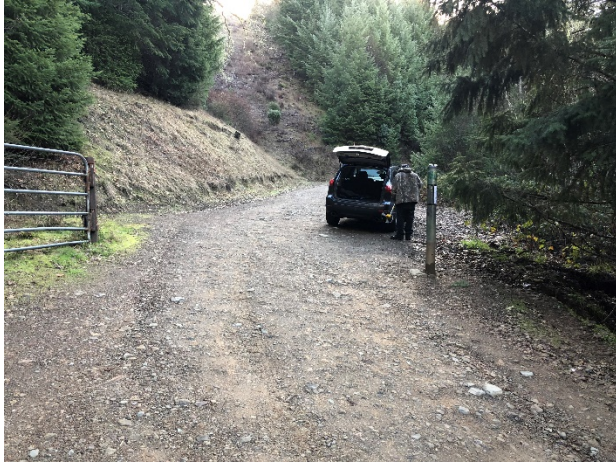
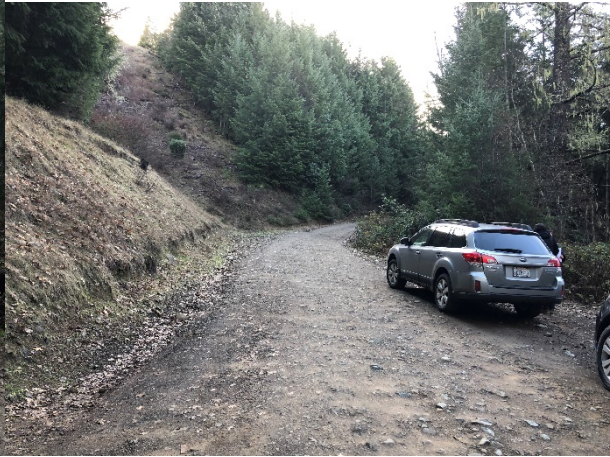
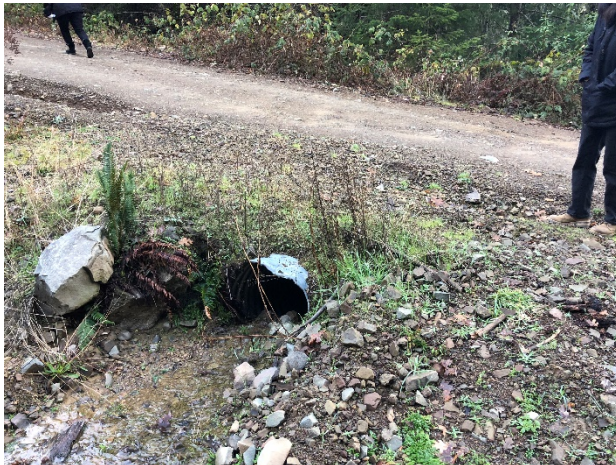
The road evaluation begins at the gated entrance to Cobb Rd and the intersection of Rattlesnake Bridge (Pictures 1-2). At this location Cobb Rd. is within the SMA and an unidentified culvert conveys water under Cobb Rd. The roadway at this location is 16 feet wide and the grade abruptly increases to approximately 8% past the gate. As Cobb Rd proceeds to the southeasterly direction the first culvert is encountered (Picture 3). The culvert is an 18 inch CMP culvert in poor condition that is supplied by a drainage way. This culvert has previously been blocked due to sediment traveling downslope from the unstabilized PG&E easement.

Picture #1 Gate @ Cobb Rd & Rattlesnake Bridge looking E.

Picture #2 Cobb Rd & Rattlesnake Bridge looking E. @ curve..

Picture #3 Cobb Rd at Curve in Picture #2 looking @ 12" CMP

At this specific location it is recommended to replace the existing culvert with a new minimum 18 inch culvert and construct an approved turnout in accordance with the Humboldt County Ordinance for California Fire Safe Regulation. In order to prevent this culvert from clogging in the future, stabilize the PG&E easement, create a little ponded rocky area at the inlet of the culvert for sediment to settle out, and possibly increase the culvert diameter to 24 inches. Reestablishment of the existing roadside ditches are also recommended.

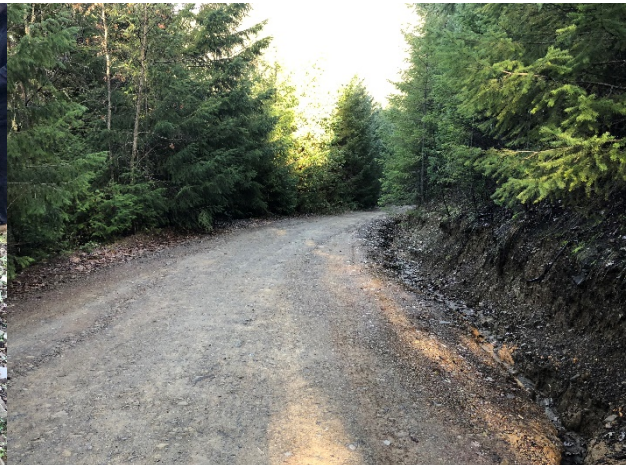
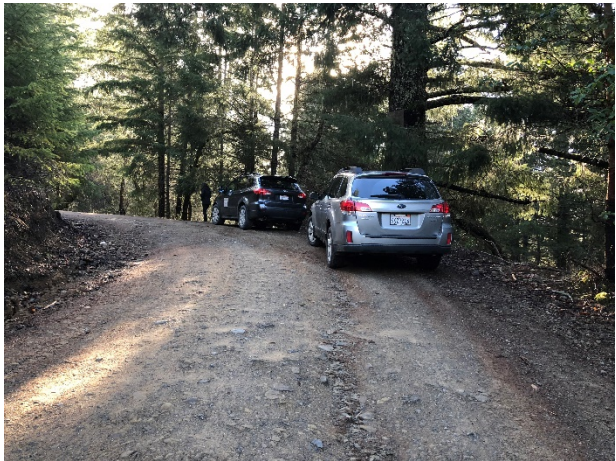
Proceeding southeasterly up grade at approximately 8%, the first curve in the roadway is encountered (Pictures 4 & 5). As shown (Picture 5), there is sufficient space for two vehicles to pass, but as with the case of all pull outs at curves evaluated on Cobb Rd, they aren't in accordance with the Humboldt County Ordinance for California Fire Safe Regulation for turnouts (Exhibit D). The width

of the roadway at the turnout is approximately 16 feet and at both end of the curve the width narrows to 11.5 feet. The pictures depict erosion occurring at the edge of the inside of the curve eroding the toe of the slope. In addition, Google Earth shows a drainage developing due to the clearing in the PG& E easement above the road, this is also contributing to the erosion on the upslope side of the curve.

Picture #4 Cobb Rd @ curve looking NW

Picture #5 Cobb Rd @ curve in Picture #4 looking SE

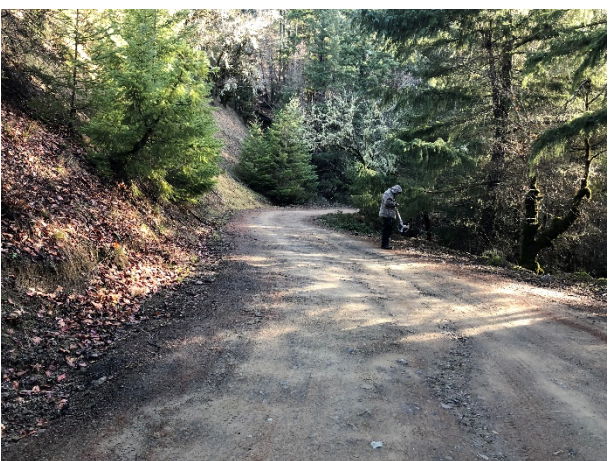
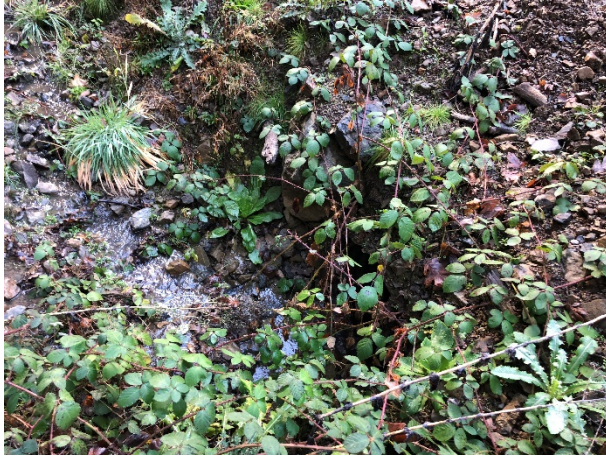
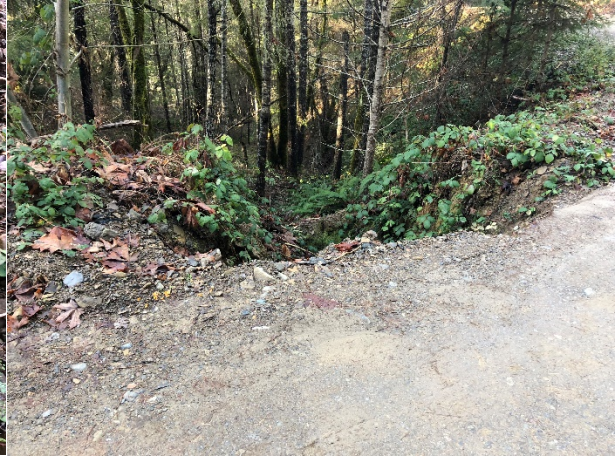
Proceeding southeasterly, the next curve is encountered (Picture 6) and as shown in the picture there are no turnouts, preventing the safe passage of two vehicles. At this location a 12 inch culvert exists, but at one point it was blocked and water cascaded over the road and over the downslope side of the hill (Picture 8). On the Google Earth image, the water overtopping the road is shown as well. Also, on the Google Earth image a drainageway is developing to the north, due to the clearing in the PG&E easement above the road.

Picture #6 Cobb Rd looking E. @ curve

Picture #7 Cobb Rd @ 12" CMP inlet at curve

Picture #8 road washout due to culvert being clogged.

At this specific location it is recommended to replace the existing culvert with a new minimum 18 inch culvert. In order to prevent this culvert from clogging in the future, stabilize the PG&E easement, create a little ponded rock area at the inlet of the culvert for sediment to settle out, and possibly increase the culvert diameter to 24 inches. Also, construct turnouts in accordance with the Humboldt County Ordinance for California Fire Safe Regulation at the curve. Reestablishment of the existing roadside ditches are also recommended.

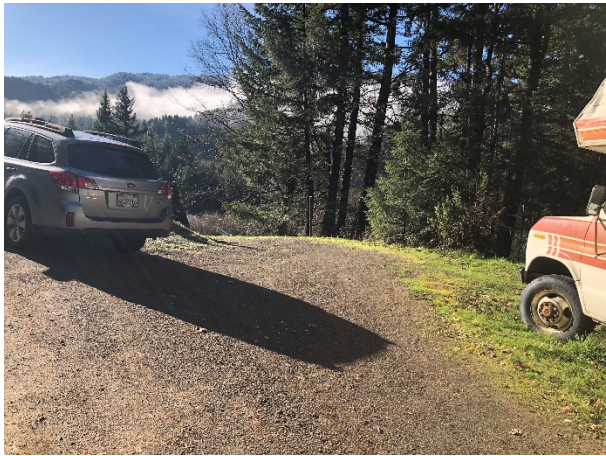
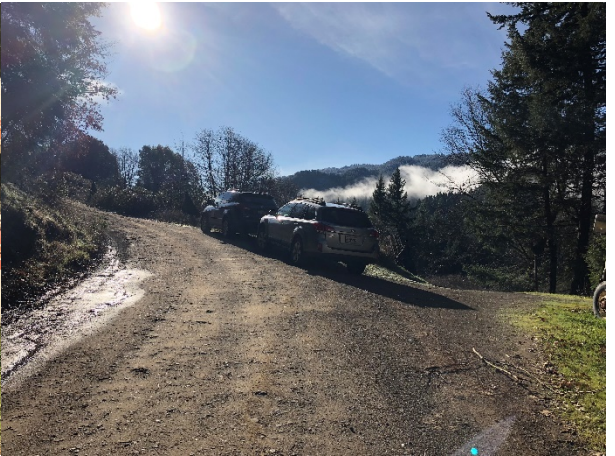
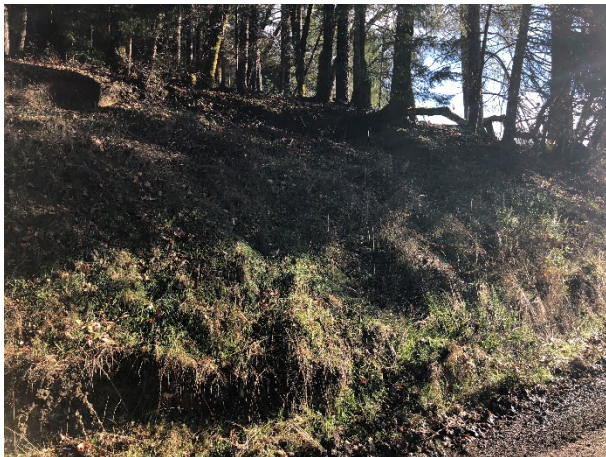
Continuing southeasterly, the first driveway is encountered (Picture 9), and just passed that driveway (Picture 10), a curve is encountered with a slope of approximately 7% upslope from the driveway. The driveway as shown (Picture 9), is steep as it intersects Cobb Rd without appropriate SSD in accordance with Humboldt County Standards for Commercial Rural Driveway (Exhibit D). Looking northeasterly (Picture 11), the upslope side of the road embankment is sloughing and as described below in sections Pictures 12-14 & 57-59, the unstabilized graded flats above the roadway on APN #208-341-011, are creating erosion and runoff coming down the hillside. The erosion is also impacting and on the inside edge of the roadway curve the runoff is eroding the toe of the slope as shown (Picture 11), causing sloughing of the hillside. The grade upslope is approximately 7%. At the drive the width of the roadway and flat area is approximately 18 feet narrowing down to 14 feet (Picture 10). At either end of the curve the roadway narrows down to 11.5 feet.

Picture #9 Cobb Rd @ unsafe driveway

Picture #10 Cobb Rd looking SE towards curve & drive in #9

Picture #11 Cobb Rd looking NE @ sloughing of embankment

At this specific location it is recommended to improve the existing driveway for compliance with Humboldt County Standards for Commercial Rural Driveway. It is

also recommended to stabilize the sloughing of the north road embankment with engineered fill and appropriate slope armoring.

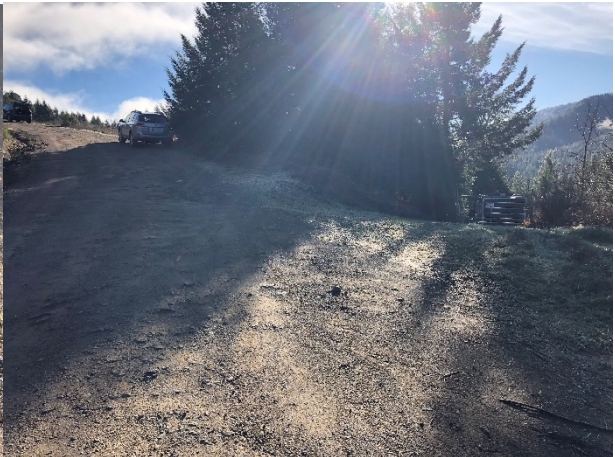
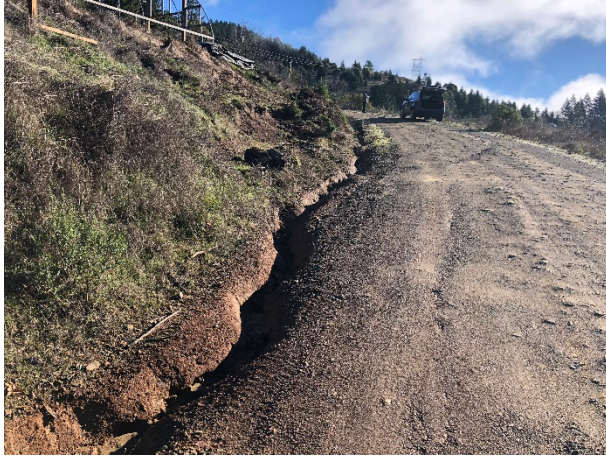
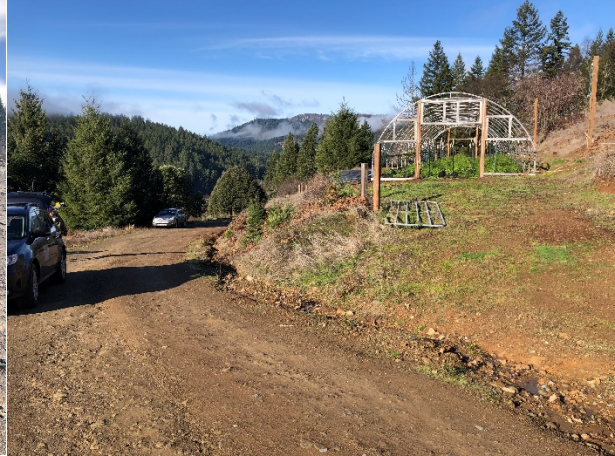
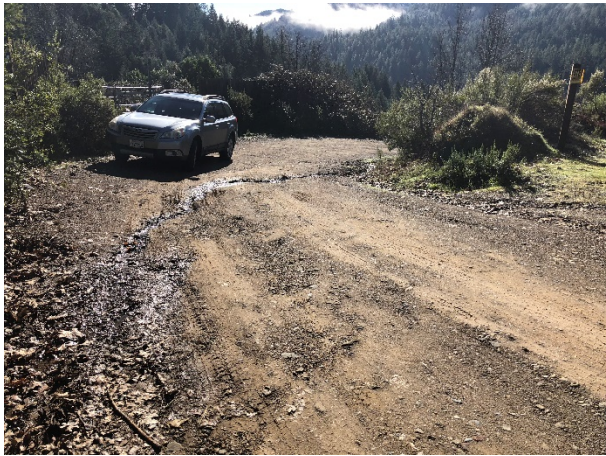
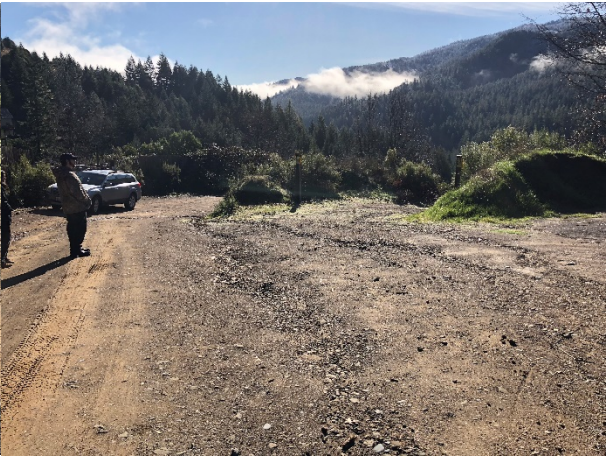
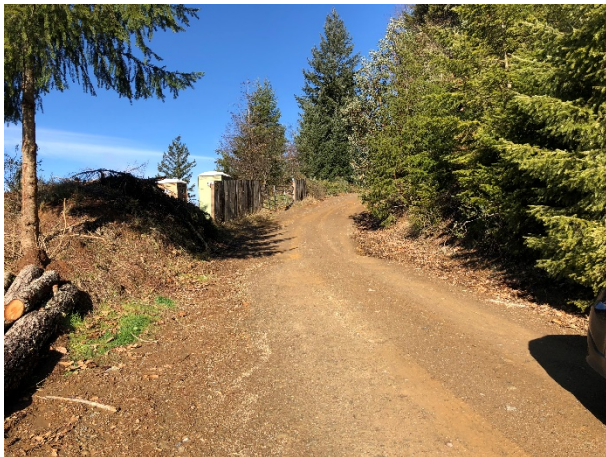
Continuing southeasterly, coming upon the horseshoe curve at APN #208-341-011 (Picture 12), which depicts the second driveway encountered. This driveway as shown also does not meet Humboldt County Standards for Commercial Rural Driveway for SSD at driveways intersecting roadways. The roadway width around the horseshoe curve expands from 12 feet at the beginning of the curve travelling southeasterly. Significant drainage is entering the roadway from the graded flat on APN #208-341-011 and is eroding the inside toe of the slope creating erosion issues, sloughing of the hillside as described in section Pictures 9-11, and the blocked culvert described in section Pictures 57-59. The roadway around the curve expands to approximately 18 feet wide with a driveway that appears to be in conformance with Humboldt County Standards for Commercial Rural Driveway is encountered with a sufficient turnout space exists allowing two vehicles to pass at the same time. After the driveway the roadway narrows in width back to approximately 12 feet with a grade of 6% approaching the next curve (Picture 22). Looking northwesterly (Picture 17) the next curve is encountered and a pull out does exist for a car to pull out, but it is placed on the opposite side of travel as the curve is approached.

Picture #12 Cobb Rd looking SE @ curve & driveway

Picture #13 Cobb Rd looking NE @ erosion due to drainage

Picture #14 Cobb Rd looking SW towards curve.

Picture #15 Cobb Rd looking SE towards curve in 14 w/ erosion

Picture #16 Cobb Rd looking SE towards curve in 14 @ drive

Picture #17 Cobb Rd looking NW towards curve

At the specific location shown (Picture 17) it is recommended to construct a turnout on the north side of the roadway in compliance with Humboldt County Ordinance for California Fire Safe Regulation. A large part of the erosion and drainage issues identified in sections Pictures 9-11, Pictures 57-59, and Pictures 12-17, have been created by APN #208-341-011 due to clearing and grading for flats without proper slope stabilization. Reestablishment of the existing roadside ditches are also recommended.

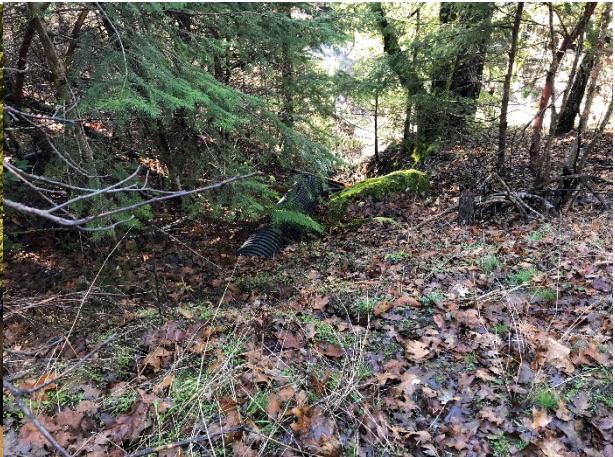
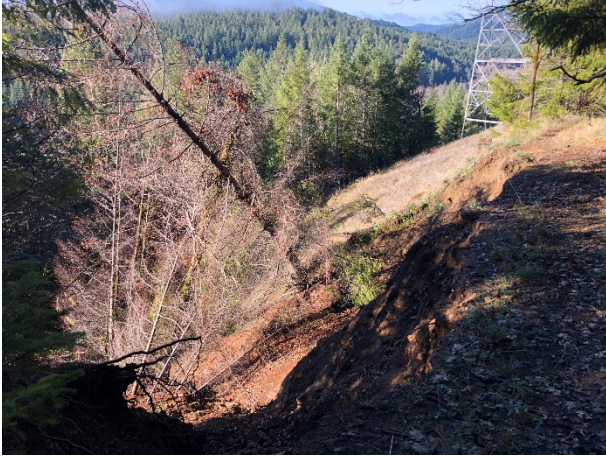
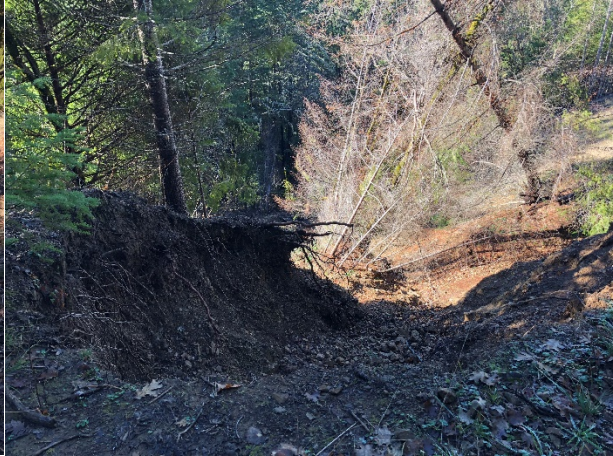
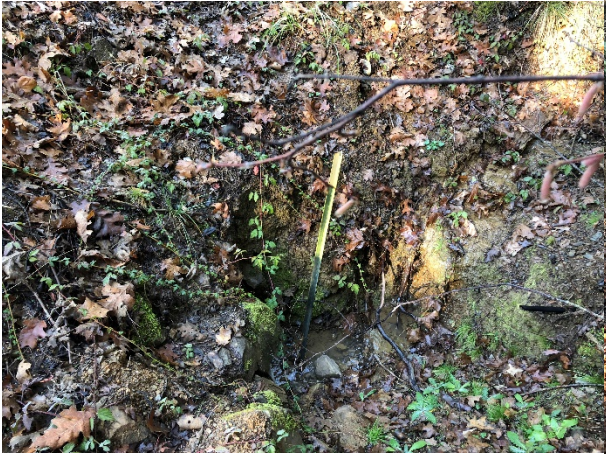
This section evaluates part of the PG&E easement clearing along with a water tank placed on the edge of a slope, along with drainage and erosion issues. The tank is shown looking downslope, Picture 25 in section Picture 22-25 below. Erosion is occurring (Pictures 19 & 20) due to un-stabilized slopes that have been created by the clearing of the PG&E easement. A 12 inch culvert that appears partially blocked (Pictures 18 & 21) on the intake side exists. There is a steel delineator marking the inlet of the 12 inch culvert (Picture 21).

Picture #18 Cobb Rd @ 18" culvert outlet looking W @ esmt.

Picture #19 On PG&E esmt looking SW

Picture #20 On PG&E esmt looking SW @ erosion.

Picture #21 On PG&E esmt looking NE @ outlet from Cobb Rd

At this location it is recommended to coordinate with PG&E regarding to legal responsibility for maintaining environmental control over the easement. Also, it is recommended to replace the existing culvert with a new minimum 18inch culvert.

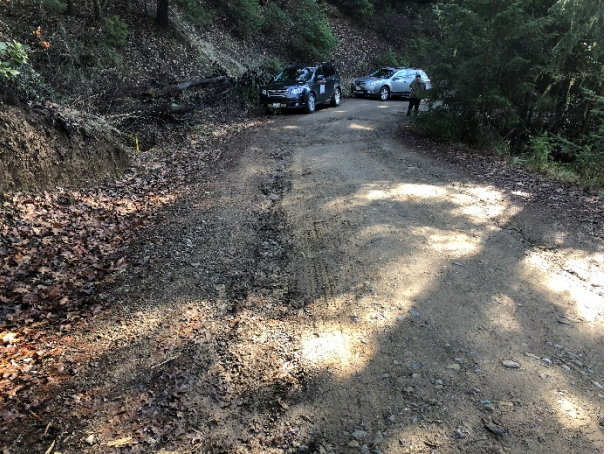
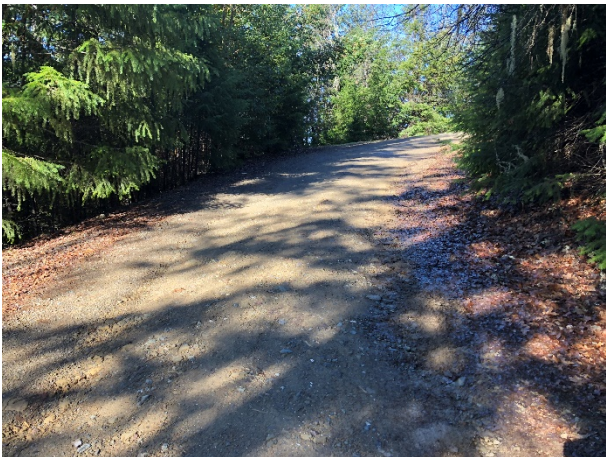
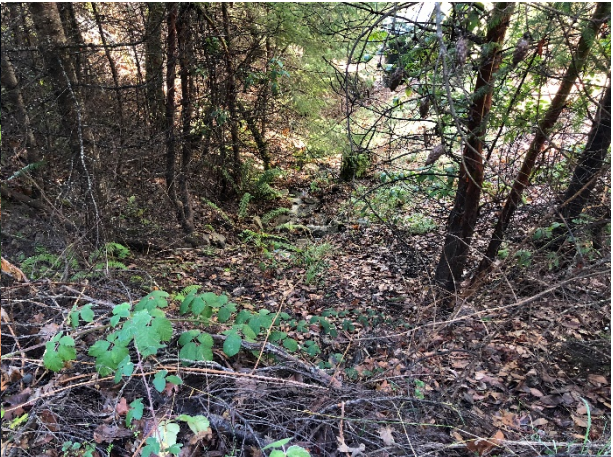
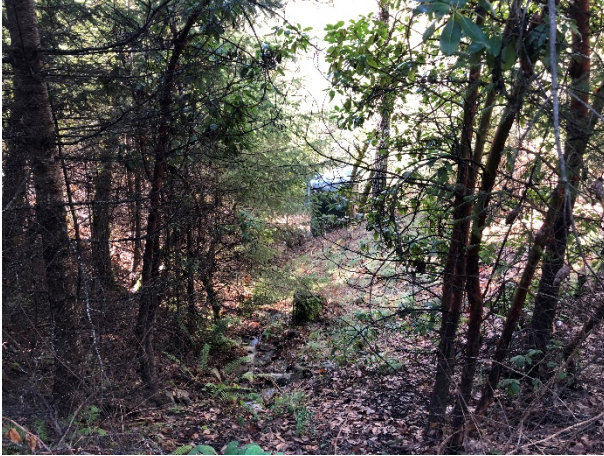
Continuing northwesterly, the next curve and culvert location is encountered (Pictures 22-25). As depicted (Picture 22) there is a narrow turnout allowing two vehicles to pass around the curve. Additionally, there is erosion and drainage occurring downhill due to the 12 inch culvert being blocked in the past as well as the ditch on either side of the road being congested with debris. The roadway before and after the curve is approximately 12 feet with clogged ditches on either side of the traveled way. The slope of the road is approximately 8%.

Picture #22 Cobb Rd SE towards curve

Picture #23 Cobb Rd looking NW @ curve

Picture #24 Cobb Rd looking @ culvert @ PG&E esmt (tank)

Picture #25 Cobb Rd outlet of 12" culvert looking @ tank

At this specific location it is recommended to replace the existing culvert with a new minimum 18inch culvert and construct a turnout at the curve in accordance with the Humboldt County Ordinance for California Fire Safe Regulation. Reestablishment of the existing roadside ditches are also recommended.

A tank was identified above on the edge of a slope (Picture 25). It is recommended to evaluate the existing slopes, the load that the tank is placing on those slopes and take remediation measures as necessary including the possibility of relocating the tank.

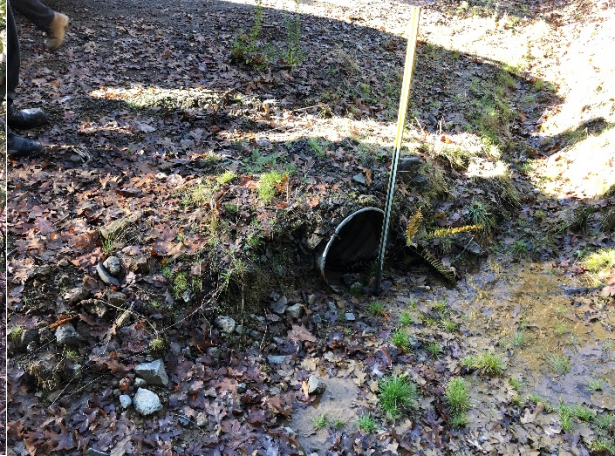
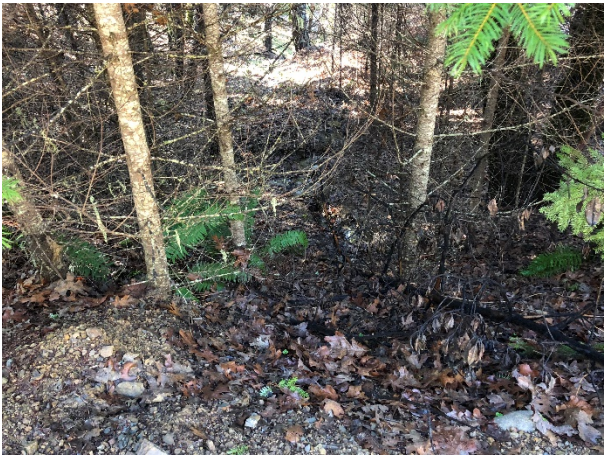
Continuing around the next horseshoe curve, a 12 inch culvert is encountered (Pictures 26 & 27). This culvert is discharging at a steep slope down hill (Picture 27) and without armoring the drainage is causing erosion. The roadway here is approximately 12 feet wide and the grade approaches 5% approaching the next curve.

Picture #26 Cobb Rd inlet of 12" culvert in Picture 27.

Picture #27 Cobb Rd outlet & erosion from culvert @ Picture 26

At this specific location it is recommended to replace the existing culvert with a new minimum 18inch culvert.

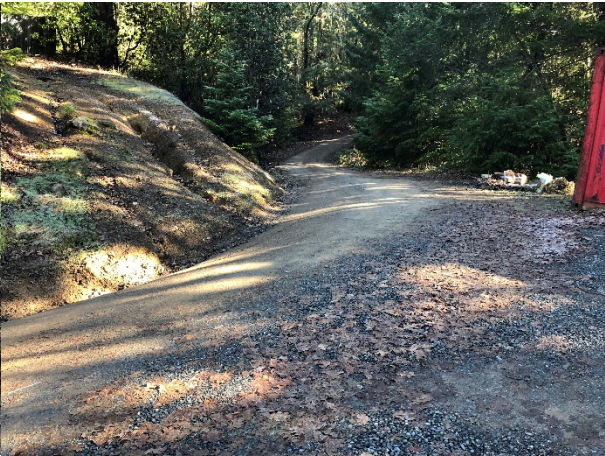
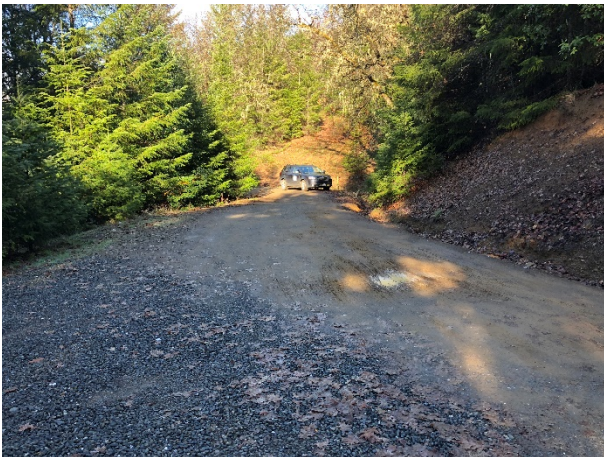
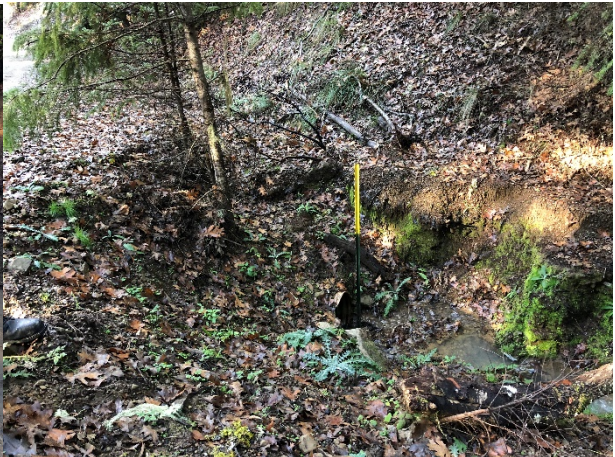
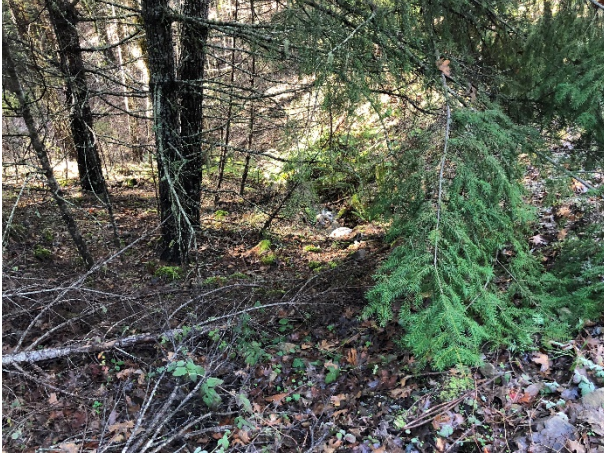
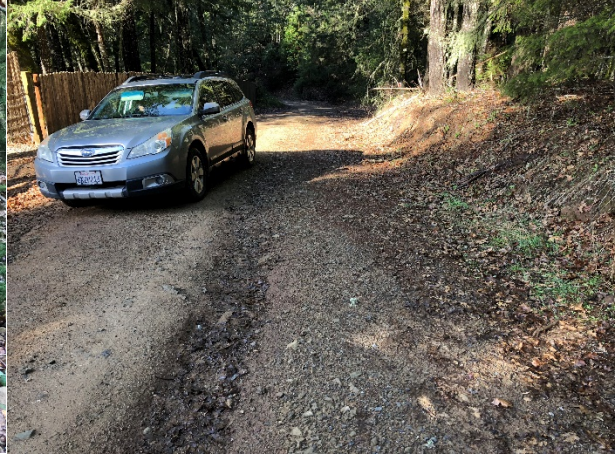
Continuing northeasterly around the next curve, another driveway is encountered at the midpoint of the curve, and the driveway appears to meet Humboldt County Standards for Commercial Rural Driveway. The roadway at this location is 18 feet wide sloping gently, allowing two vehicles to pass.. The width of the roadway before and after the curve are 12 feet with a 5% grade approaching (Picture 28) and a 3% slope departing the curve (Picture 29). A 12 inch culvert exists (Pictures 30 & 31).

Picture #28 Cobb Rd looking E towards curve

Picture #29 Cobb Rd looking NW towards curve

Picture #30 Cobb Rd 12" culvert inlet

Picture #31 Cobb Rd 12" culvert outlet

Picture #32 Cobb Rd looking W towards curve.

At this specific location it is recommended to replace the existing culvert with a new minimum 18inch culvert and construct a turnout at the curve in accordance with the Humboldt County Ordinance for California Fire Safe Regulation. Reestablishment of the existing roadside ditches are also recommended.

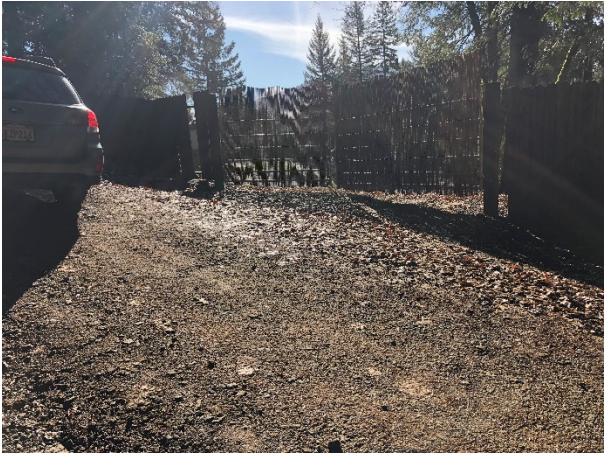
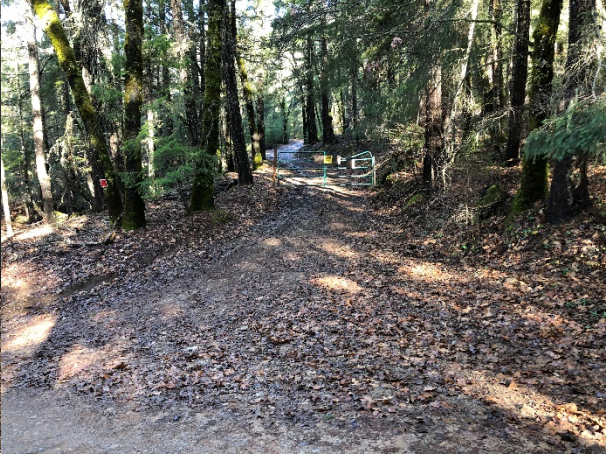
At this location a gated drive (Picture 33), exists on the southside of the roadway and the northside of the roadway (Picture 34), exists a drive that is steep and carrying drainage and erosion onto Cobb Rd. The roadway width at this location is 12 feet at a 3% grade and erosion is occurring along the north side of the road, eroding the toe of the slope creating a potential sloughing situation on the hillside.

Picture #33 Cobb Rd looking @ driveway

Picture #34 Cobb Rd looking N. @ driveway w/ erosion

At this location a specific recommendation to stabilize the driveway at this location and construct a grated 18inch CMP pipe parallel to Cobb Rd to capture drainage from the driveway and convey it downhill minimizing erosion. Reestablishment of the existing roadside ditches are also recommended.

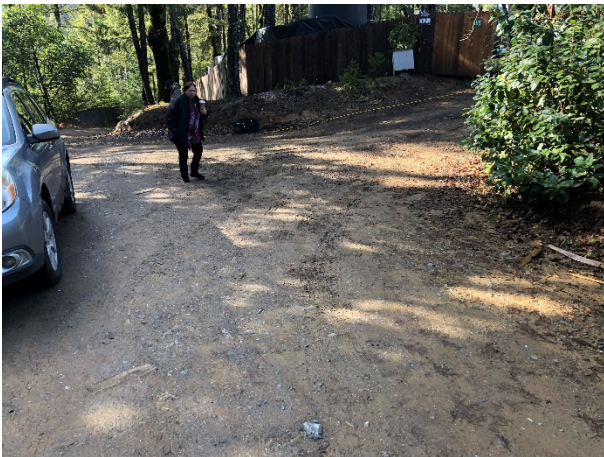
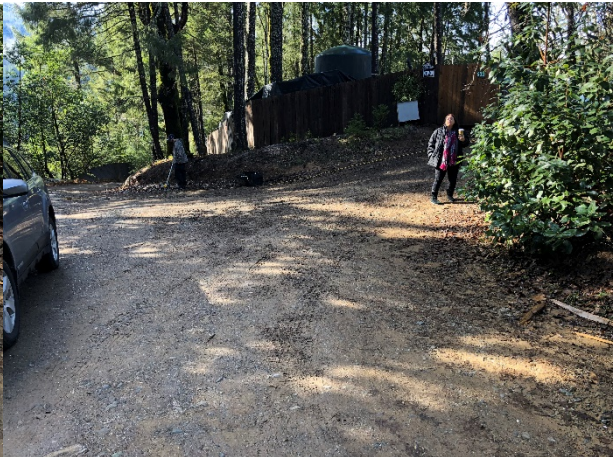
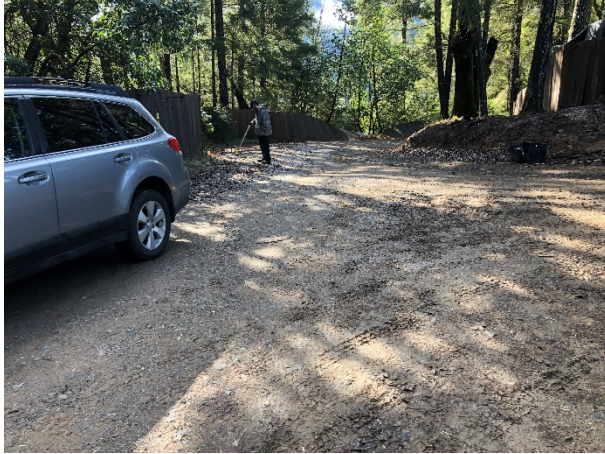
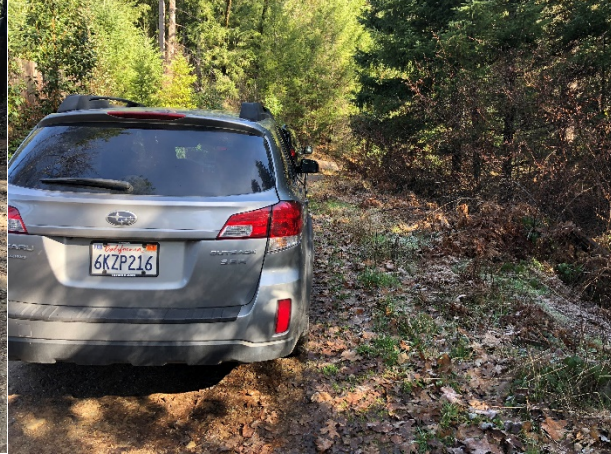
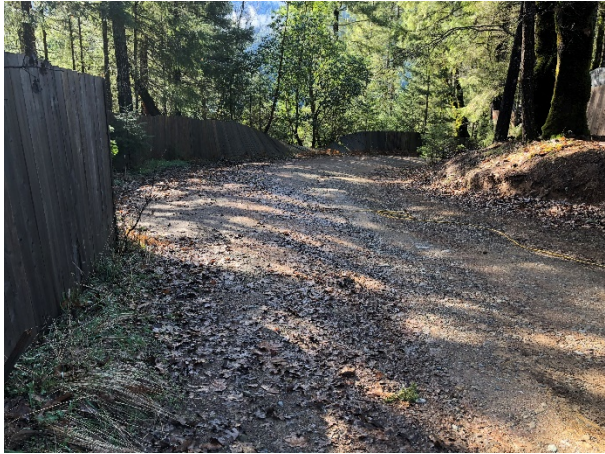
Continuing southeasterly around the next curve (Picture 38 & 39), the curve does have a pull out allowing two vehicles to pass. At this location the roadway widens to from 12 feet at 4% grade to 18 feet at the next driveway, which appears to be in conformance with Humboldt County Standards for Commercial Rural Driveway. Drainage appears to be coming off of the driveway serving APN #208-341-005,

flowing southwesterly along the toe of the slope eroding away the toe and creating a sloughing situation (Picture 39).

Picture #35 Cobb Rd looking SW towards curve

Picture #36 Cobb Rd looking SW at driveway

Picture #37 RVF Cobb Rd looking SE towards curve

Picture #38 RVF Access Rd looking NW towards curve pullout.

Picture #39 Cobb Rd looking SE towards curve

At this specific location it is recommended to construct a turnout at the curve in accordance with the Humboldt County Ordinance for California Fire Safe Regulation and to reestablish the roadside ditches are also recommended.

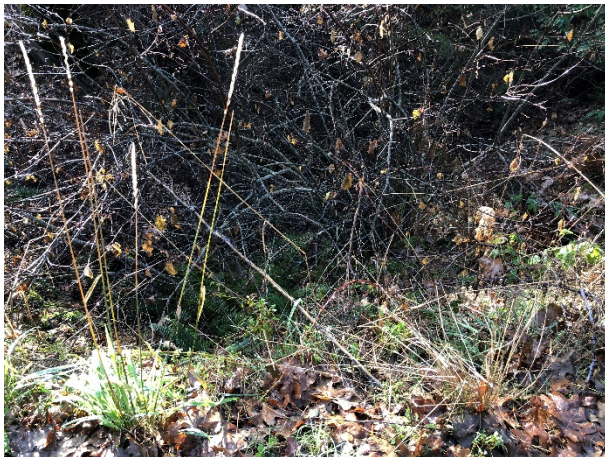
At this location a 12 inch CMP culvert exists. The roadway is 12 feet wide and the grade is gradual at approximately 3%.

Picture #41 Cobb Rd looking @ outlet of 12" culvert in Picture 40

At this specific location it is recommended to replace the existing culvert with a new minimum 18 inch culvert. Reestablishment of the existing roadside ditches are also recommended.

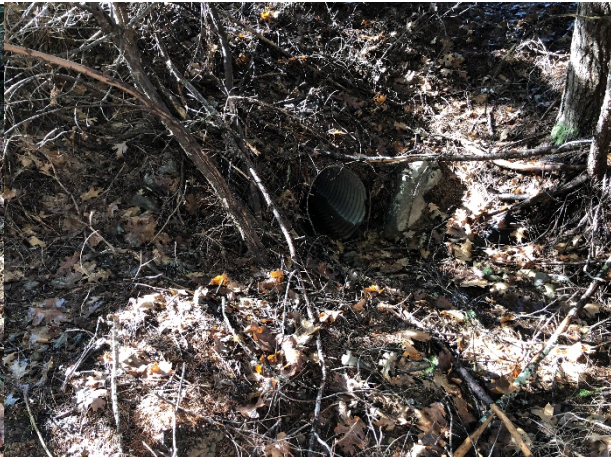
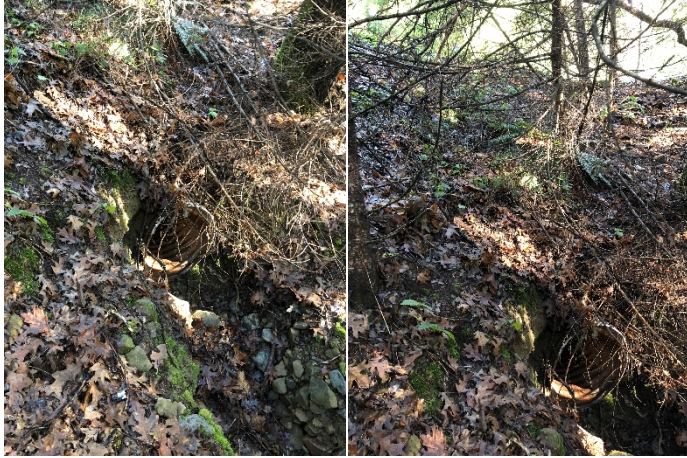
At this location a 12 inch CMP culvert exists. The roadway is 12 feet wide and the grade is gradual at approximately 3%

Picture #42 Cobb Rd looking @ inlet of 12" culvert

Picture #43 Cobb Rd inlet of 12" culvert Picture #44 Cobb Rd outlet from culverts in Pictures 42 & 43.

At this specific location it is recommended to replace the existing culvert with a new minimum 18 inch culvert. Reestablishment of the existing roadside ditches are also recommended.

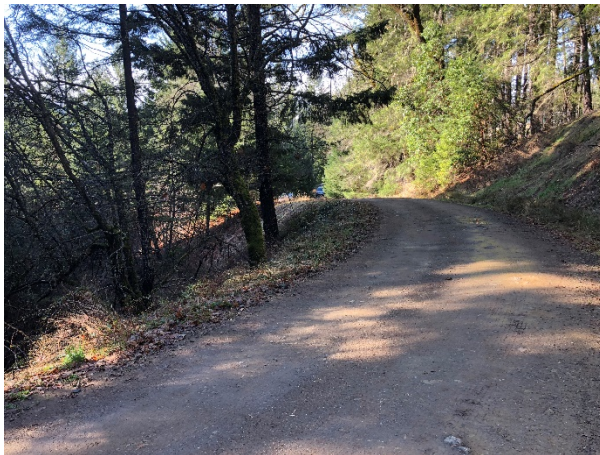
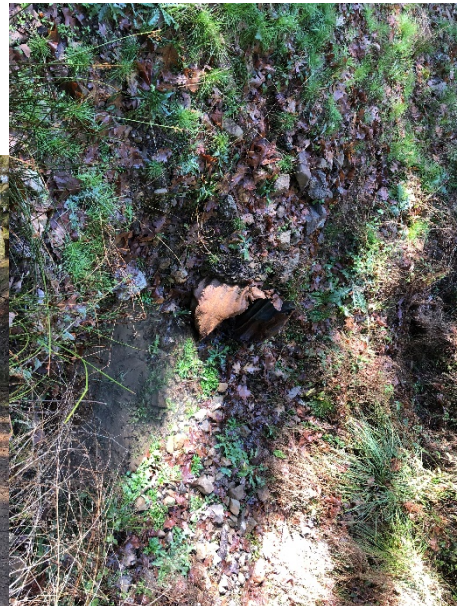
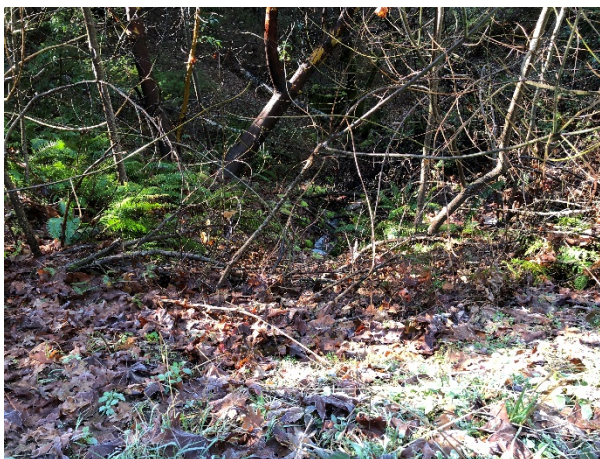
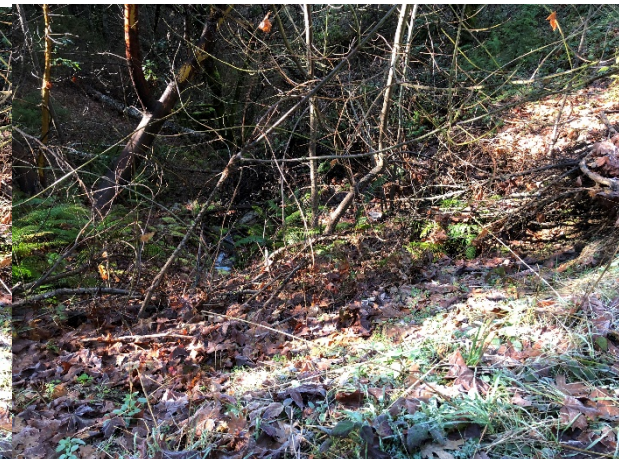
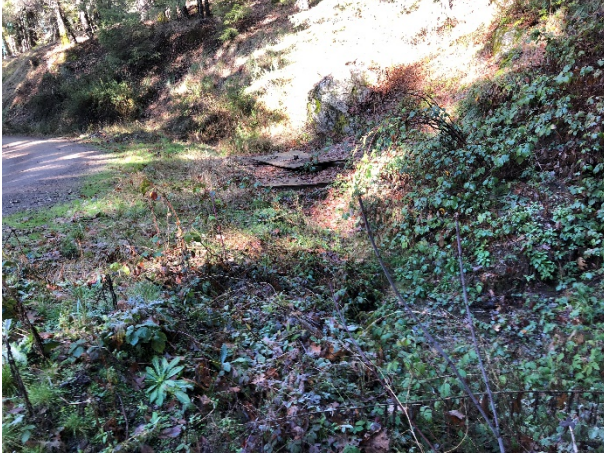
Continuing northeasterly the next curve is encountered. The roadway approaching the curve is 12 feet in width and at the curve the roadway widens to 16 feet (Pictures 45 & 49). At the middle of the curve on the northside of the road where the roadway widens, two 12 inch CMP culverts exists (Pictures 46 & 49) with a constructed dam between them (Picture 49). The inlets are damaged, and the outlets are unarmored creating erosion downstream (Pictures 47 & 48).

Picture #45 Cobb Rd looking NE @ curve

Picture #46 Cobb Rd looking at 12" crushed CMP inlet

Picture #47 Cobb Rd outlet of 12" culvert in Picture 46

Picture #48 Cobb Rd outlet of 12" culvert in Picture 46

Picture #49 Cobb Rd @ double 12" culvert w/ dam in middle

At this specific location it is recommended to replace the existing culvert with a new minimum 18 inch culvert and construct a turnout at the curve in accordance with the Humboldt County Ordinance for California Fire Safe Regulation. Reestablishment of the existing roadside ditches are also recommended.

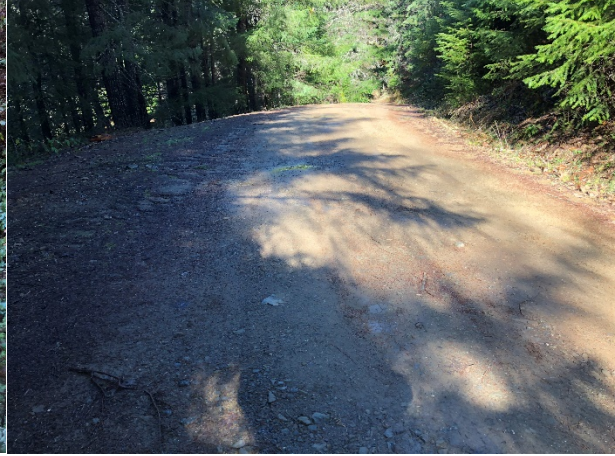
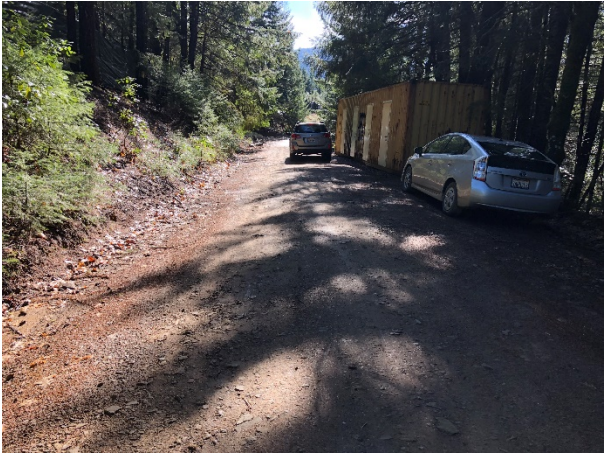
Continuing southeasterly the roadway is 12 feet wide with 1-2 foot drainage ditches on either side of the road that are clogged with debris. The gradient is approximately is gradual at 2-3%. There is a large container stored on the south side of the roadway (Picture 51) creating a traffic hazard.

Picture #50 Cobb Rd looking SW towards curve.

Picture #51 Cobb Rd looking NE at storage container in road

It is recommended to immediately remove the container. Reestablishment of the existing roadside ditches are also recommended.

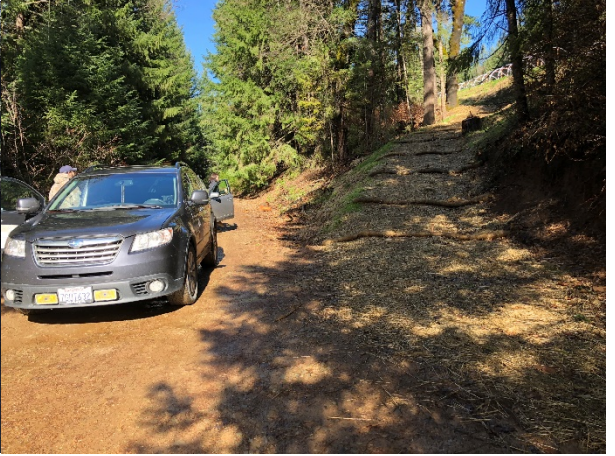
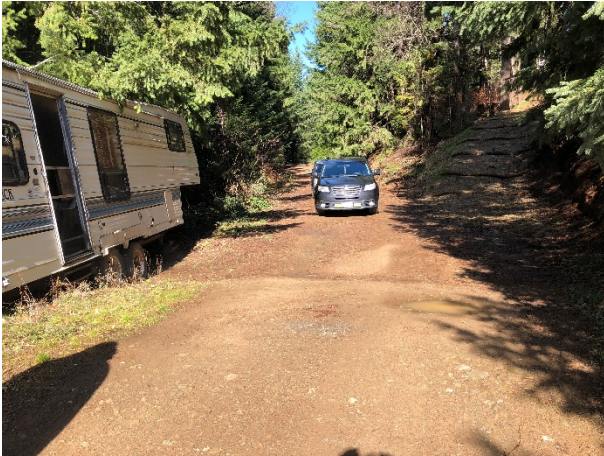
Continuing southeasterly the roadway is 12 feet wide with 1-2 foot drainage ditches on either side of the road. The gradient is also gradual at 2-3%. On the northside of the roadway exists a stabilized slope that looks as if it were a driveway at one time. The stabilization with both mulch and fiber rolls is appropriate and should be used as an example for stabilizing the slopes that are mentioned in the Summary and Recommendations section of this report below. There is a container stored on the south side of the roadway creating a traffic hazard (Picture 53).

Picture #52 Cobb Rd looking NW towards properly stabilized slope

Picture #53 Cobb Rd looking NW @ abandoned RV in road

It is recommended to immediately remove the container. Reestablishment of the existing roadside ditches are also recommended.

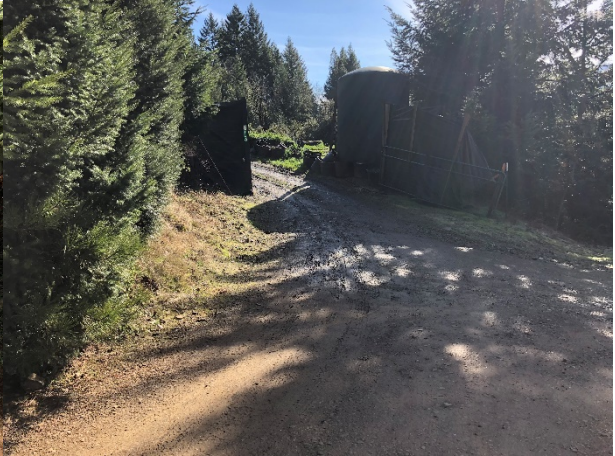
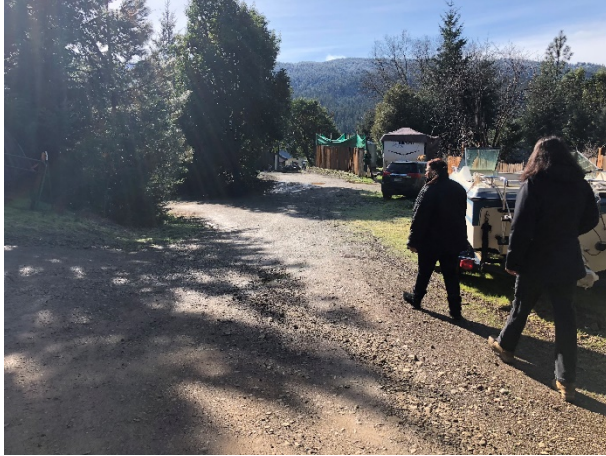
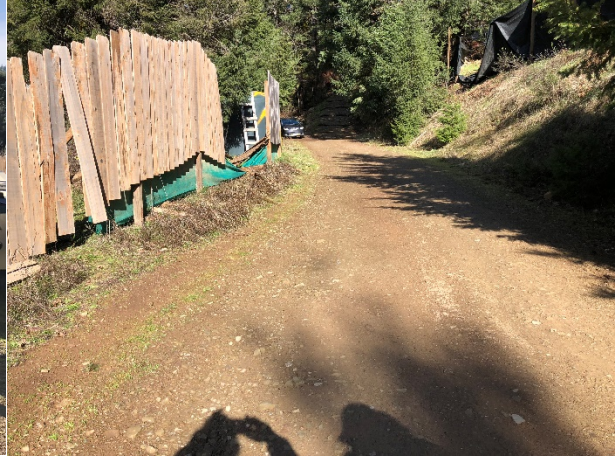
Continuing southeasterly the roadway is 12 feet wide with 1-2 foot drainage ditches on either side of the road. The gradient is approximately is gradual at 2-3%. At this location the road evaluation is terminated and there are two driveways at this location as Cobb Rd continues in a southerly location serving four additional parcels.

Picture #54 Cobb Rd looking E @ driveway

Picture #55 Cobb Rd looking SE @ road end

Picture #56 Cobb Rd at road end looking NW.

It is recommended to construct a turnaround in accordance with the Humboldt County Ordinance for California Fire Safe Regulation. Reestablishment of the existing roadside ditches are also recommended.

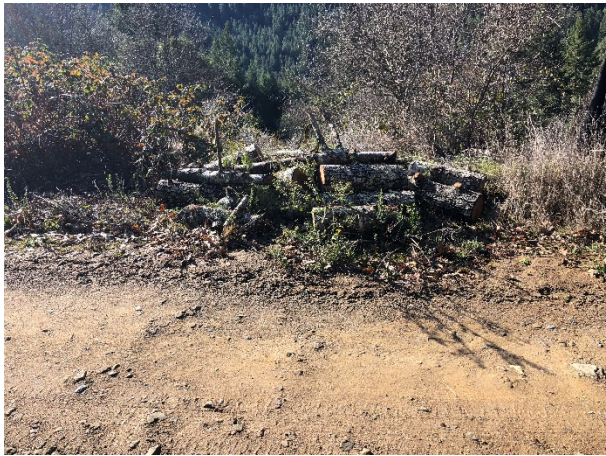
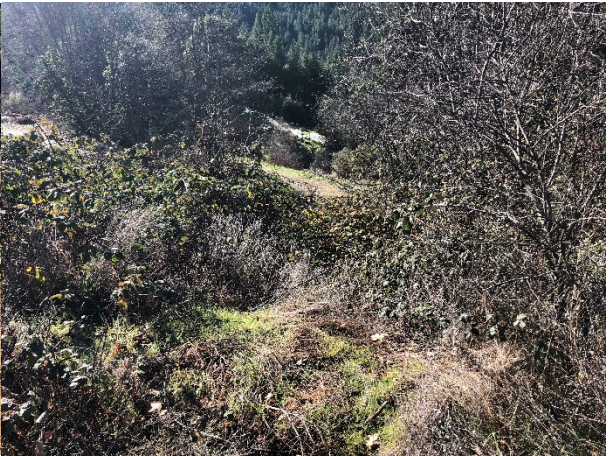
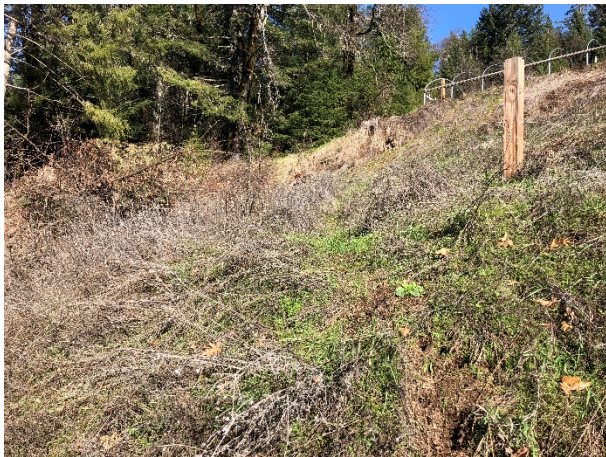
Continuing southeasterly a previously blocked and undersized 12 inch CMP culvert exists (Pictures 57-59). Because of the erosion coming off the hillside from the graded flat above, the carried sediment is clogging the culvert forcing water over the road. One of the residents living below that part of the road has constructed a dam to prevent water from overtopping the road onto their property (Picture 57). The roadway at this location is approximately 12 feet wide with 1 foot shoulders and the roadway has minimal slope at this location.

Picture #57 Cobb Rd @ outlet of culvert where water tops road

Picture #58 Cobb Rd outlet of culvert in Picture 57

Picture #59 Looking uNW @ erosion @ outlet of culvert in Picture 58

At this specific location it is recommended to replace the existing culvert with a new minimum 18 inch culvert. The drainage issues with APN #208-341-011 are impacting Cobb Rd and the parcels downslope. With that APN securing a permit through the Humboldt County Commercial Medical Marijuana Ordinance, the conditions of that permit should address the erosion and drainage issues created by clearing and grading the flats without proper permits and engineering. It is recommended that a site evaluation to be performed as soon as possible to begin remediation of the issues impacting the roadway. Reestablishment of the existing roadside ditches are also recommended.
