Water Resource Protection Plan

180101060405TRC383

WDID: 1B171720CHUM

4/02/2018
Revised 10/02/2018

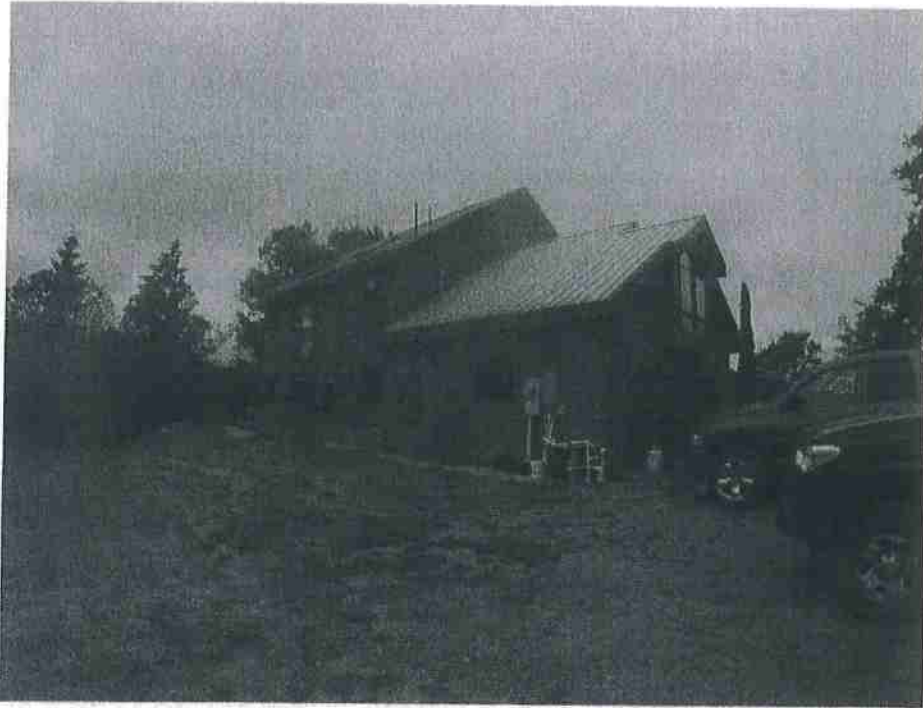
This property currently utilizes a septic system attached to the residence. The discharger relayed that the residence and septic system are permitted.

Primary residence: This residence has a permitted septic system.

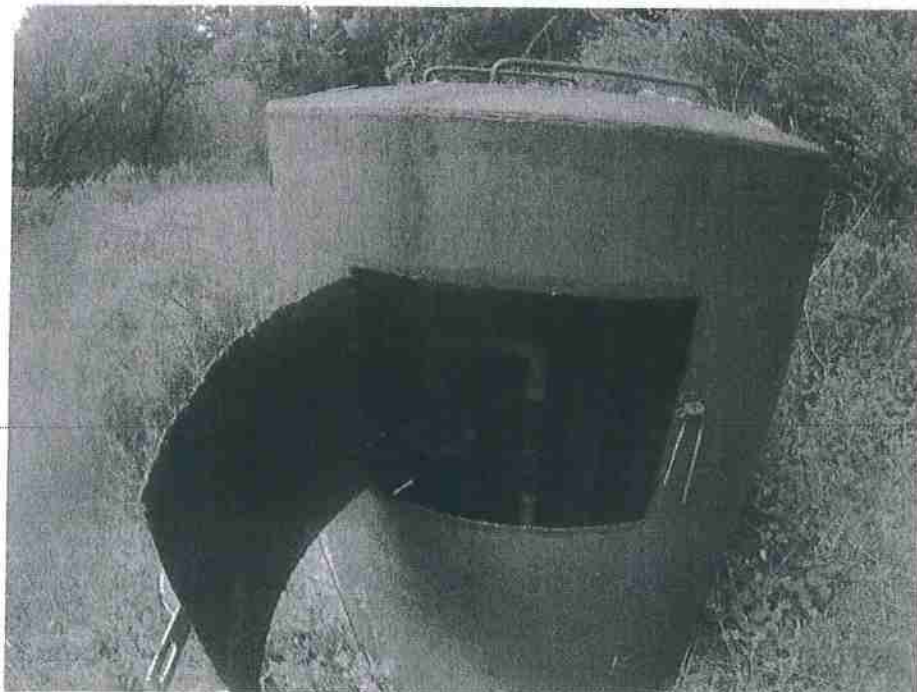
Well: Sole source of water for domestic and agricultural uses.

See General Recommendation #2

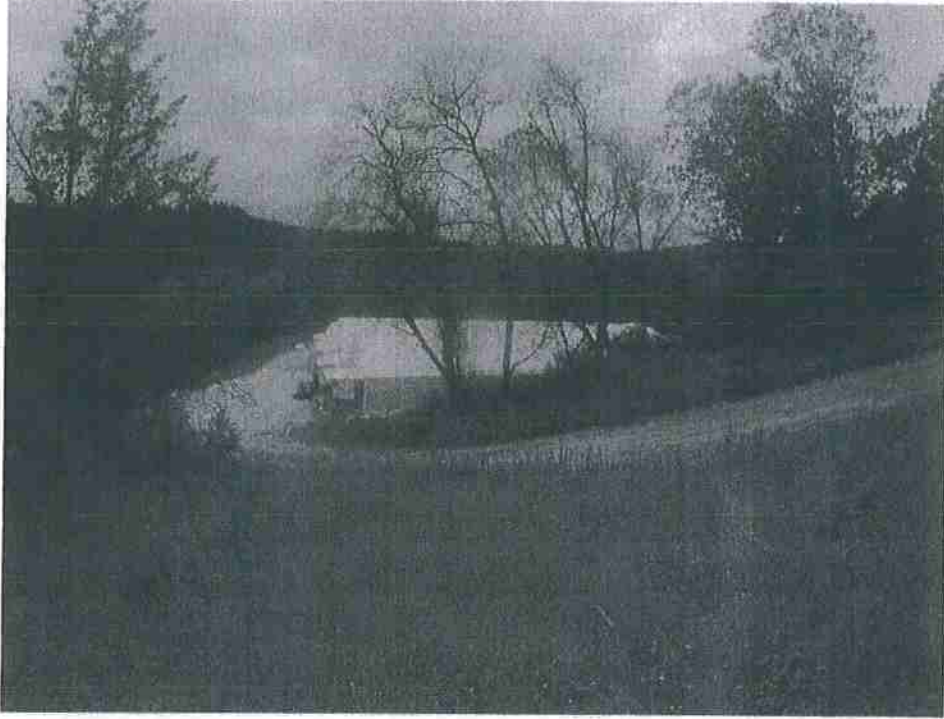
Cultivation Area A consists of a graded area that accommodates two 120'X30' greenhouses. Slopes within the cultivation area are 1-5% with surrounding slopes of approximately 25%. No site maintenance or erosion control features were identified for this cultivation area.

Cultivation Area A: Two greenhouses located on a graded flat.

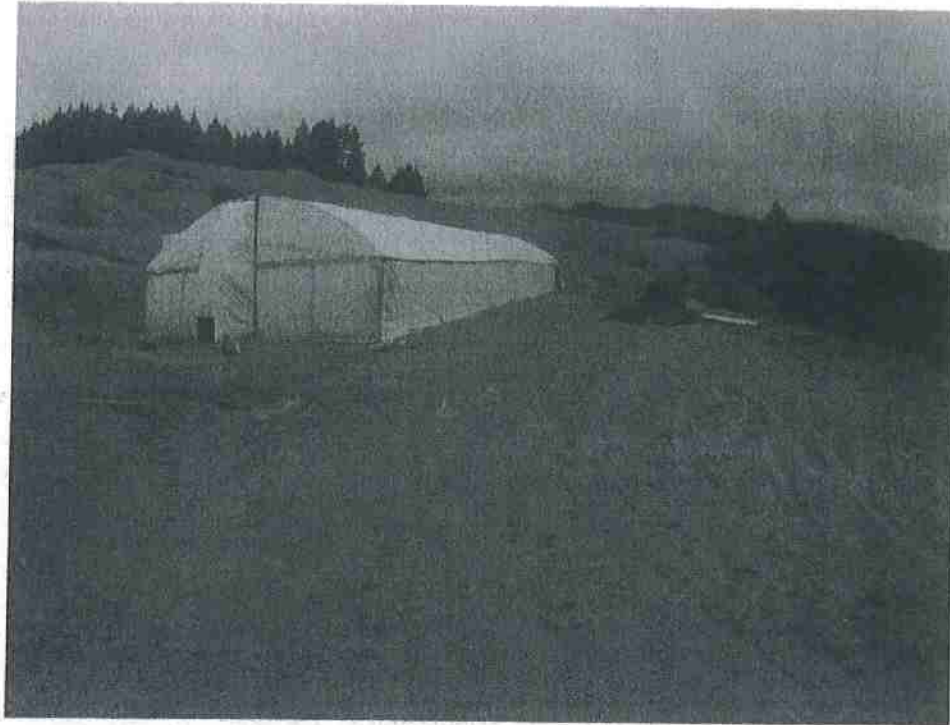
Cultivation Area B consists of an area that has been graded in the past to accommodate one 120'X30' greenhouse. Slopes within the cultivation area range from 1-5% with surrounding slopes averaging approximately 20%. It has been recommended to seed and mulch all of the exposed soils within this cultivation area due to an unstable area to the south.

Cultivation Area B: One greenhouse located on a graded flat.

Current Condition: The edge of this cultivation area is approximately 63.5ft from a Class III watercourse. This graded area drains away from this watercourse.

Prescribed Action: It has been recommended to install a berm or staked straw waddle around the entire eastern and southern edge of this cultivation area. Additionally all exposed soils within this Cultivation Area shall be seeded and mulched.

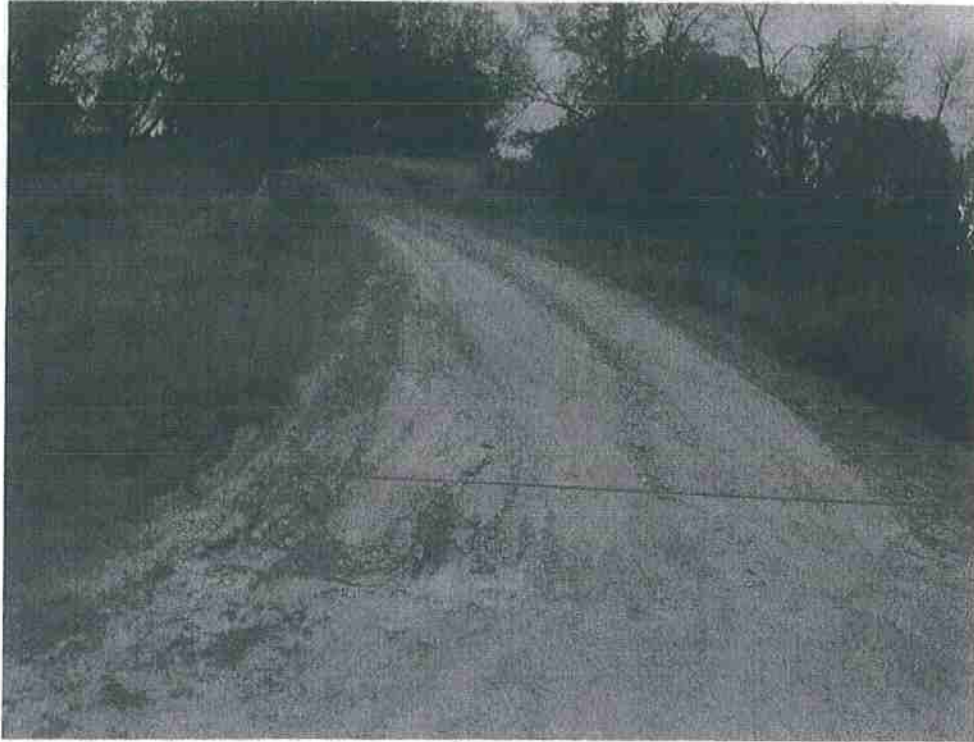
The permanent road is used to access the primary residence, an agricultural storage structure, Cultivation Area A, and Cultivation Area B. The permanent road was well rocked with appropriate and adequately spaced drainage structures. It has been recommended to install drainage structures at Site 01 and 02.

Sites 01 and 02: Install rolling dips in these locations. Install an inside ditch between these proposed rolling dips.

See General Recommendation #1

Unique Point	Lat-Long NAD 83	Road Type	Mitigation Planned	Monitor	1600	Standard Conditions	Treatment Priority	Date Completed
1	-123.817 40.2223	Permanent	X	X	-	A.1.	Prior to 10/15/19	
Current Condition: Existing rolling dip is not functioning adequately. This drainage feature has become beaten down due to year around vehicle use.						Prescribed Action: Install a Type 1 rocked rolling dip in this location per the specifications of the attached BMP's.		
Unique Point	Lat-Long NAD 83	Road Type	Mitigation Planned	Monitor	1600	Standard Conditions	Treatment Priority	Date Completed
2	-123.817 40.2224	Permanent	X	X	-	A.1.	Prior to 10/15/19	
Current Condition: Existing rolling dip is not functioning adequately. This drainage feature has become beaten down due to year around vehicle use.						Prescribed Action: Install a Type 1 rocked rolling dip in this location per the specifications of the attached BMP's.

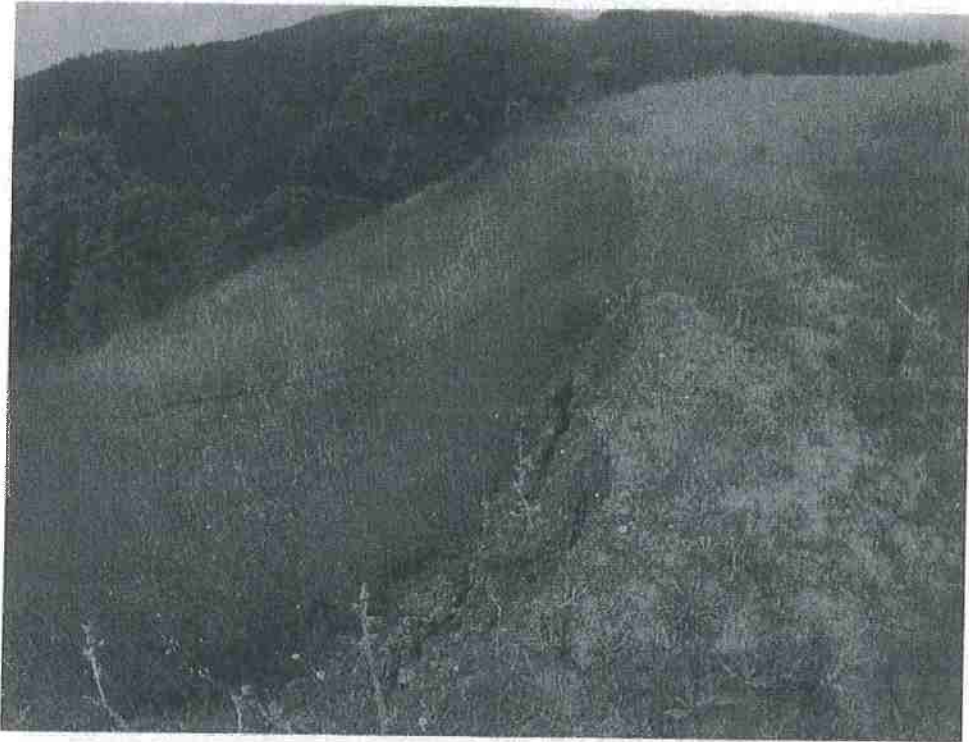
An unstable area was identified to the south of the graded area of Cultivation Area B. This area is defined as an unstable area on the site map and referenced as Site 04 in the attached Mitigation Report. The unstable area is approximately 8,371 square feet. There are multiple vertical scarps of approximately 2-3 feet. There is a Class III watercourse approximately 90 feet away. There was no observed hydrological connectivity due to the unstable area being caught in a swale feature. There is a graded flat above this unstable area that will require improved drainage to prevent saturation of this unstable area during storm events. As an interim measure it has been recommended to install staked straw wattles around the entire eastern and southern edge of the graded flat. Additionally, drainage of this area shall be re-constructed to drain towards a grass hillside to the south west in effort to minimize saturation of the unstable area. See pictures for more details. The installation of straw wattles shall be implemented prior to 10/15/2018 and reconstruction of the drainage of the graded area shall be implemented prior to 10/15/2019.

Site 04: Unstable area with multiple vertical scarps of 2-3ft.

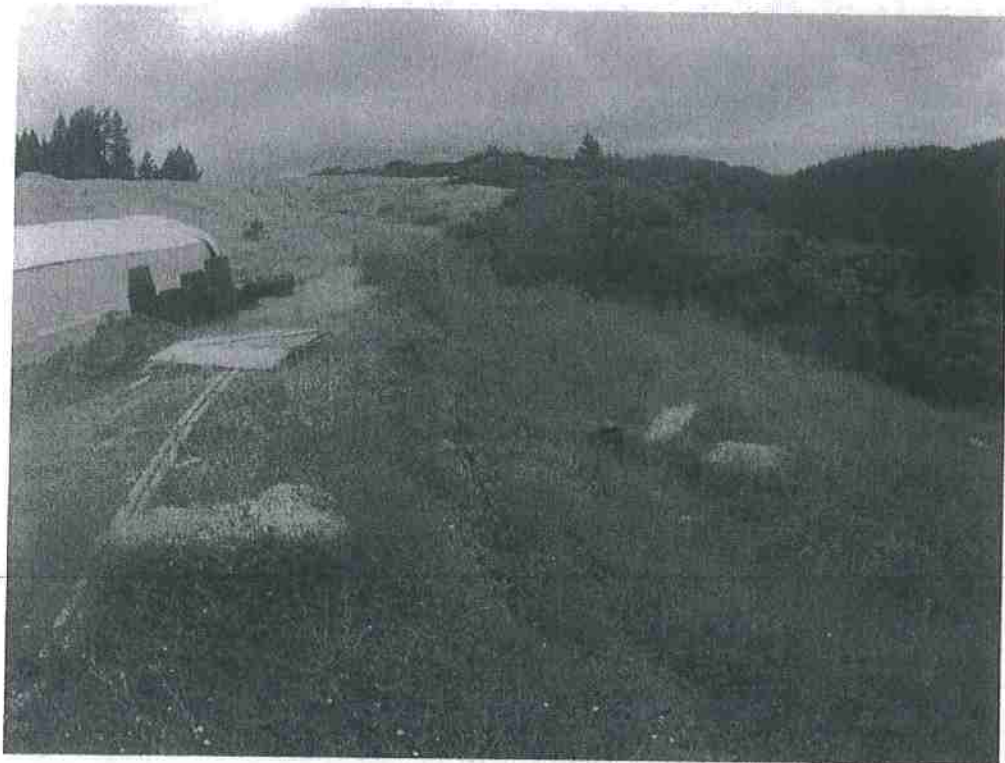
Site 04: alternate view.

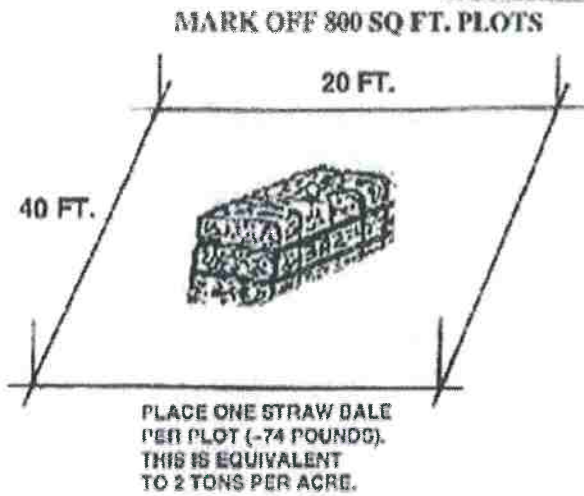
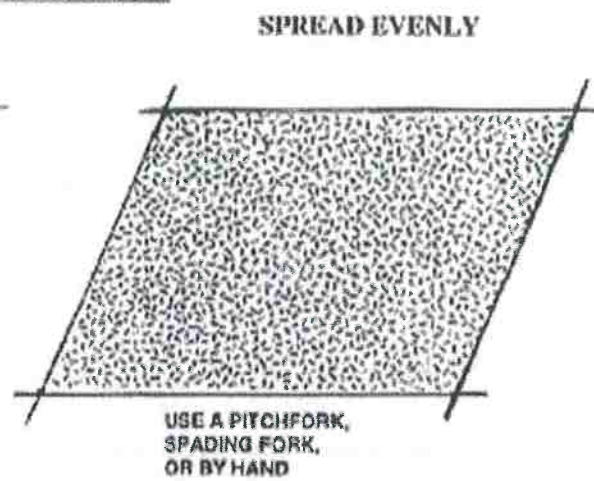
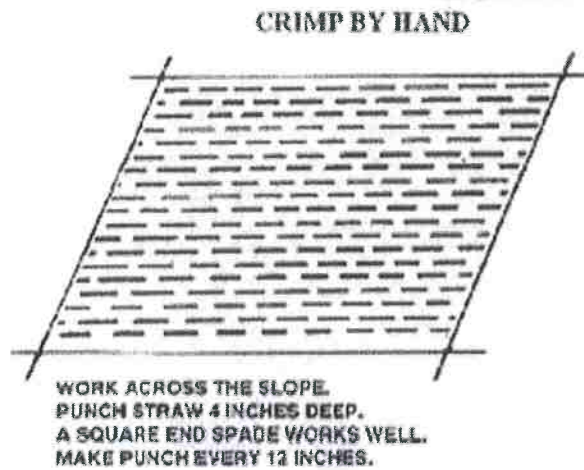
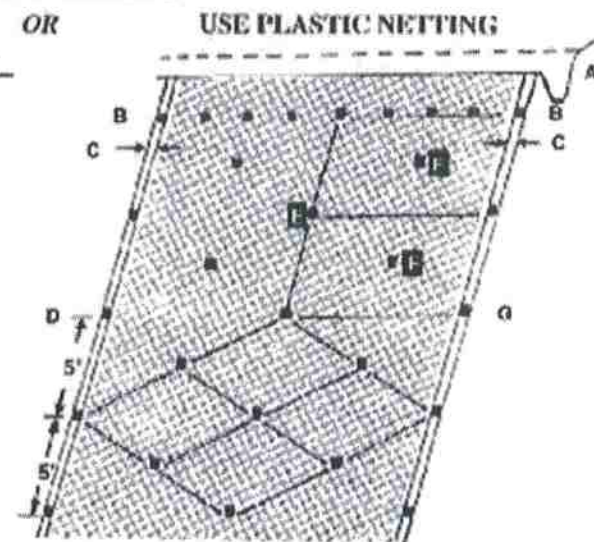
SPREAD THE STRAW

ANCHOR THE STRAW

- A. LAY BIRD CONTROL NETTING OR SIMILAR MATTING IN STRIPS DOWN THE SLOPE OVER THE STRAW. BURY UPPER END IN 6-8 INCH DEEP AND WIDE TRENCH.. MOST NETTING COMES IN 14 TO 17 FT. WIDE ROLLS.
- B. SECURE THE UPPER END WITH STAKES EVERY 2 FEET.
- C. OVERLAP SEAMS ON EACH SIDE 4-5 INCHES.
- D. SECURE SEAMS WITH STAKES EVERY 5 FEET.
- E. STAKE DOWN THE CENTER EVERY 5 FEET.

- F. STAKE MIDDLES TO CREATE DIAMOND PATTERN THAT PROVIDES STAKES SPACED 4-5 FEET APART.
- G. USE POINTED 1X2 INCH STAKES 8 TO 9 INCHES LONG. LEAVE 1 TO 2 INCH TOP ABOVE NETTING, OR USE "U" SHAPED METAL PINS AT LEAST 9 INCHES LONG.

NOTE: WHEN JOINING TWO STRIPS, OVERLAP UPPER STRIP 3 FEET OVER LOWER STRIP AND SECURE WITH STAKES EVERY 2 FEET LIKE IN "B" ABOVE

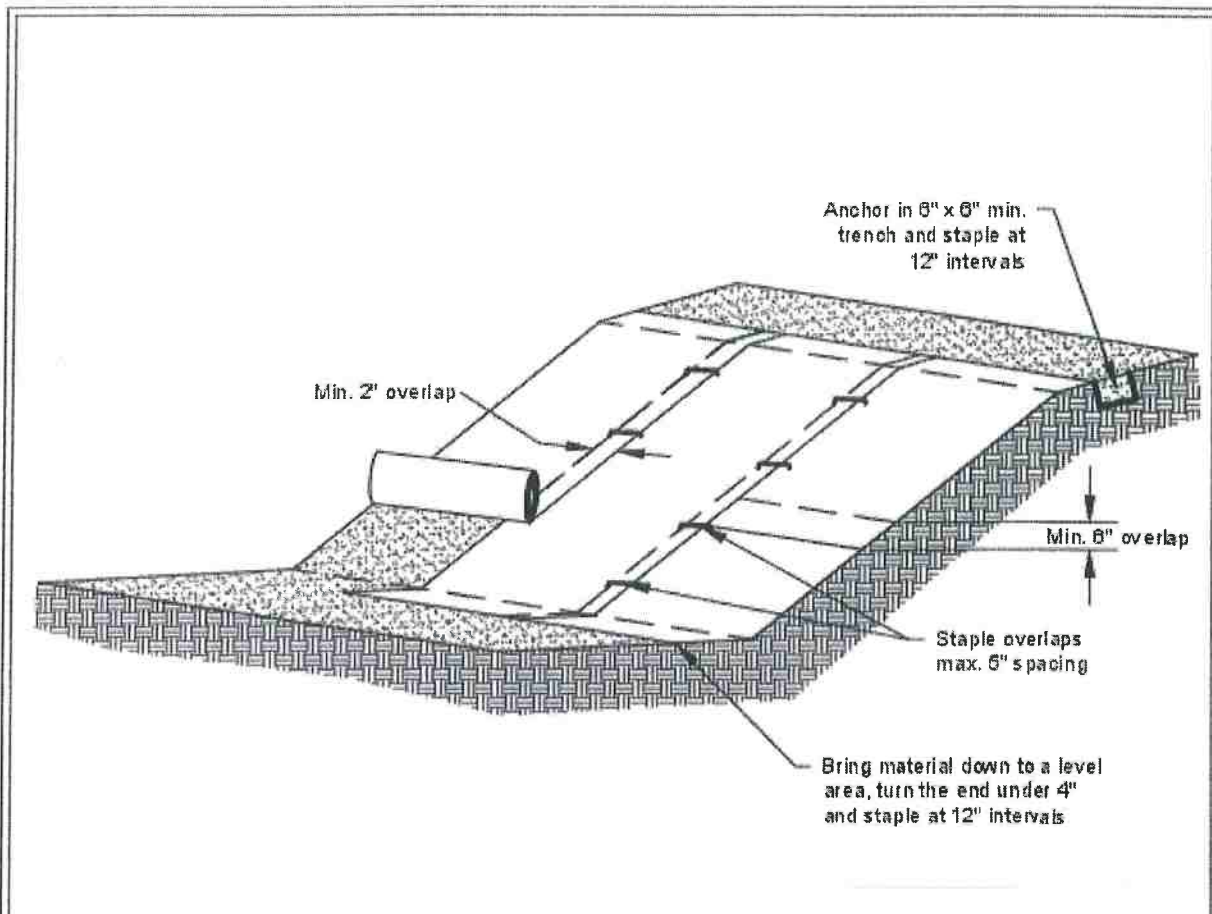
1. Slope surface shall be smooth before placement for proper soil contact.
2. Stapling pattern as per manufacturer's recommendations.
3. Do not stretch blankets/matting tight - allow the rolls to mold to any irregularities.
4. For slopes less than 3H:1V, rolls may be placed in horizontal strips.
5. If there is a berm at the top of the slope, anchor upslope of the berm.
6. Lime, fertilize, and seed before installation. Planting of shrubs, trees, etc. should occur after installation.

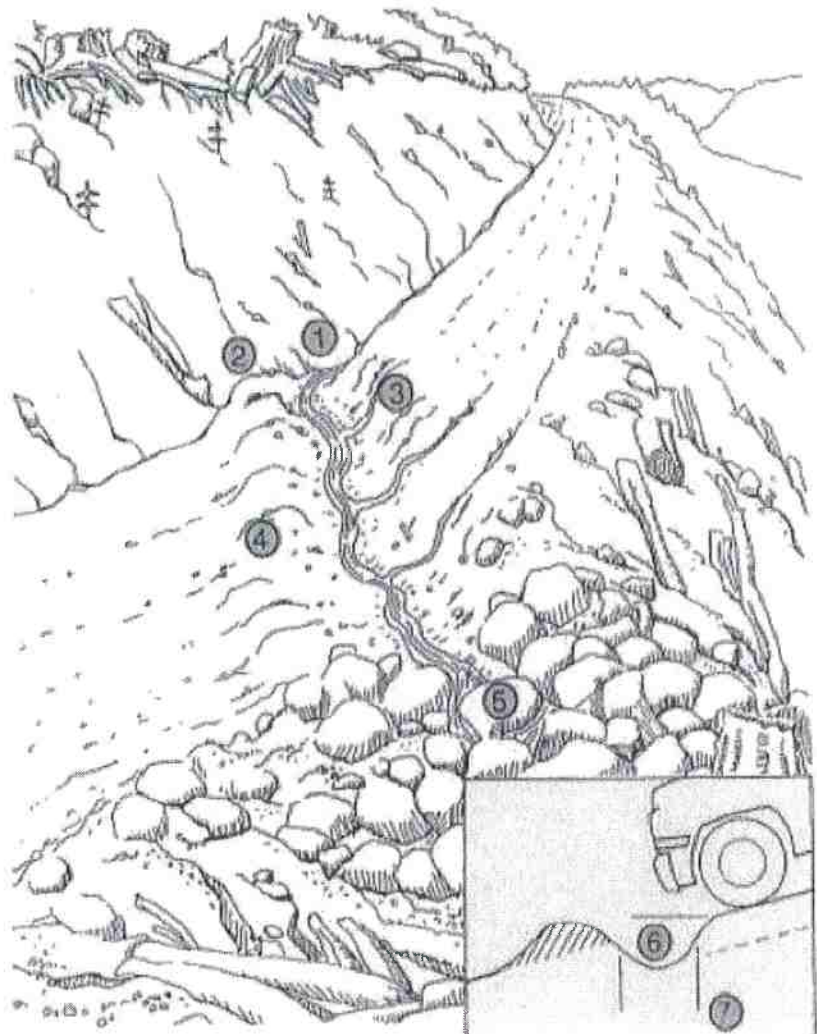
FIGURE 40. Waterbars are constructed on unsurfaced forest and ranch roads that will have little or no traffic during the wet season. The waterbar should be extended to the cutbank to intercept all ditch flow (1) and extend beyond the shoulder of the road. A berm (2) must block and prevent ditch flow from continuing down the road during flood flows. The excavated waterbar (3) should be constructed to be self-cleaning, typically with a 30° skew to the road alignment with the excavated material bermed on the downhill grade of the road (4). Water should always be discharged onto the downhill side on a stable slope protected by vegetation. Rock (shown in the figure) should not be necessary if waterbars are spaced close enough to prevent serious erosion. (5) The cross ditch depth (6) and width (7) must allow vehicle cross-over without destroying the function of the drain. Several alternate types of waterbars are possible, including one that drains only the road surface (not the ditch), and one that drains the road surface into the inside ditch (BCMF, 1991).

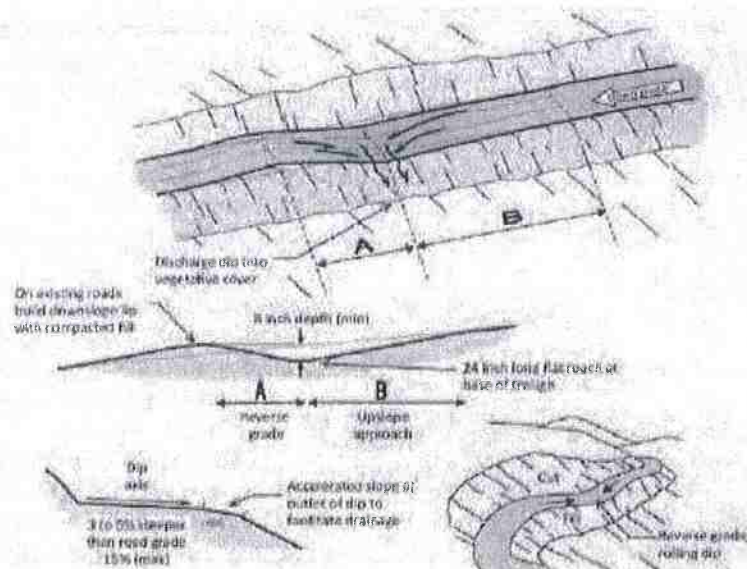
FIGURE 34. A classic Type I rolling dip, where the excavated up-road approach (B) to the rolling dip is several percent steeper than the approaching road and extends for 60 to 80 feet to the dip axis. The lower side of the structure reverses grade (A) over approximately 15 feet or more, and then falls down to rejoin the original road grade. The dip must be deep enough that it is not obliterated by normal grading, but not so deep that it is difficult to negotiate or a hazard to normal traffic. The outward cross-slope of the dip axis should be 3% to 5% greater than the up-road grade (B) so it will drain properly. The dip axis should be out-sloped sufficiently to be self-cleaning, without triggering excessive downcutting or sediment deposition in the dip axis (Modified from Best, 2013).

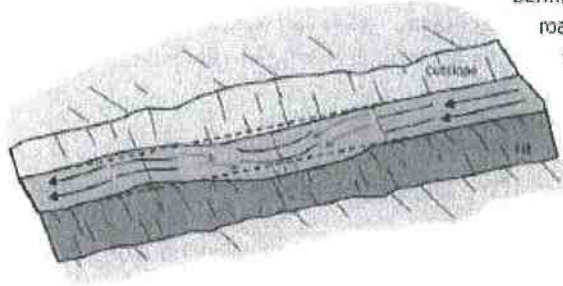
Type 1 Rolling Dip
(Standard)

Type 1 rolling dips are used where road grades are less than about 12-14% and road runoff is not confined by a large through cut or berm. The axis of the dip should be perpendicular to the road alignment and sloped at 3-4% across the road tread. Steep roads will have longer and more abrupt dip dimensions to develop reverse grade through the dip axis. The road tread and/or the dip outlet can be rocked to protect against erosion, if needed.

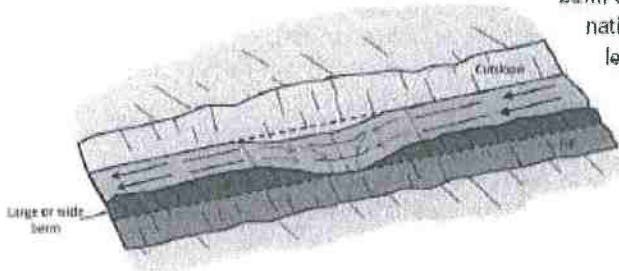
Type 2 Rolling Dip
(Through-cut or thick berm road reaches)

Type 2 rolling dips are constructed on roads up to 12-14% grade where there is a through cut up to 3 feet tall, or a wide or tall berm that otherwise blocks road drainage. The berm or native through cut material should be removed for the length of the dip, or at least through the axis of the dip, to the extent needed to provide for uninterrupted drainage onto the adjacent slope. The berm and slope material can be excavated and endhauled, or the material can be sidecast onto native slopes up to 45%, provided it will not enter a stream.

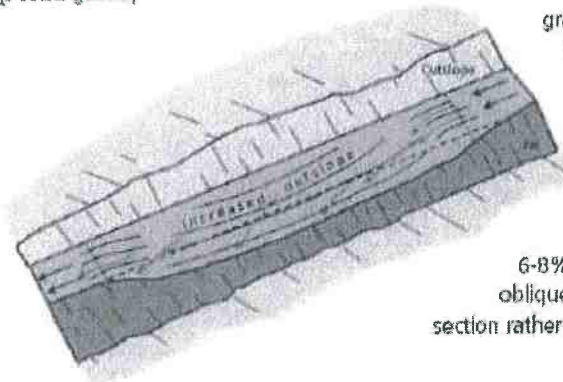
Type 3 Rolling Dip
(Steep road grade)

Type 3 rolling dips are utilized where road grades are steeper than about 12% and it is not feasible to develop a reverse grade that will also allow passage of the design vehicle (steep road grades require more abrupt grade reversals that some vehicles may not be able to traverse without bottoming out).

Instead of relying on the dip's grade reversal to turn runoff off the roadbed, the road is built with an exaggerated outslope of 6-8% across the dip axis. Road runoff is deflected obliquely across the dip axis and is shed off the outsloped section rather than continuing down the steep road grade.

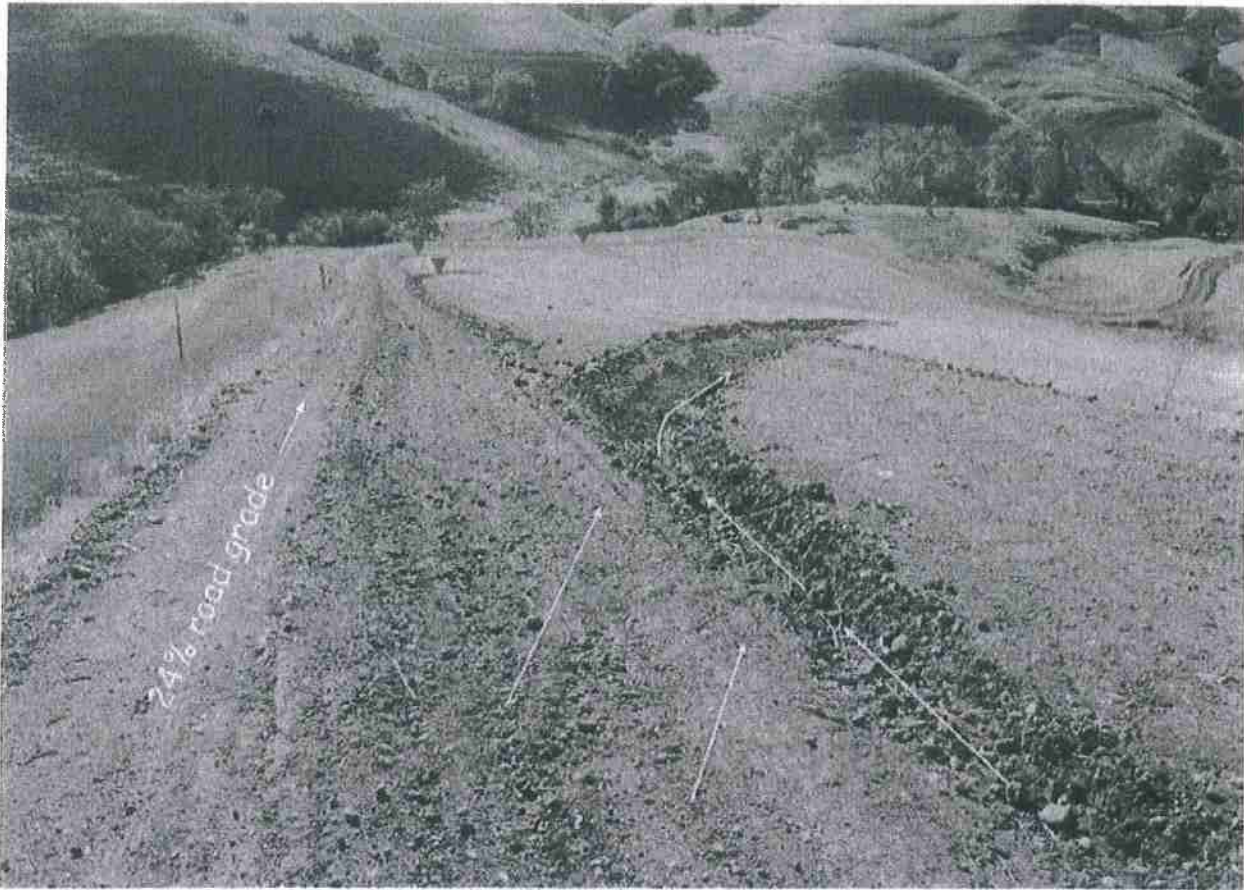
FIGURE 55. Steep roads that go straight up or down a hillside are very difficult to drain. This steep, fall line road developed a through cut cross section that was drained using lead out ditches to direct runoff off the road and onto the adjacent, vegetated hillside. The road was "outsloped" to drain runoff to the right side, and the lead out ditch was built slightly steeper than the road grade, to be self-cleaning. Four lead out ditches have been constructed at 100-foot intervals to the bottom of the hillside.

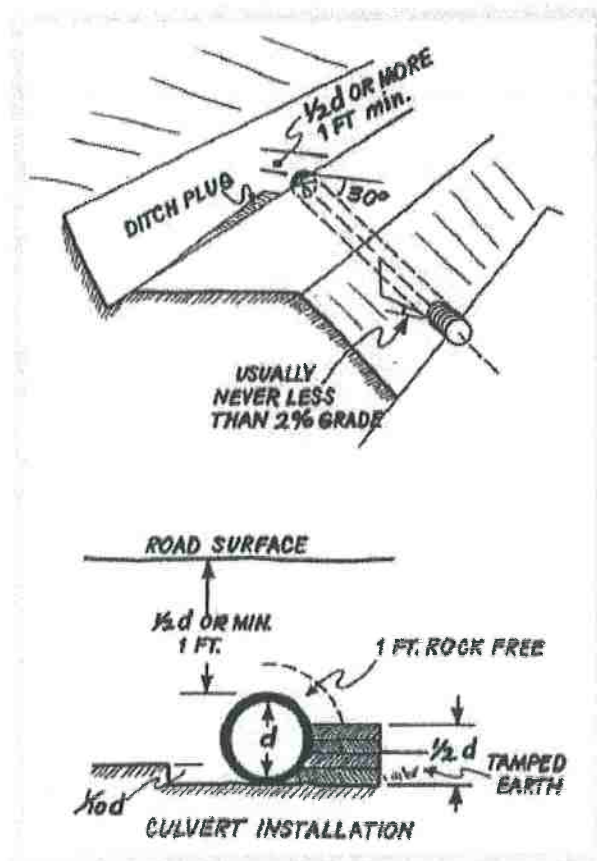
FIGURE 4B. The elements of a properly installed ditch relief culvert. The culvert is angled at about 30 degrees to the road alignment to help capture flow and prevent culvert plugging or erosion of the inlet area. It is set at the base of the fill (ideally) or with a grade slightly steeper than the grade of the contributing ditch (but never with a grade less than 2 percent) (USDA-SCS, 1983). At a minimum, the grade of the ditch relief culvert should be sufficient to prevent sediment accumulation at the inlet or deposition within the culvert itself (it should be self-cleaning) (USDA-SCS, 1983).

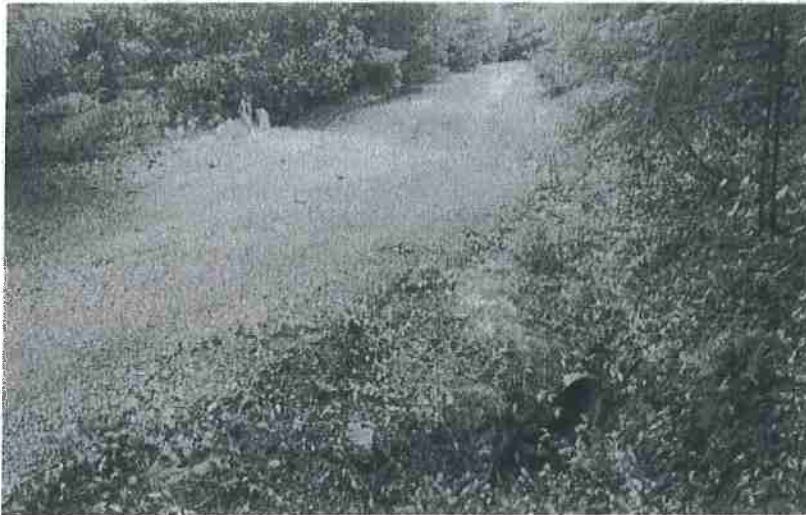
FIGURE 39.

Waterbars are often used to drain surface runoff from seasonal, unsurfaced roads. Because they are easily broken down by vehicles, waterbars are only used on unsurfaced roads where there is little or no wet weather traffic. In this photo, a waterbar and ditch relief culvert are used to drain all road surface and ditch runoff from the insloped road prism.

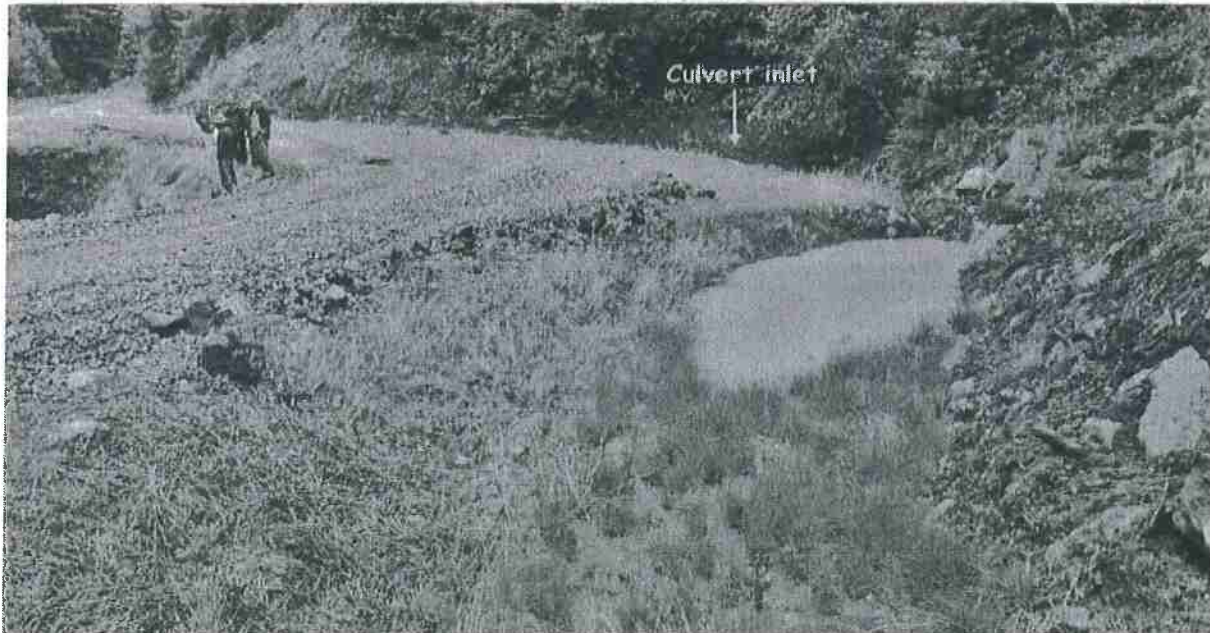
FIGURE 238. Traffic and surface runoff from graveled roads often produces surface erosion, turbid runoff and fine sediment transport that can be delivered to streams. Where ditches can't be eliminated, sediment traps and roadside settling basins can be installed to capture and remove most of the eroded sediment.

This settling basin has been constructed along the inside ditch just before a stream crossing culvert inlet (see arrow). Eroded sediment from the road and ditch are deposited in the basin before flow is released to the stream. Fine sediments have filled about 1/3 of this basin and vegetation is now growing. Sediment basins require periodic maintenance to maintain their storage capacity.

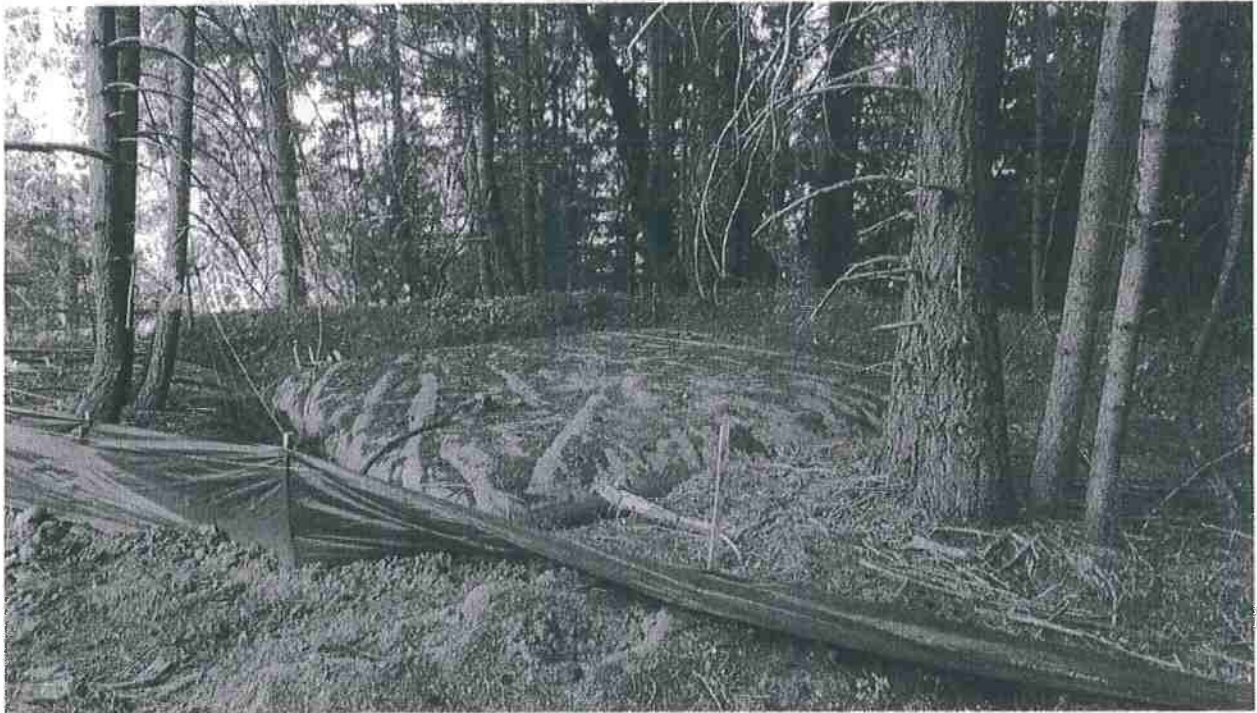
This is an example of a containment pit which will assist in mitigating the impacts if this storage bladder failed.
