WILDLIFE ENTRAPMENT IN WELDED PLASTIC/MONOFILAMENT NETTING

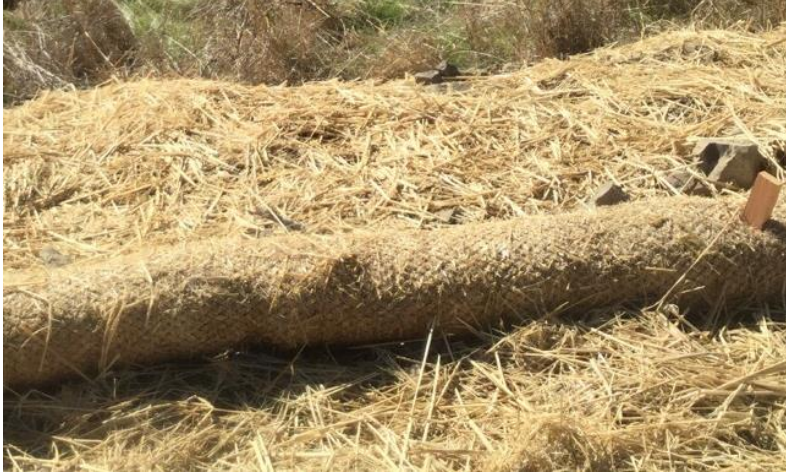
Plastic erosion control netting with welded weaves (Below). Wildlife may be entrapped in this material and sustain injuries and/or perish.

TO MINIMIZE THE RISK OF WILDLIFE ENTRAPMENT, THE CA DEPARTMENT OF FISH AND WILDLIFE (CDFW) RECOMMENDS AVOIDING THE USE OF SYNTHETIC NETTING (E.G., PLASTIC OR NYLON) INCLUDING PHOTO OR BIODEGRADABLE PLASTIC NETTING FOR THE PURPOSE OF EROSION CONTROL AND/OR CULTIVATION OPERATIONS. CDFW RECOMMENDS THAT ALTERNATIVES SUCH AS GEOTEXTILES, FIBER ROLLS, AND OTHER EROSION CONTROL OR AGRICULTURAL TRELLIS MATERIALS BE MADE OF LOOSE-WEAVE MESH, SUCH AS JUTE, HEMP, COCONUT (COIR) FIBER, OR OTHER PRODUCTS WITHOUT WELDED WEAVES.

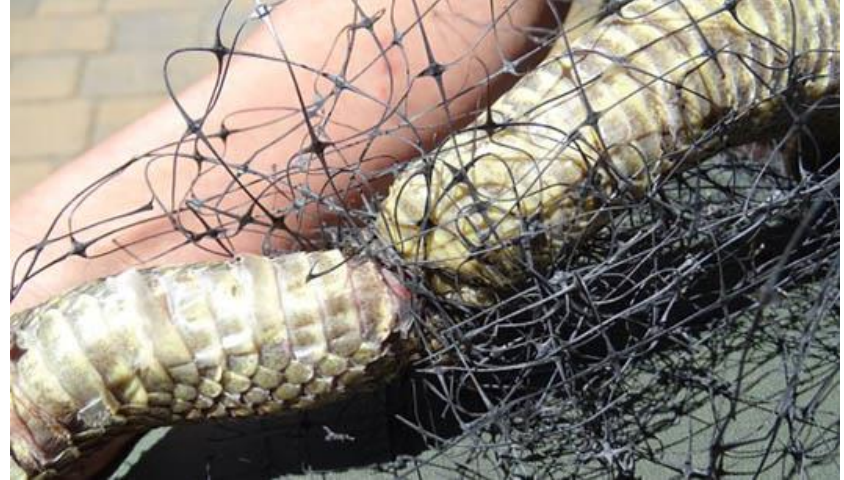
Rattlesnake caught in welded plastic erosion control netting (Below). (Photo by Wildlife Emergency Services)

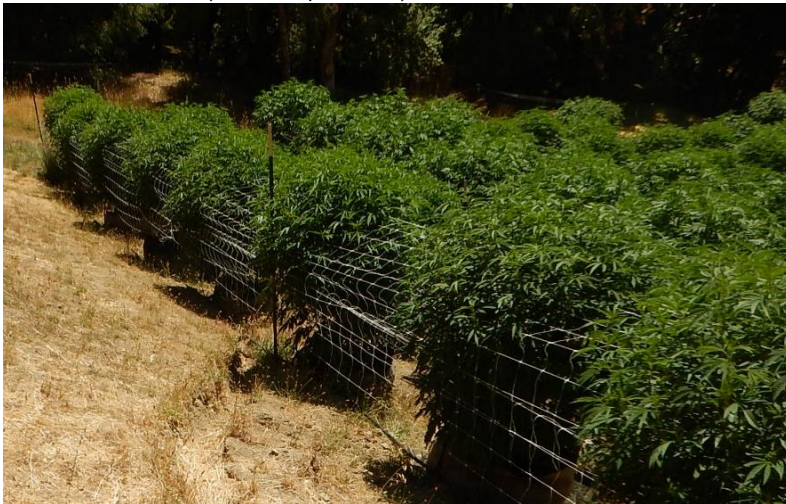
Birds, bats, reptiles, deer, and other wildlife are victims of inappropriate netting, such as the monofilament netting often used for cannabis. Wildlife may become tangled in this netting and cannot free themselves. (Photo by CDFW)

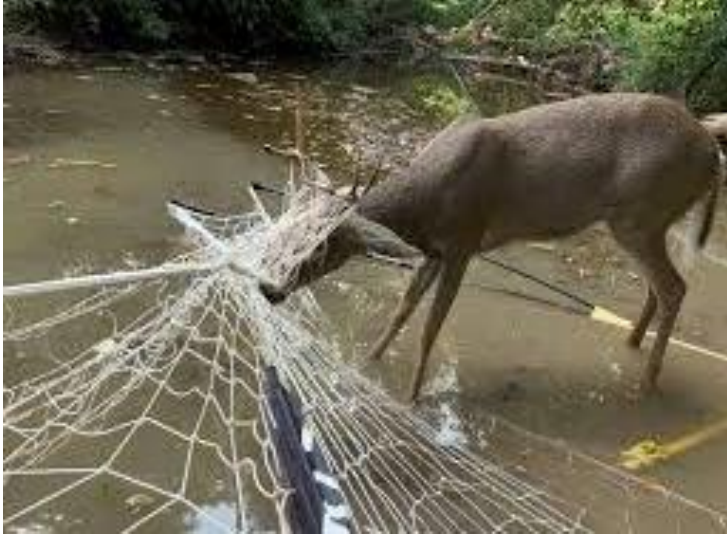
Deer caught in monofilament trellis netting (Below). (Photo by MO Dept. Conservation)

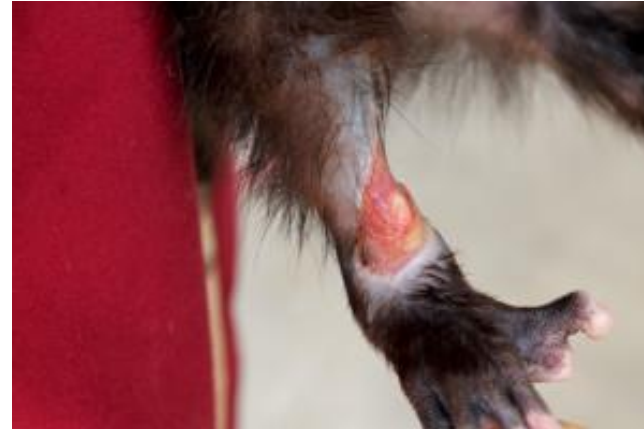
An opossum caught in plastic fencing in California received treatment for his leg wound from the Fund for Animals Wildlife Center. Unfortunately, many aren't found until too late. (Photos by Allison Gibson/The HSUS)

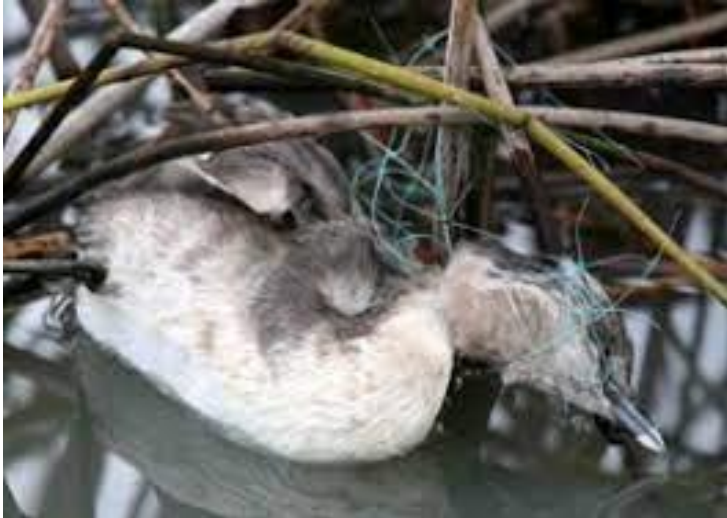
Bird caught in plastic netting (below). (Photo by Mandy Hall)
