Water Resource Protection Plan

APN 217-244-008

1B170491CHUM

Timberland Resource Consultants

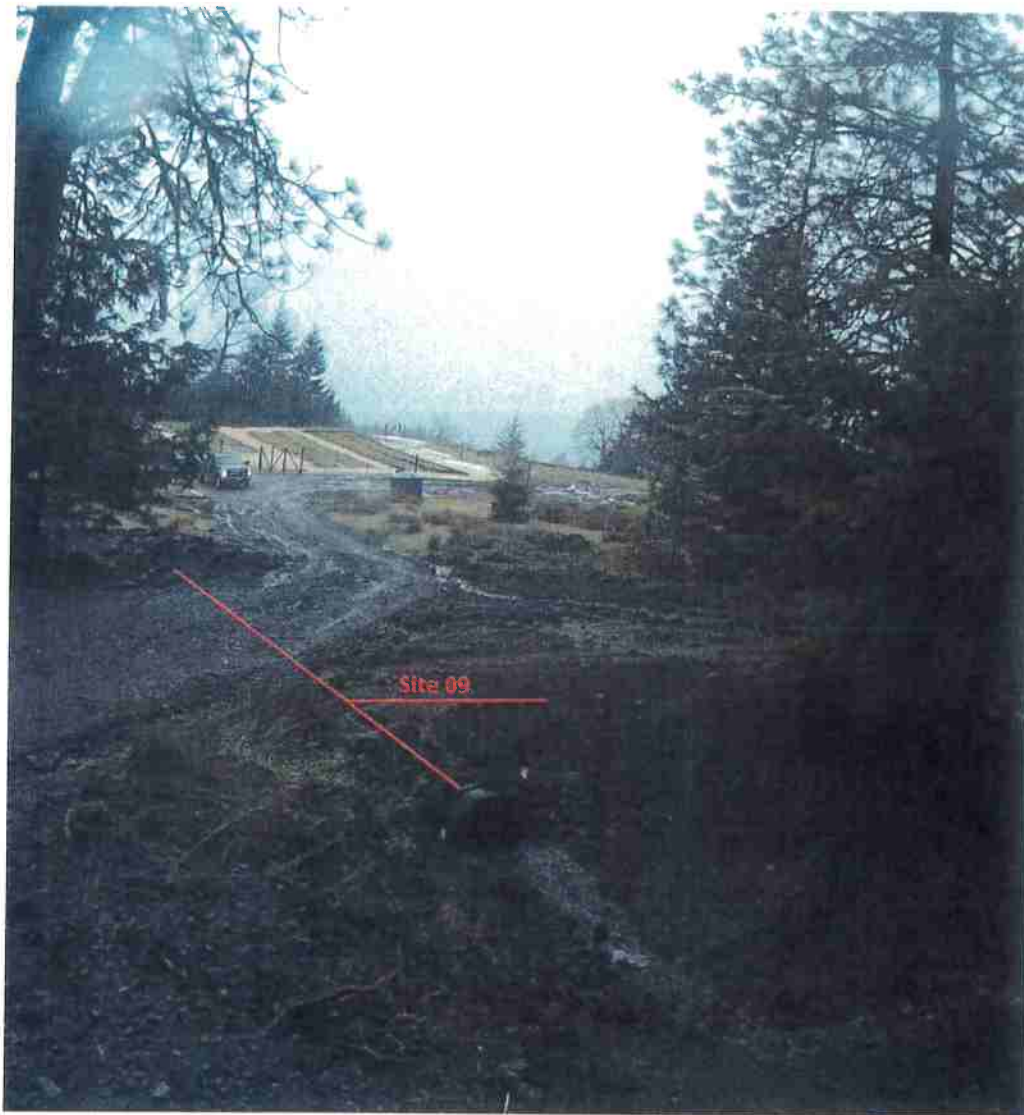
This photograph references Site 09 a 24" ditch relief culvert. Cultivation Area A is in the background.

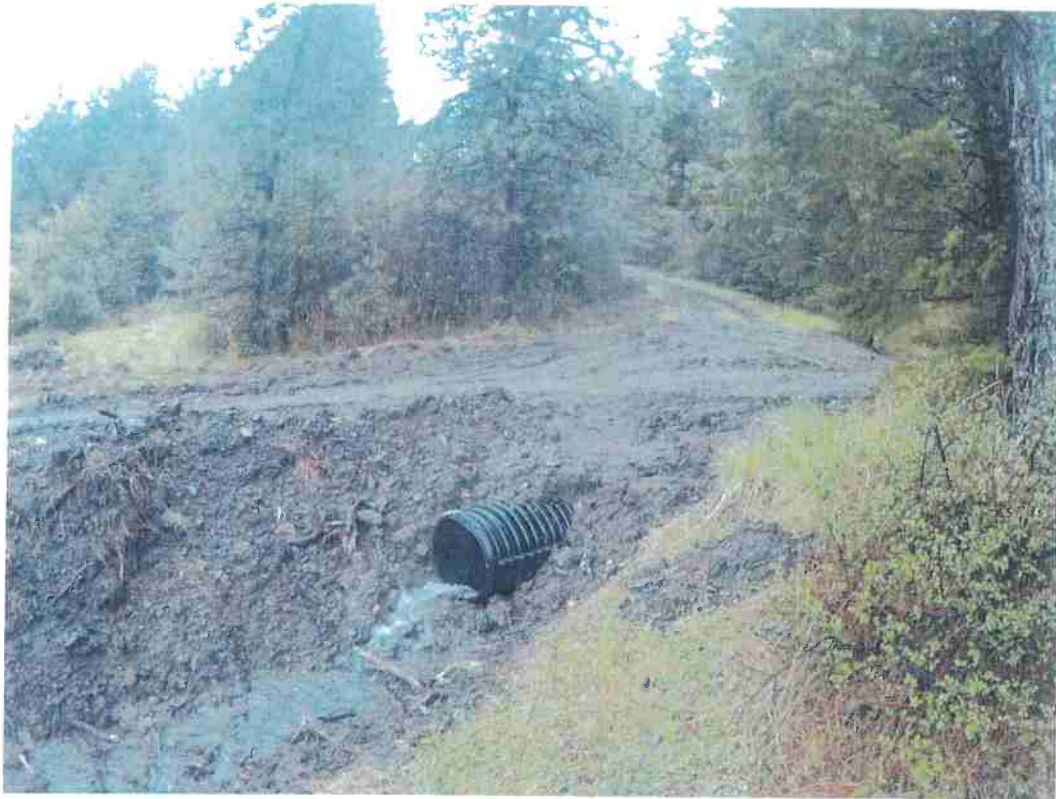
Site 09 – 24" ditch relief culvert. Functioning adequately.

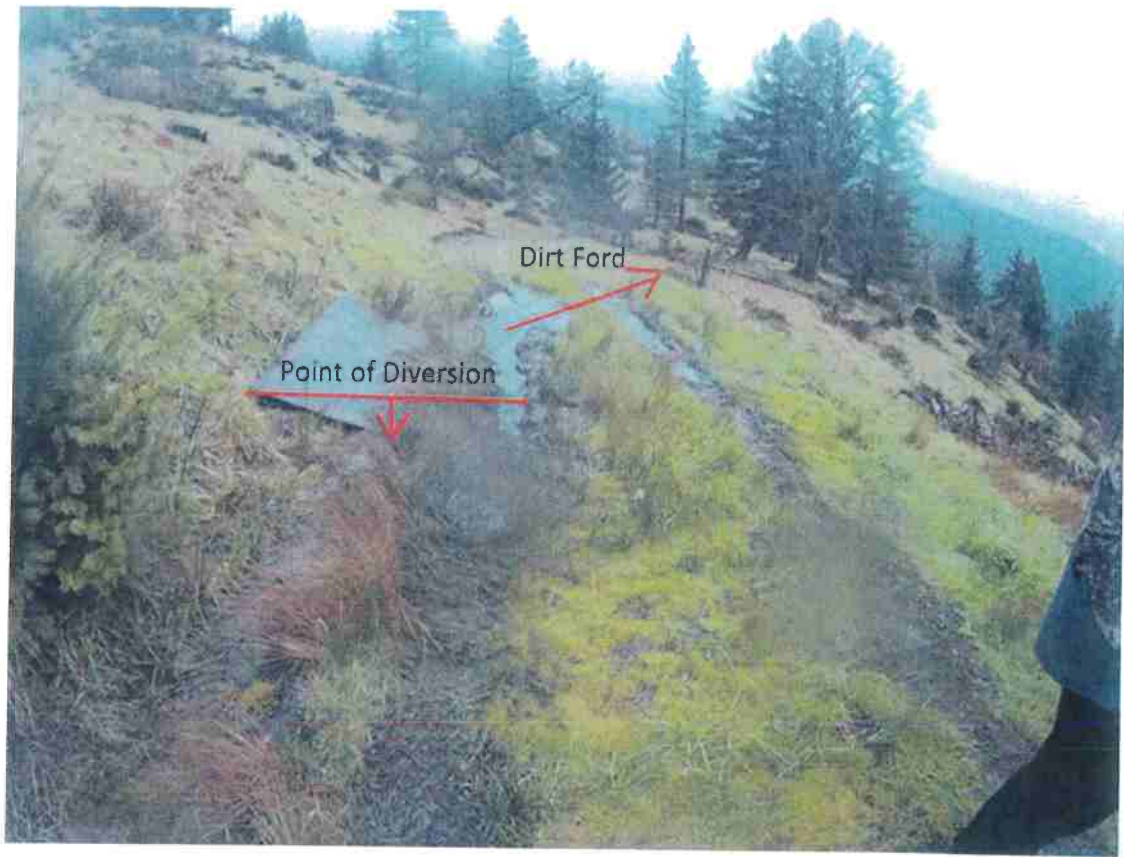
Site 12 the point of diversion and Site 11 a dirt ford. Bank seep drains across legacy hunting road. It is being recommended to install a water bar at Site 11 to ensure the bank seep does not drain down the road surface.

Unique Point	Lat-Long NAD 83	Road Type	Mitigation Planned	Monitor	1600	Standard Conditions	Treatment Priority	Date Completed
11	-123.597 40.3013	Seasonal	X	X		A.1.		
Current Condition: Location of a bank seep located on a legacy road. Spatial reference for monitoring.						Proposed Action : Bank seep pools on the road surface. It is being recommended to install a water bar at this location to ensure the bank seep does not drain down the road surface.		
Unique Point	Lat-Long NAD 83	Road Type	Mitigation Planned	Monitor	1600	Standard Conditions	Treatment Priority	Date Completed
12	-123.594 40.3015	Seasonal		X		A.1.		
Current Condition: Five gallon bucket buried in a bank seep, used as a point of diversion for domestic use.						Proposed Action: This point of diversion will require a Lake and Streambed Alteration Agreement.		
Unique Point	Lat-Long NAD 83	Road Type	Mitigation Planned	Monitor	1600	Standard Conditions	Treatment Priority	Date Completed

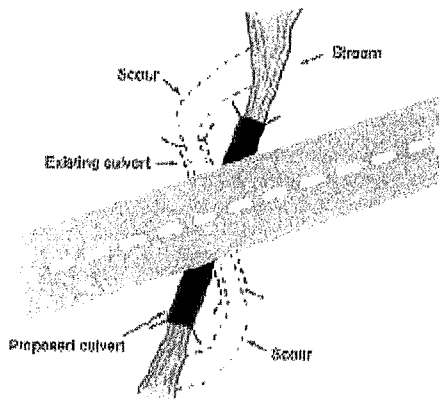
FIGURE 97. Culvert alignment should be in relation to the stream and not the road. It is important that the stream enters and leaves the culvert in a relatively straight horizontal alignment so streamflow does not have to turn to enter the inlet or discharge into a bank as it exits. This figure shows a redesigned culvert installation that replaces the bending alignment that previously existed. Channel turns at the inlet increase plugging potential because wood going through the turn will not align with the inlet. Similarly, channel turns at the inlet and outlet are often accompanied by scour against the channel banks (Wisconsin Transportation Information Center, 2004).

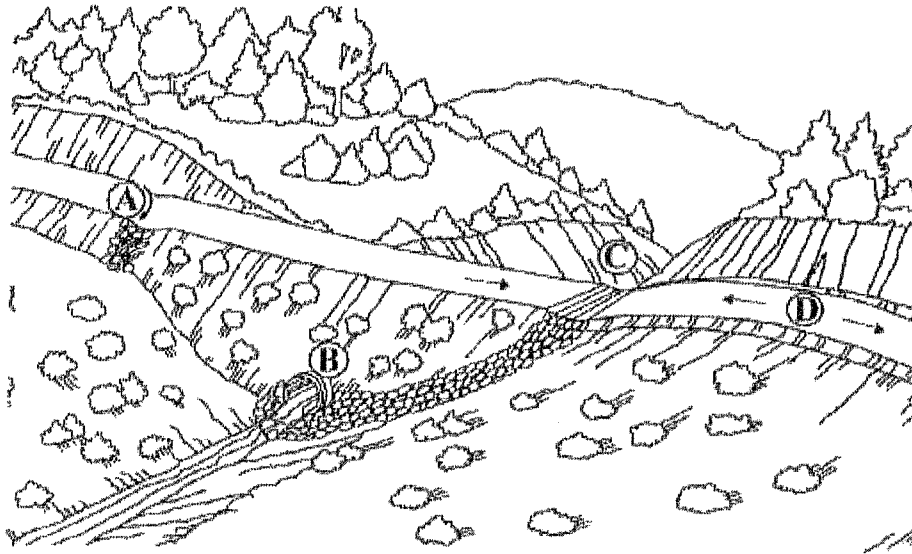
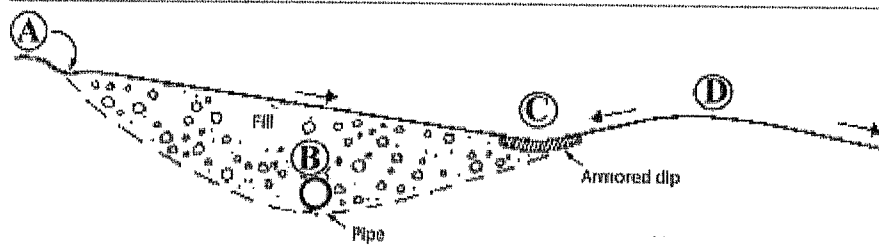
FIGURE 84. Critical dips or dipped crossing fills should be centered near a stream crossing's down-road hingeline, not over the centerline of the crossing where overtopping could cause washout or severe erosion of the fill. If the stream crossing culvert (B) plugs, water will pond behind the fill until reaching the critical dip or low point in the crossing (C) and flowing back down into the natural stream channel. The down-road ditch must be plugged to prevent streamflow from diverting down the ditch line. For extra protection in this sketch, riprap armor has been placed at the critical dip outfall and extending downslope to the stream channel. This is only required or suggested on stream crossings where the culvert is highly likely to plug and the crossing fill overtopped. The dip at the hinge line is usually sufficient to limit erosional damage during an overtopping event. Road surface and ditch runoff is disconnected from the stream crossing by installing a rolling dip and ditch relief culvert just up-road from the crossing (A) (Keller and Sharar, 2003).

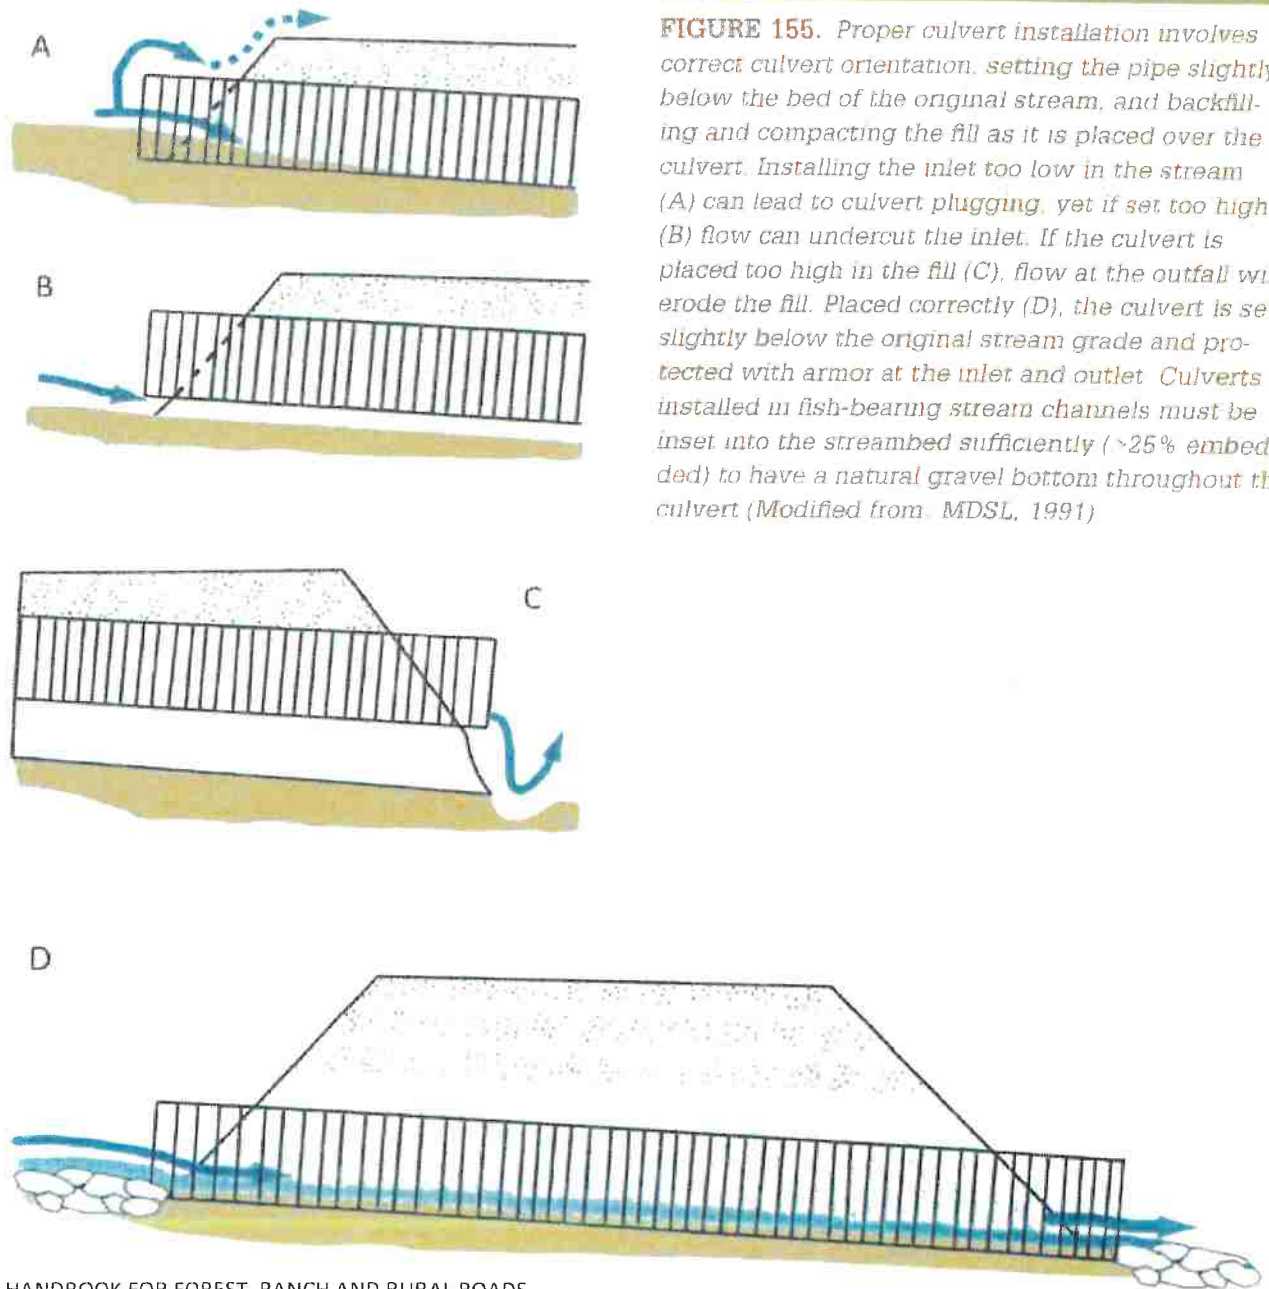
FIGURE 155. Proper culvert installation involves correct culvert orientation, setting the pipe slightly below the bed of the original stream, and backfilling and compacting the fill as it is placed over the culvert. Installing the inlet too low in the stream (A) can lead to culvert plugging, yet if set too high (B) flow can undercut the inlet. If the culvert is placed too high in the fill (C), flow at the outfall will erode the fill. Placed correctly (D), the culvert is set slightly below the original stream grade and protected with armor at the inlet and outlet. Culverts installed in fish-bearing stream channels must be inset into the streambed sufficiently (~25% embedded) to have a natural gravel bottom throughout the culvert (Modified from MDSL, 1991)

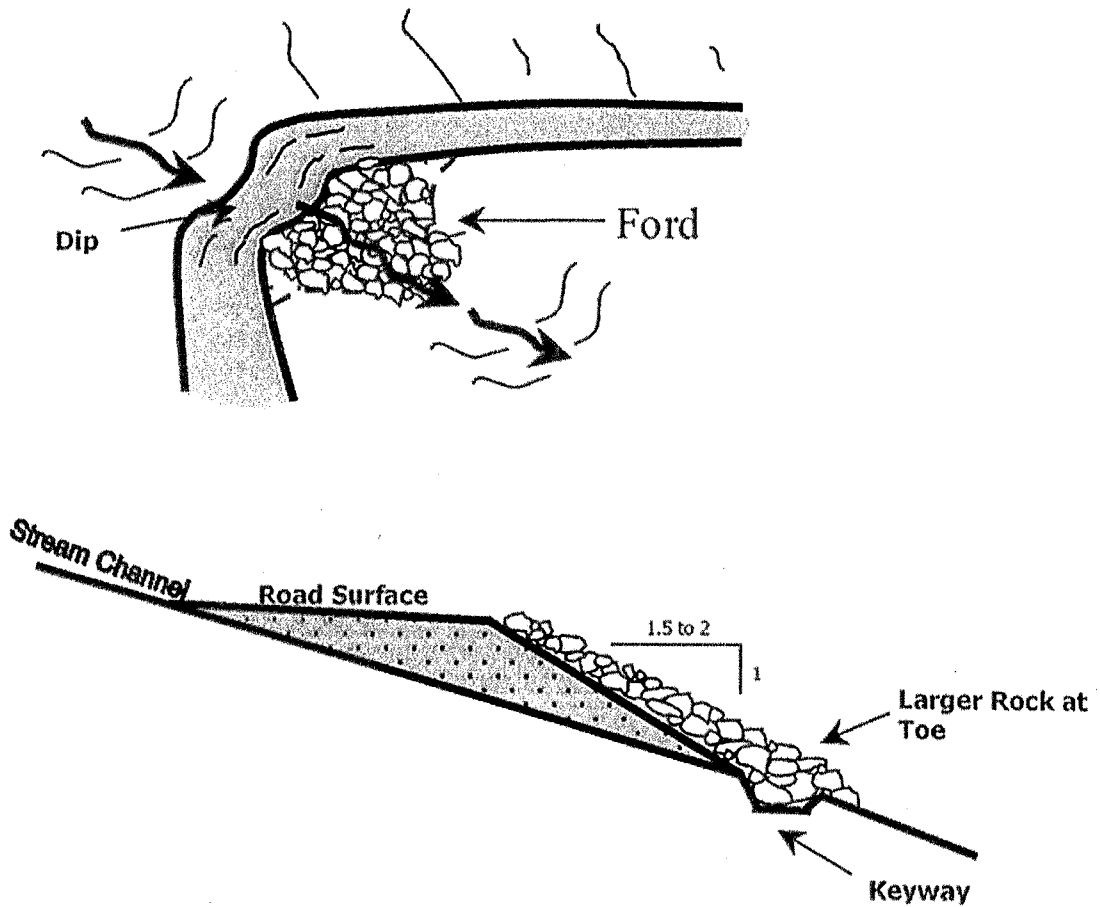
FORD: A large dip is graded into the road at the axis of the stream channel. The outside fill face is dished out to form a spillway with large rock. On large watercourses, rock is keyed several feet into firm native soils. The road surface is rocked with 6" of minus rock .

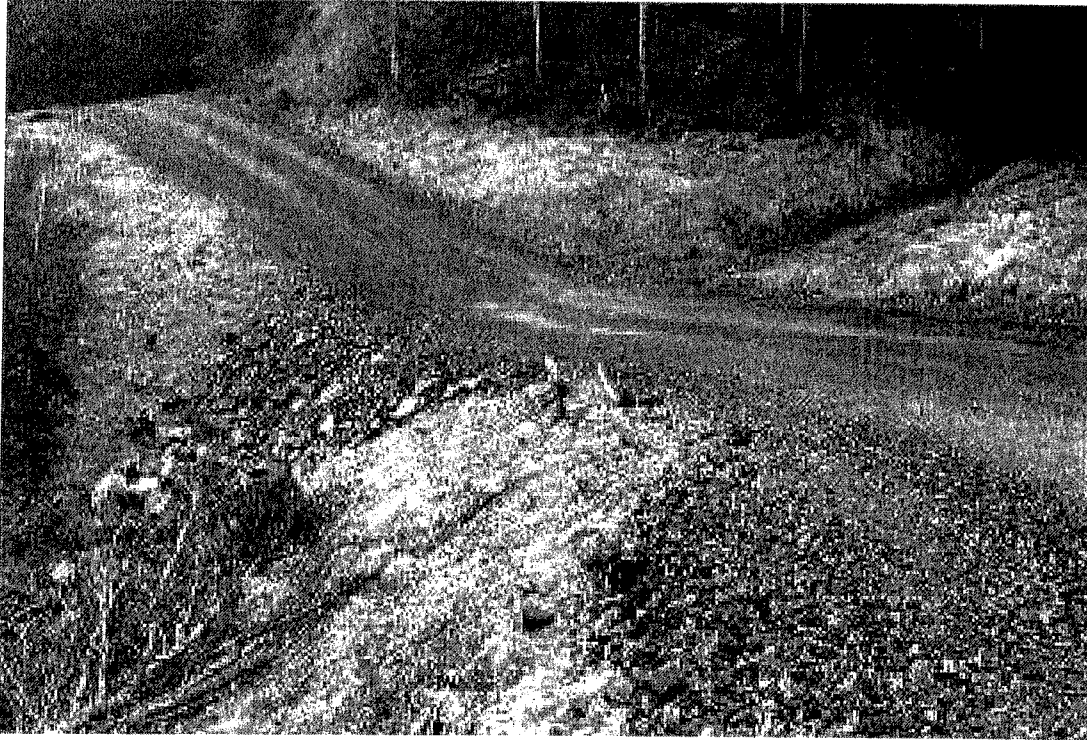
FIGURE 120. This armored fill crossing of a steep, ephemeral stream was constructed to provide a low maintenance crossing. The crossing has been deeply dipped to reduce the volume of road fill and to eliminate the potential for stream diversion. The fill slope has been heavily armored through the axis of the crossing to contain flood flows and prevent down-cutting. Armored fills cannot be used on fish bearing streams.

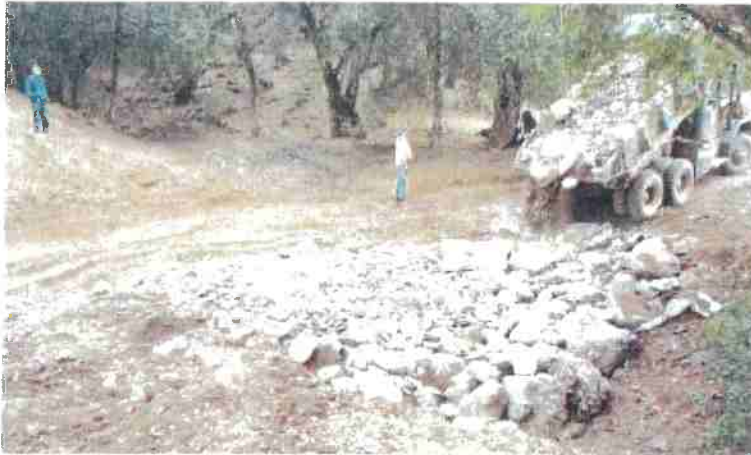
FIGURE 121D. Well graded rock armor is then backfilled into the structure and spread across the breadth of the U-shaped stream crossing, and about one-third the way up the roadbed, so that streamflow will only flow over or come in contact with resistant armor material. The armor must be spread and compacted across the design width of the expected flood flow channel width so peak flows will not flank the armored structure.

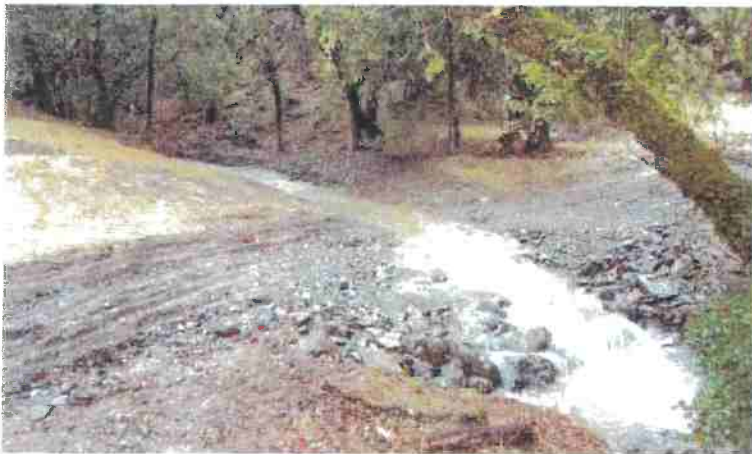
FIGURE 121E. Two weeks after this armored fill was constructed, a storm flow event occurred and the structure maintained its function and integrity. The road approaches had not yet been compacted or surfaced with road rock.

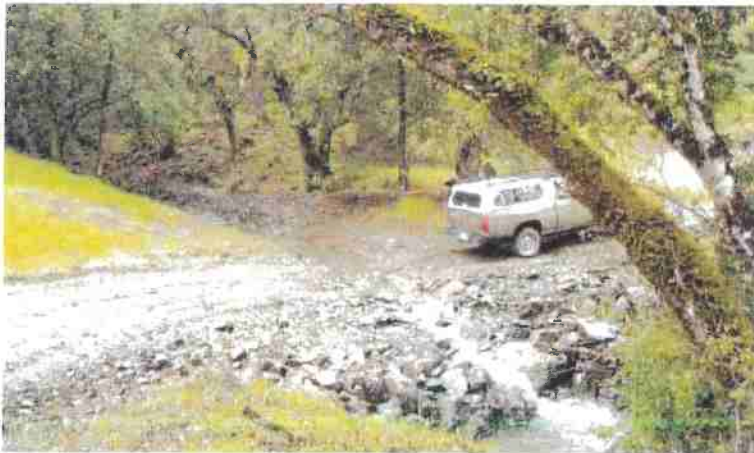
FIGURE 121F. The same armored fill as it appeared after the first winter flood flows. No maintenance was required to reopen the road. It is also clear that no stream diversion is possible at this stream crossing site, and the volume of fill within the crossing has been reduced to the minimum amount needed to maintain a relatively smooth driving surface on this low volume road.

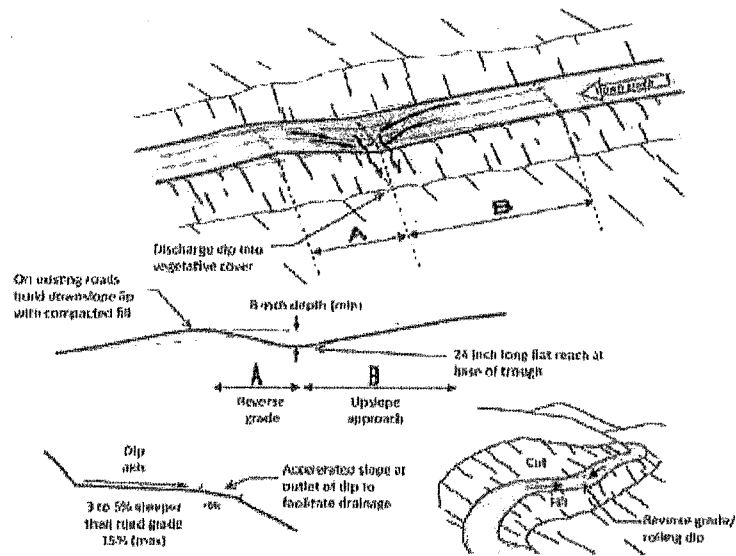
FIGURE 34. A classic Type I rolling dip, where the excavated up-road approach (B) to the rolling dip is several percent steeper than the approaching road and extends for 60 to 80 feet to the dip axis. The lower side of the structure reverses grade (A) over approximately 15 feet or more, and then falls down to rejoin the original road grade. The dip must be deep enough that it is not obliterated by normal grading, but not so deep that it is difficult to negotiate or a hazard to normal traffic. The outward cross-slope of the dip axis should be 3% to 5% greater than the up-road grade (B) so it will drain properly. The dip axis should be out-sloped sufficiently to be self-cleaning, without triggering excessive downcutting or sediment deposition in the dip axis (Modified from: Best, 2013).

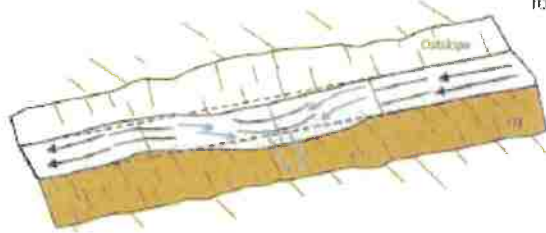
Type 1 Rolling Dip
(Standard)

Type 1 rolling dips are used where road grades are less than about 12-14% and road runoff is not confined by a large through cut or berm. The axis of the dip should be perpendicular to the road alignment and sloped at 3-4% across the road tread. Steep roads will have longer and more abrupt dip dimensions to develop reverse grade through the dip axis. The road tread and/or the dip outlet can be rocked to protect against erosion, if needed.

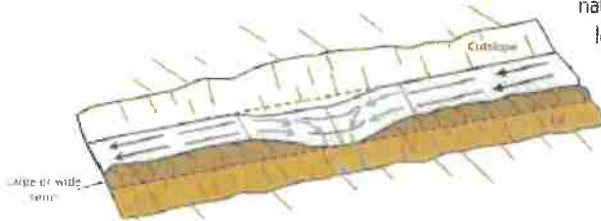
Type 2 Rolling Dip
(Through-cut or thick berm road reaches)

Type 2 rolling dips are constructed on roads up to 12-14% grade where there is a through cut up to 3 feet tall, or a wide or tall berm that otherwise blocks road drainage. The berm or native through cut material should be removed for the length of the dip, or at least through the axis of the dip, to the extent needed to provide for uninterrupted drainage onto the adjacent slope. The berm and slope material can be excavated and endhauling, or the material can be sidecast onto native slopes up to 45%, provided it will not enter a stream.

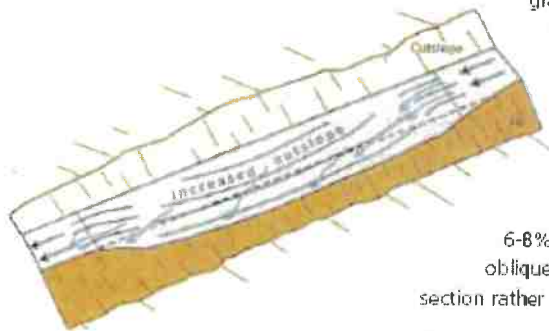
Type 3 Rolling Dip
(Steep road grade)

Type 3 rolling dips are utilized where road grades are steeper than about 12% and it is not feasible to develop a reverse grade that will also allow passage of the design vehicle (steep road grades require more abrupt grade reversals that some vehicles may not be able to traverse without bottoming out).

Instead of relying on the dip's grade reversal to turn runoff off the roadbed, the road is built with an exaggerated outslope of 6-8% across the dip axis. Road runoff is deflected obliquely across the dip axis and is shed off the outsloped section rather than continuing down the steep road grade.

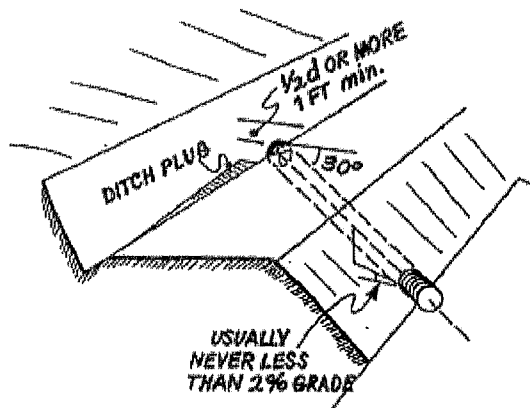
FIGURE 48. The elements of a properly installed ditch relief culvert. The culvert is angled at about 30 degrees to the road alignment to help capture flow and prevent culvert plugging or erosion of the inlet area. It is set at the base of the fill (ideally) or with a grade slightly steeper than the grade of the contributing ditch (but never with a grade less than 2 percent) (USDA-SCS, 1983). At a minimum, the grade of the ditch relief culvert should be sufficient to prevent sediment accumulation at the inlet or deposition within the culvert itself (it should be self-cleaning) (USDA-SCS, 1983).

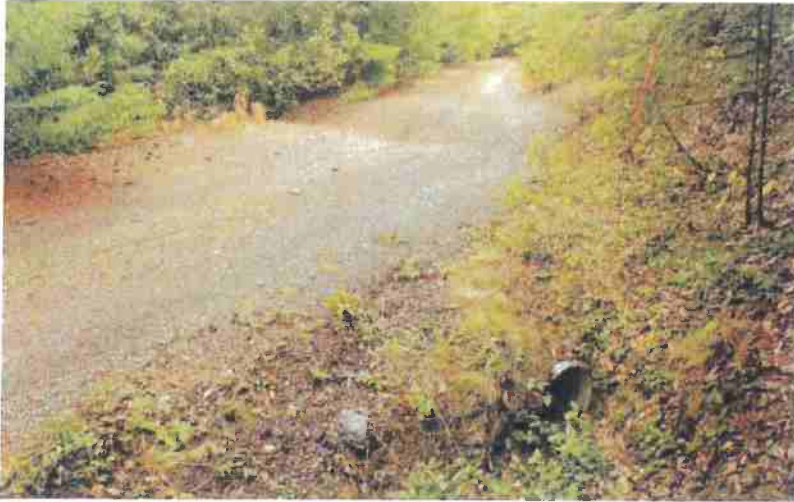
FIGURE 39.

Waterbars are often used to drain surface runoff from seasonal, unsurfaced roads. Because they are easily broken down by vehicles, waterbars are only used on unsurfaced roads where there is little or no wet weather traffic. In this photo, a waterbar and ditch relief culvert are used to drain all road surface and ditch runoff from the insloped road prism.

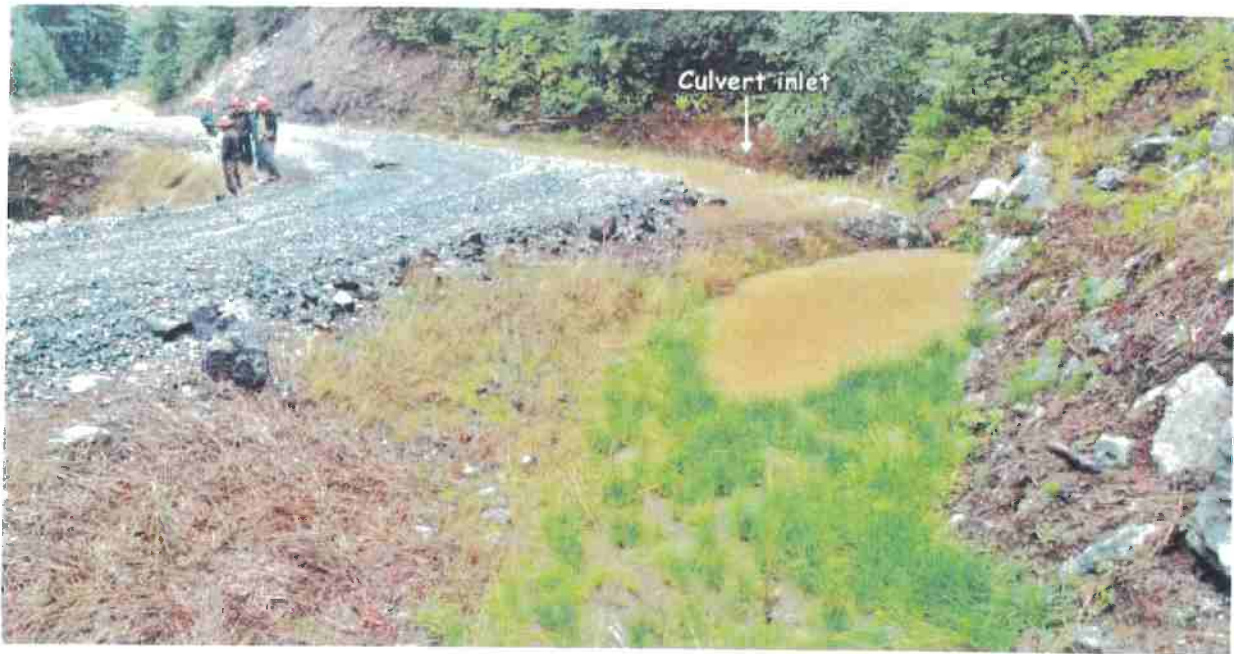
FIGURE 238. Traffic and surface runoff from graveled roads often produces surface erosion, turbid runoff and fine sediment transport that can be delivered to streams. Where ditches can't be eliminated, sediment traps and roadside settling basins can be installed to capture and remove most of the eroded sediment. This settling basin has been constructed along the inside ditch just before a stream crossing culvert inlet (see arrow). Eroded sediment from the road and ditch are deposited in the basin before flow is released to the stream. Fine sediments have filled about 1/3 of this basin and vegetation is now growing. Sediment basins require periodic maintenance to maintain their storage capacity.

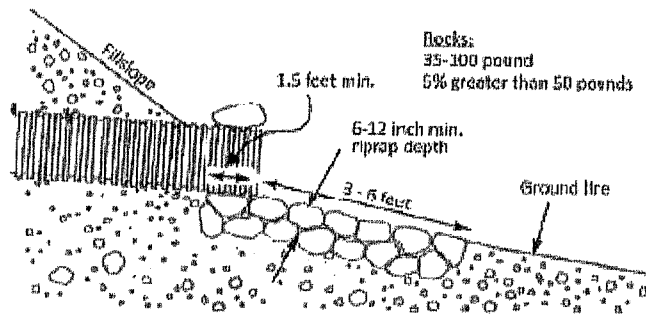
FIGURE 107A. Riprap armor at culvert outlet (Modified from: Keller et al., 2011).

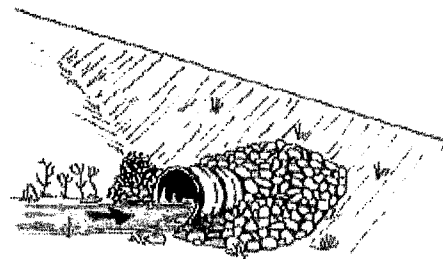
FIGURE 107B. Riprap armor at culvert inlet (Keller and Sherat, 2003).
