ATTACHMENT 1b  
Sprowl Creek Full Resubmittal

# ETA Humboldt, LLC

25 July 2023

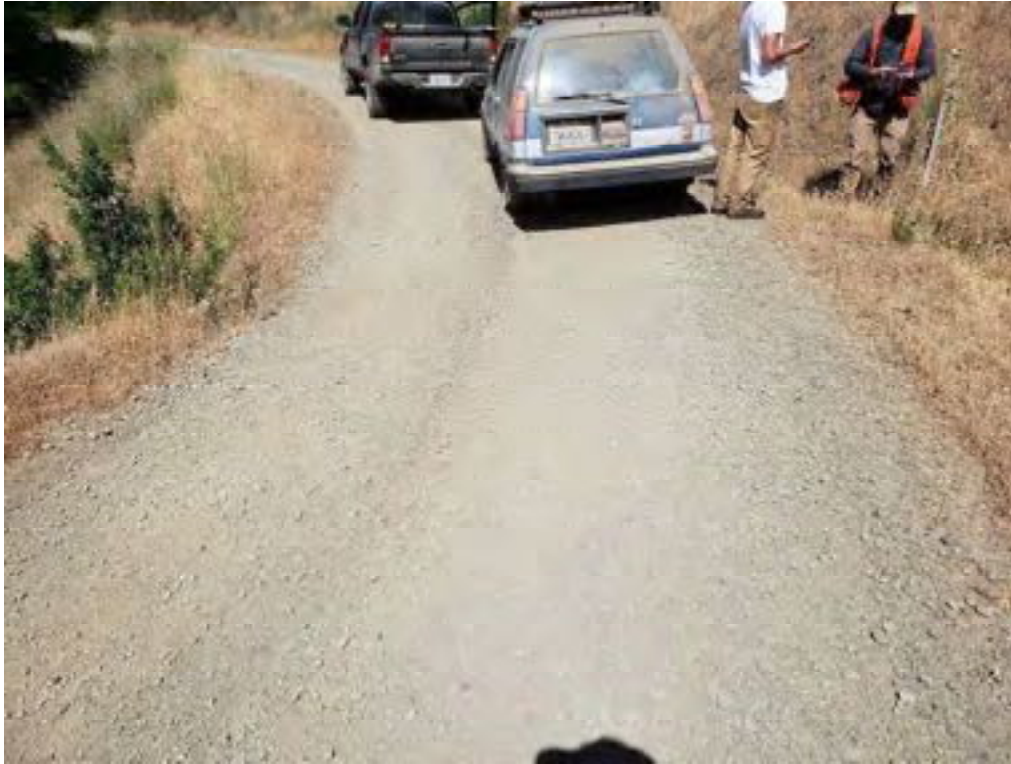
*Site 03. Looking west.*

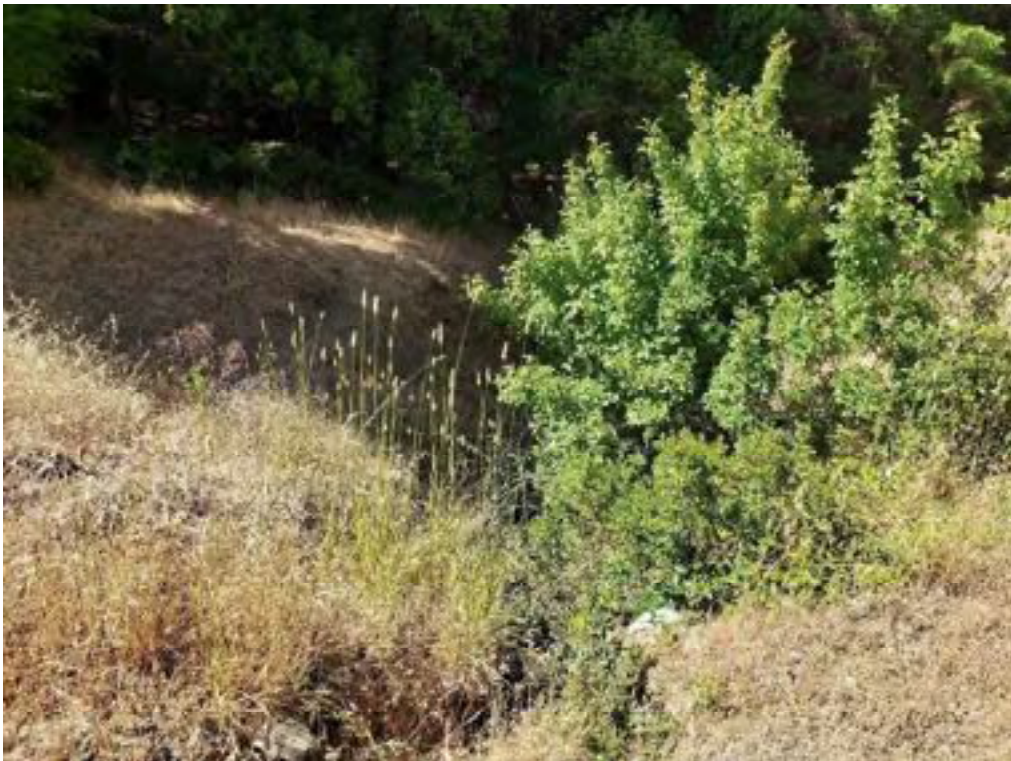
*Site 03. Looking down channel from the outlet.*

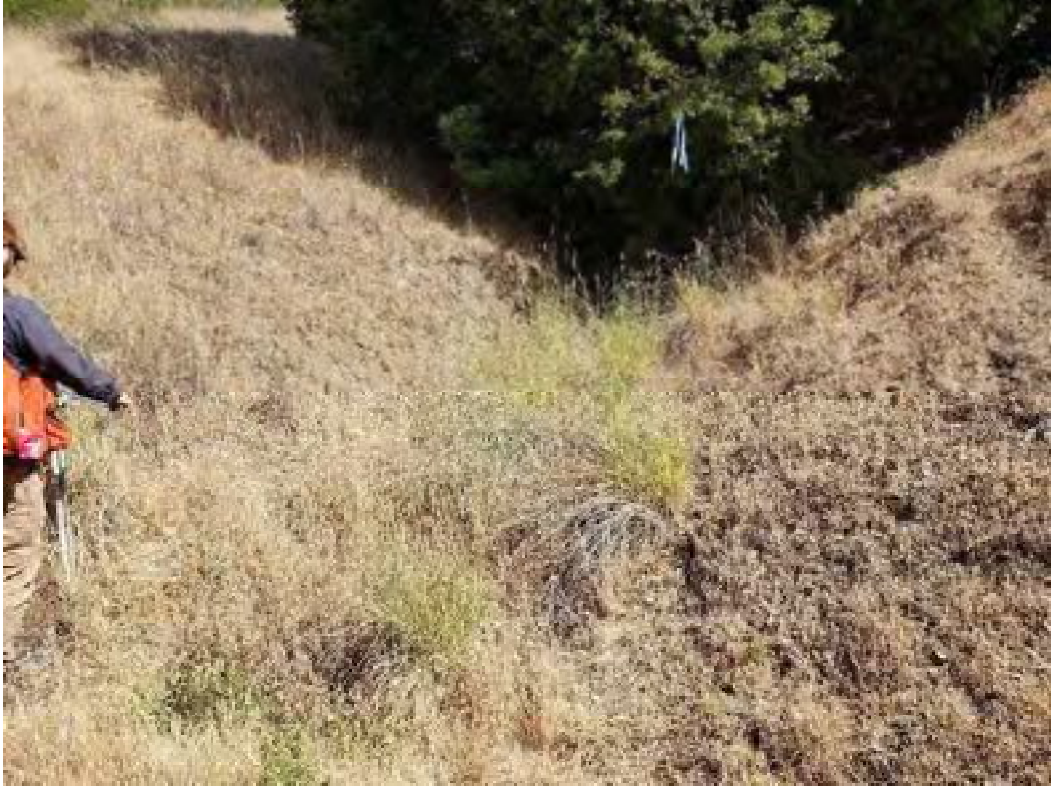
Site 03. Looking up channel from the inlet.

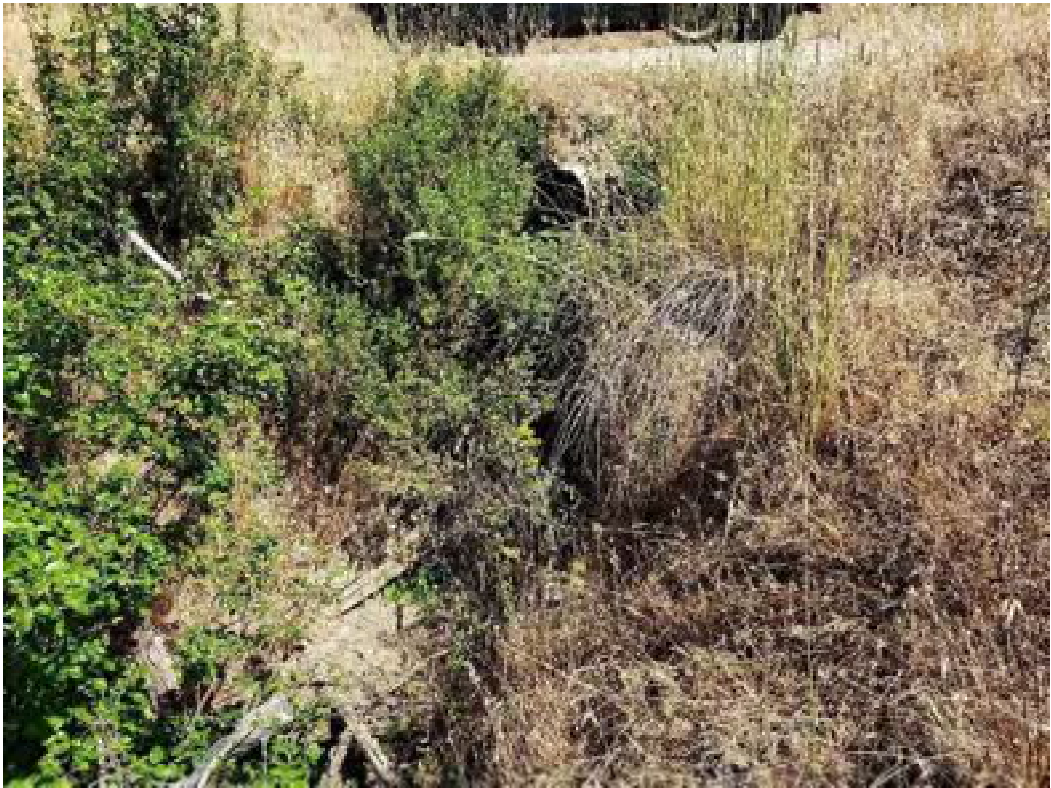
Site 03. Looking at the outlet.

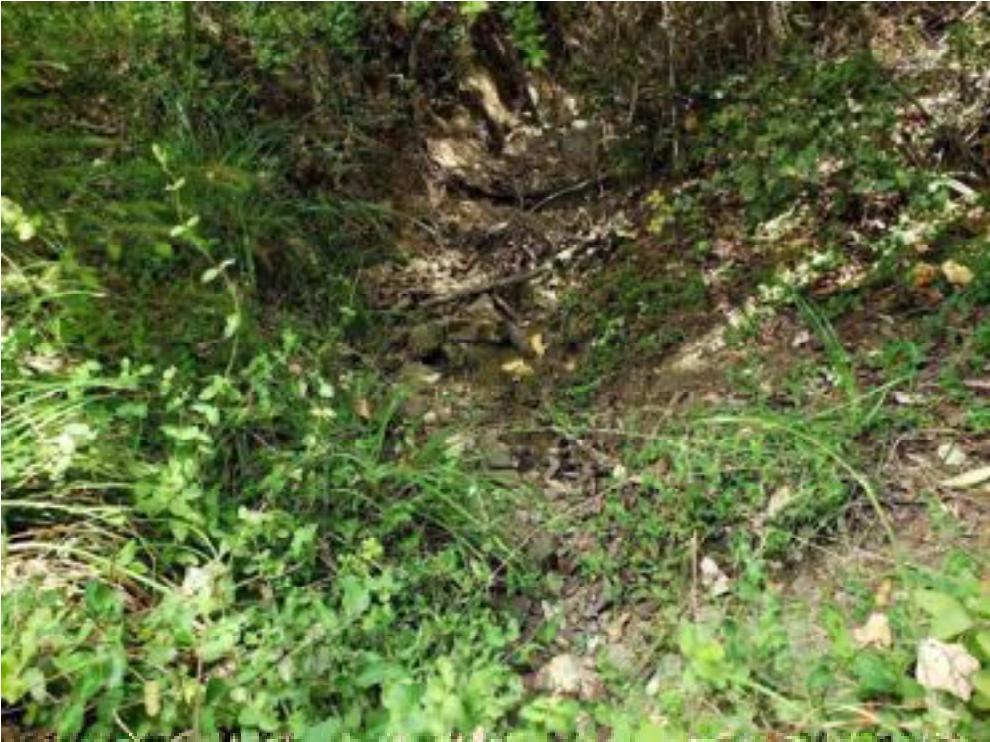
Site 06. Looking up channel from the inlet.

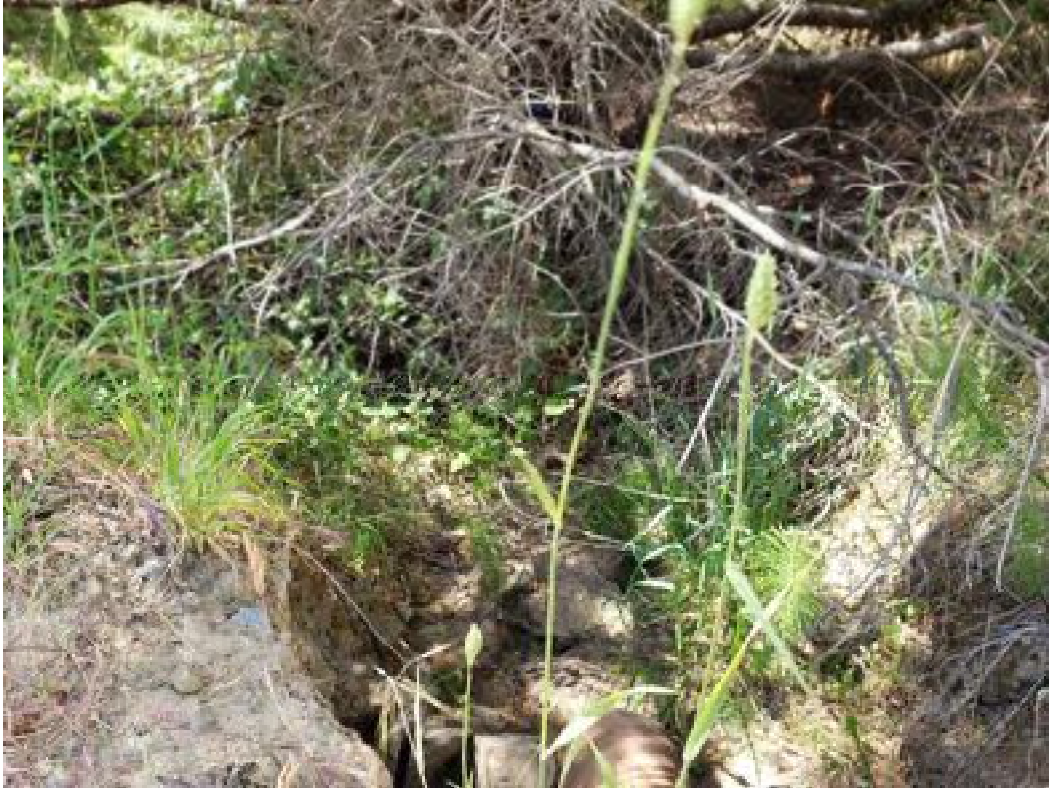
*Site 07. Looking down channel from the outlet. The upgraded culvert will outlet approximately in the brush to the upper center of the photo.*

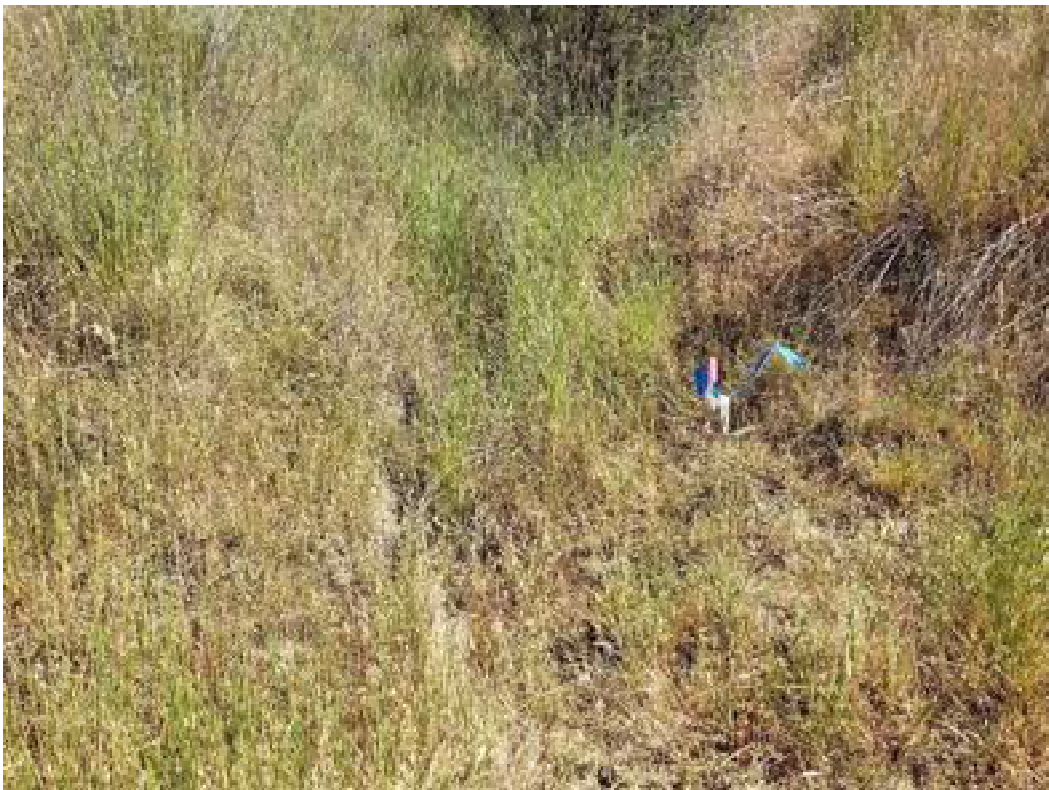
*Site 08. Looking up channel from the inlet of the culvert.*

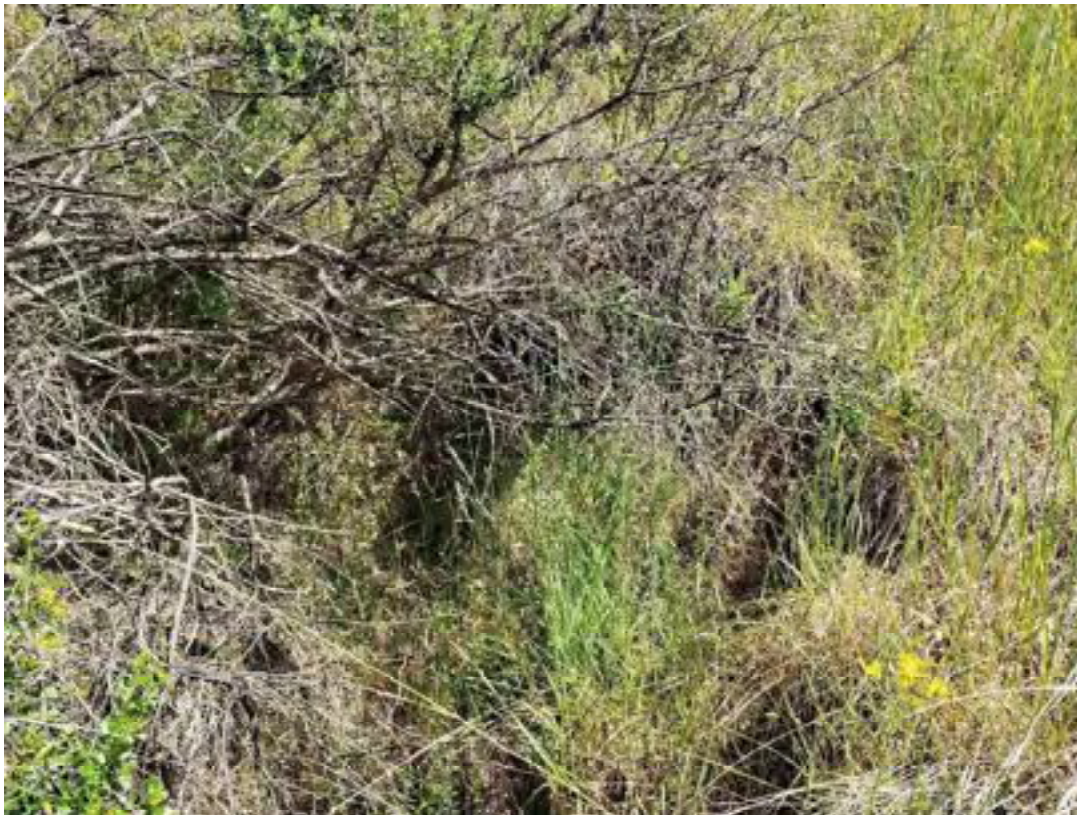
*Site 08. Looking at the outlet of the culvert.*

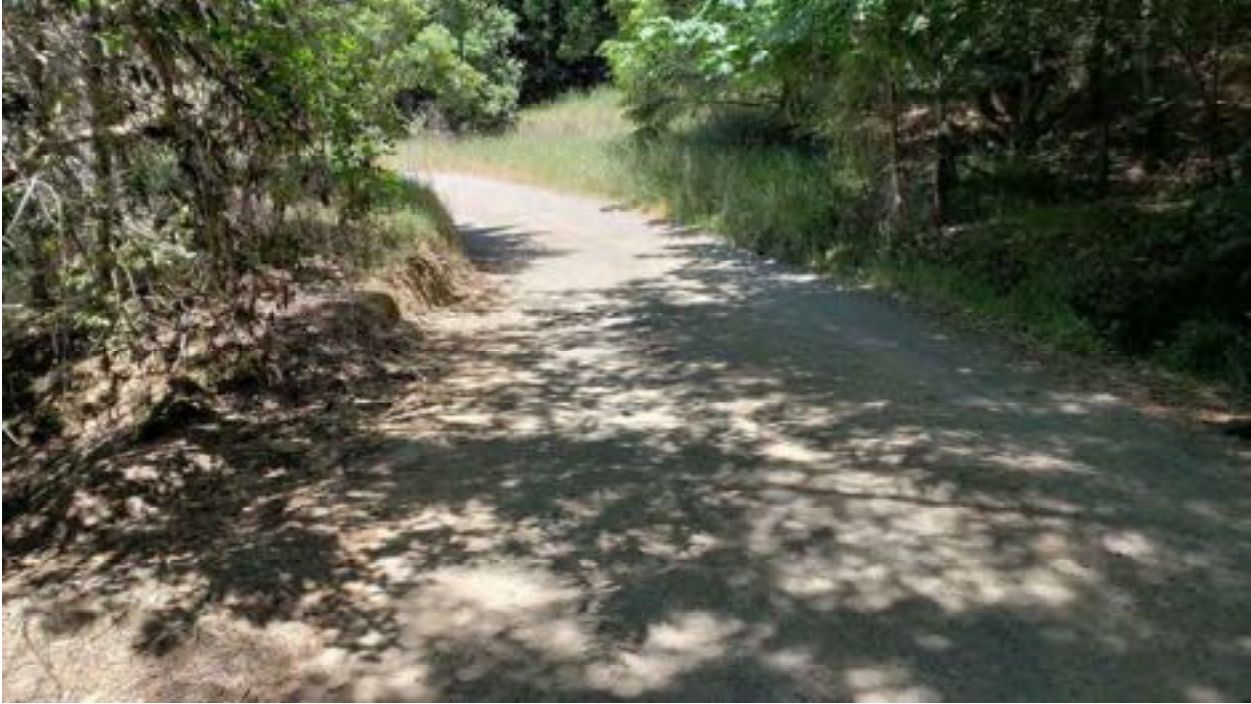
*Looking up grade from Site 12 towards Site 11.*

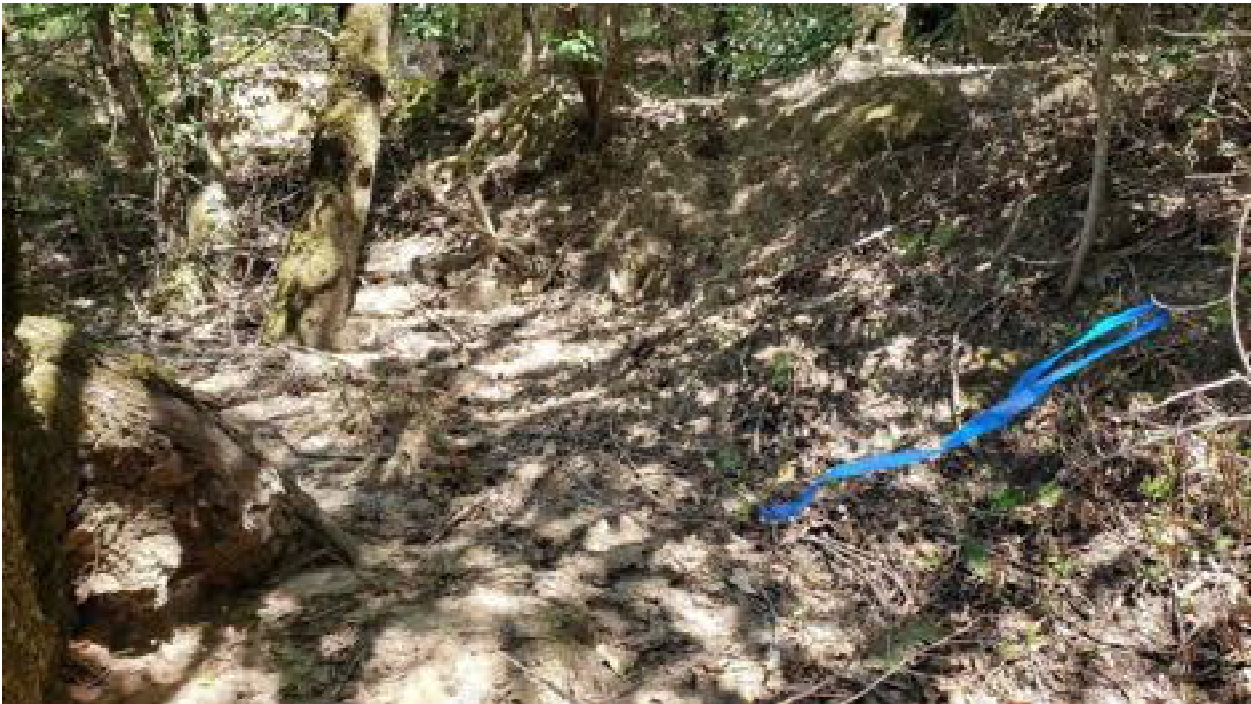
Site 13. Looking up grade at Site 13. A Class III watercourse is diverted down the inside ditch to the right. Re-alignment of this watercourse will consist of a culvert installed diagonally across the road from the grass patch in the upper center right to the lower left of the photo.

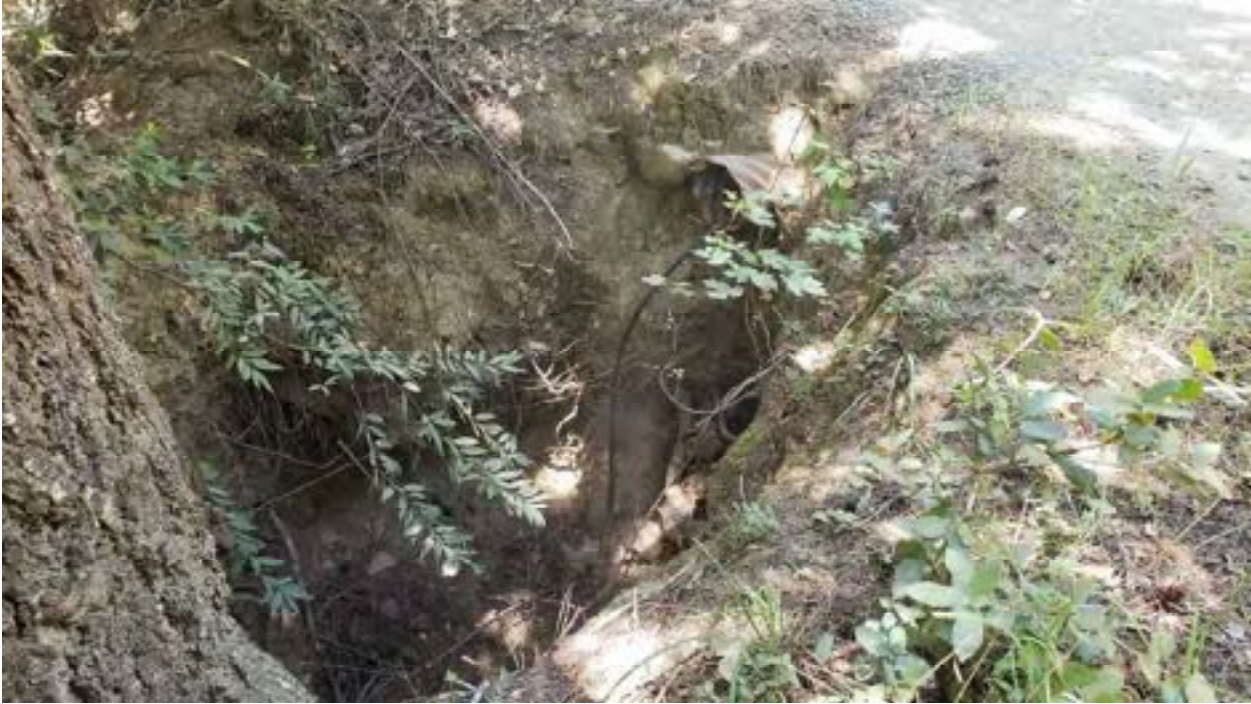
*Site 14. Looking down grade at Site 14 with Site 15 further down grade a short distance.*

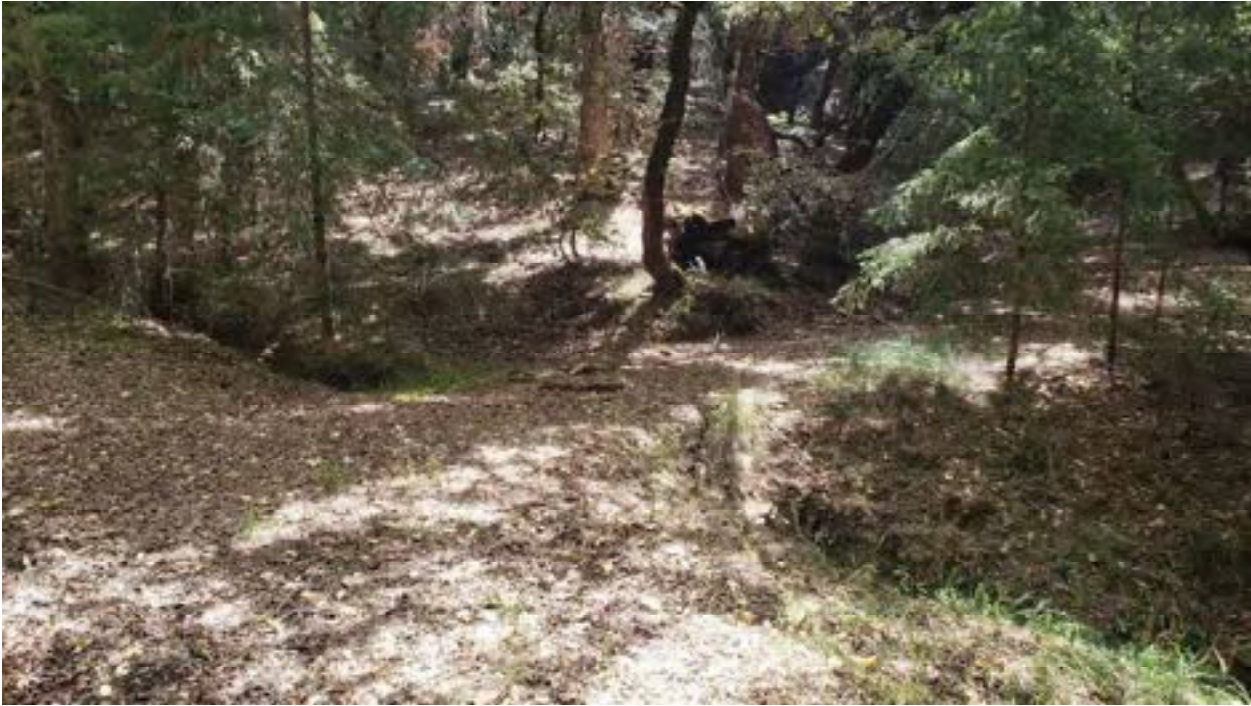
*Photo looking up grade at Site 16.*

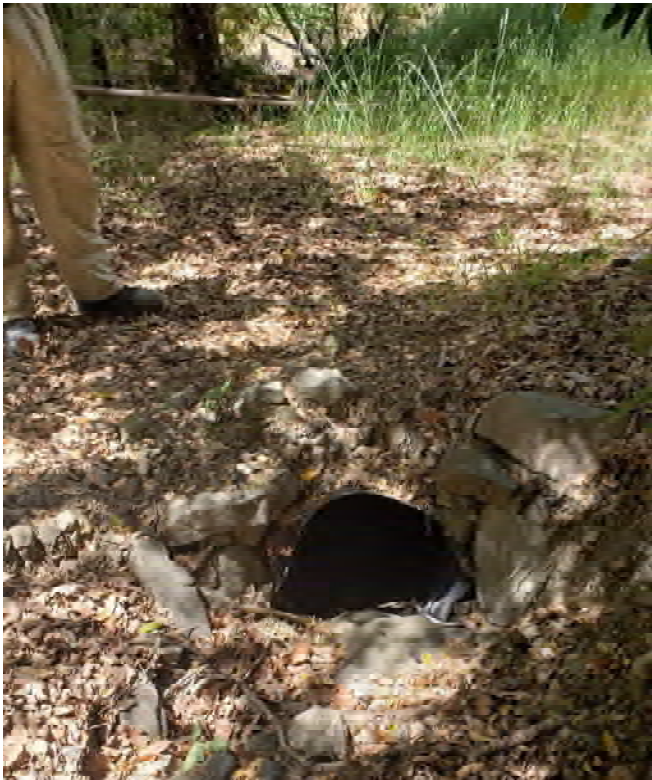
Site 19. Approximately location of watercourse re-alignment. A waterbar (Site 18) will be installed further up grade from the re-aligned watercourse.

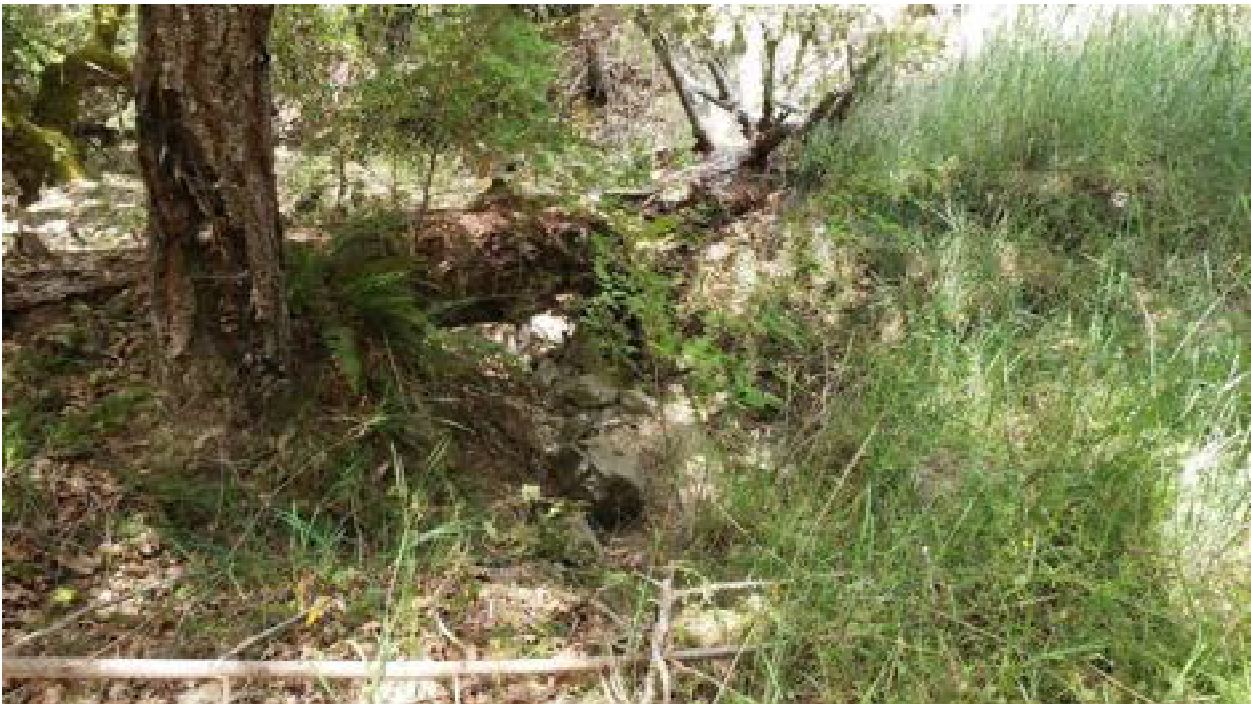
*Inlet of Site 19 looking up channel.*

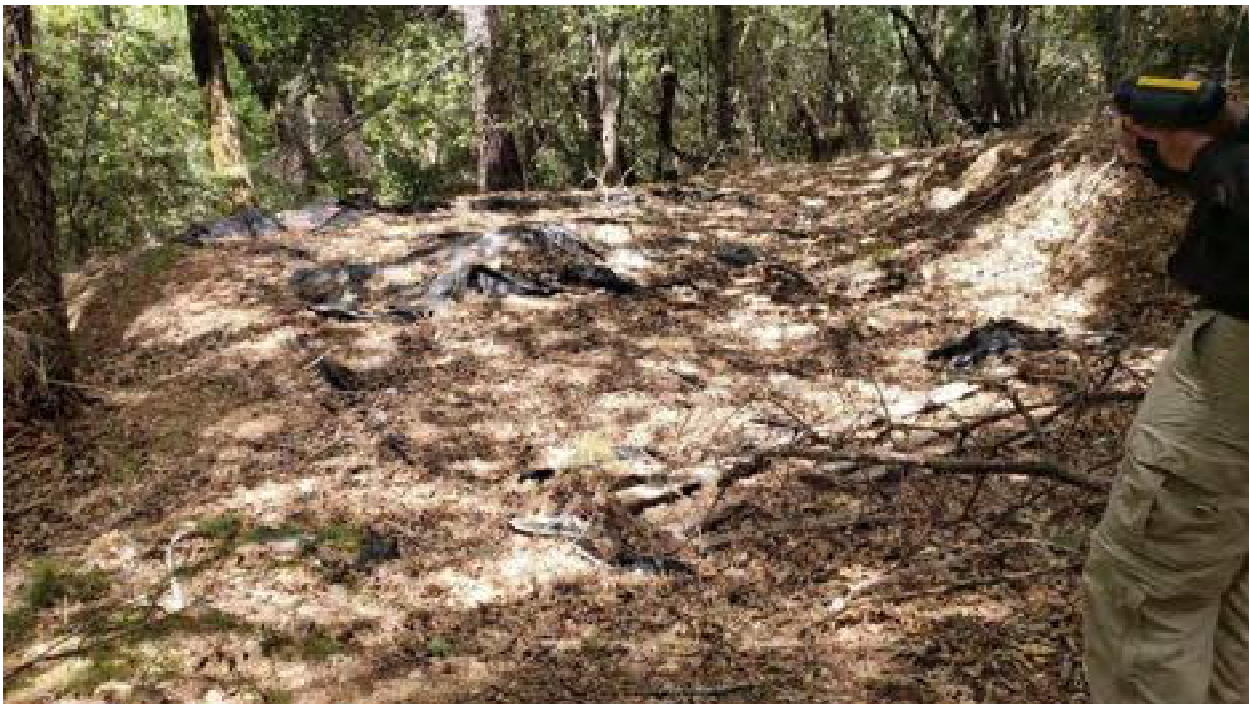
*Photo looking north at G5, G6, & G6 from the channel immediately below Site 19.*

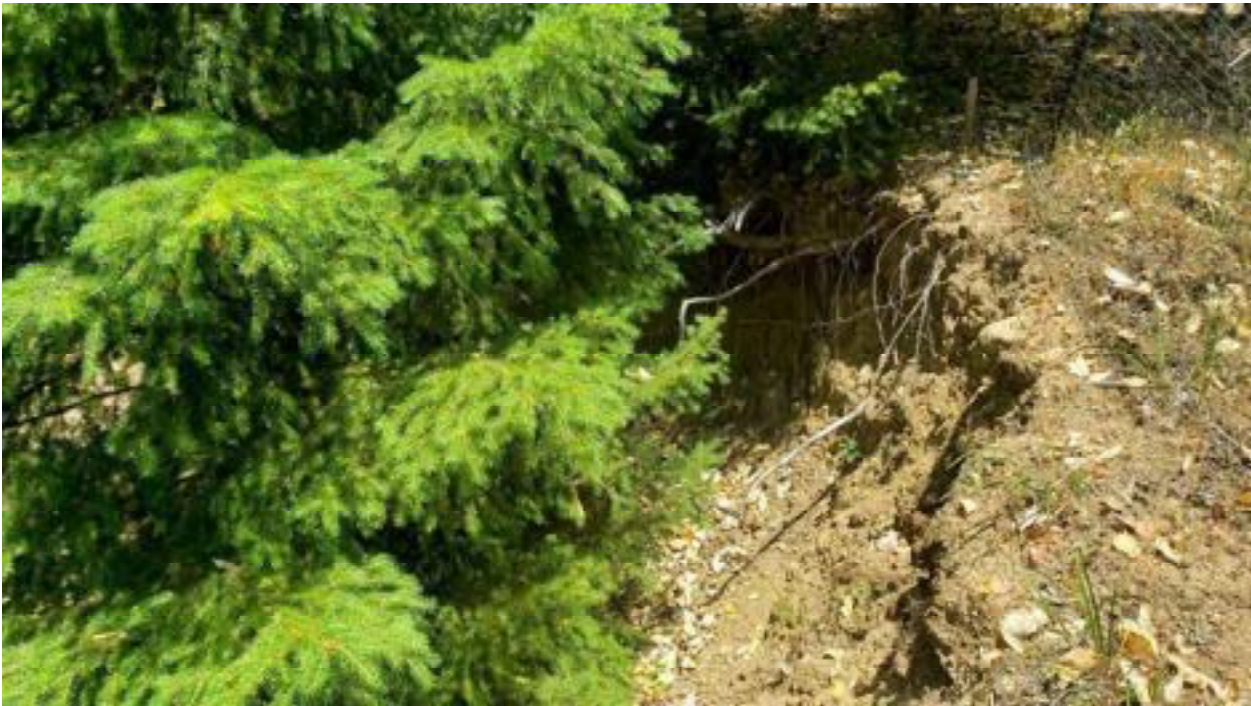
*Site 21. This site was in the 2015 Inspection Report*

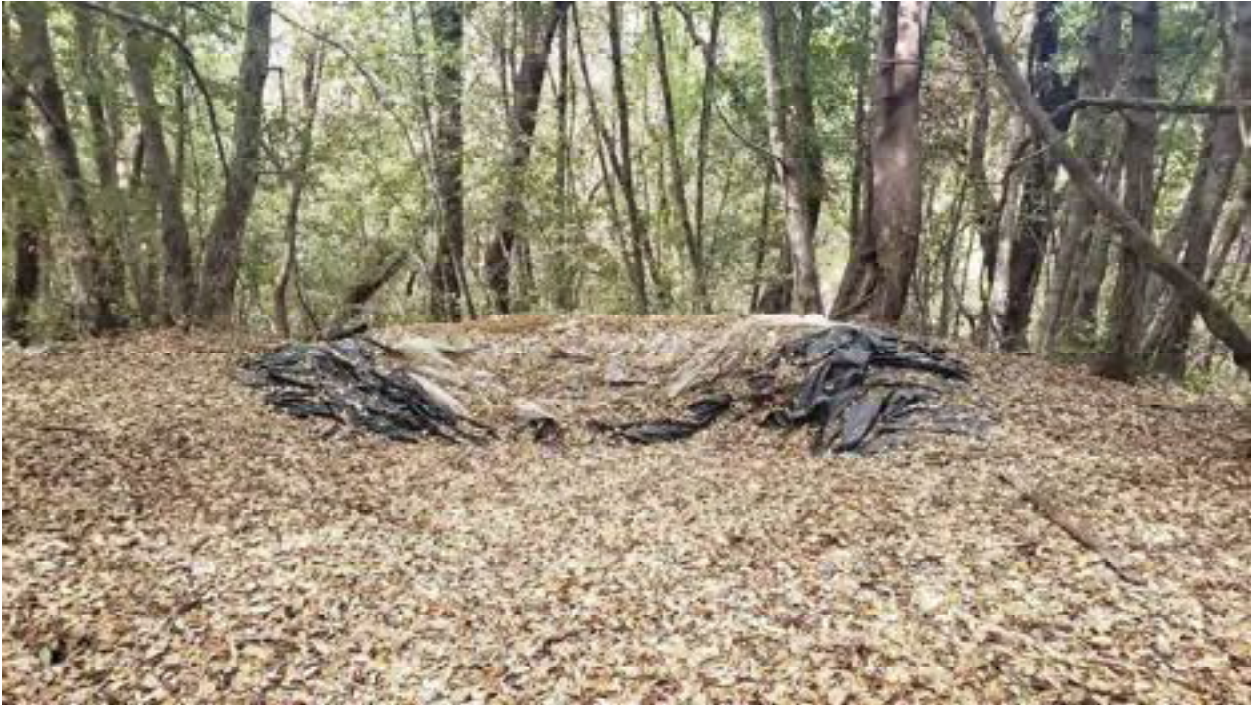
*Photo looking southwest at Site 21.*

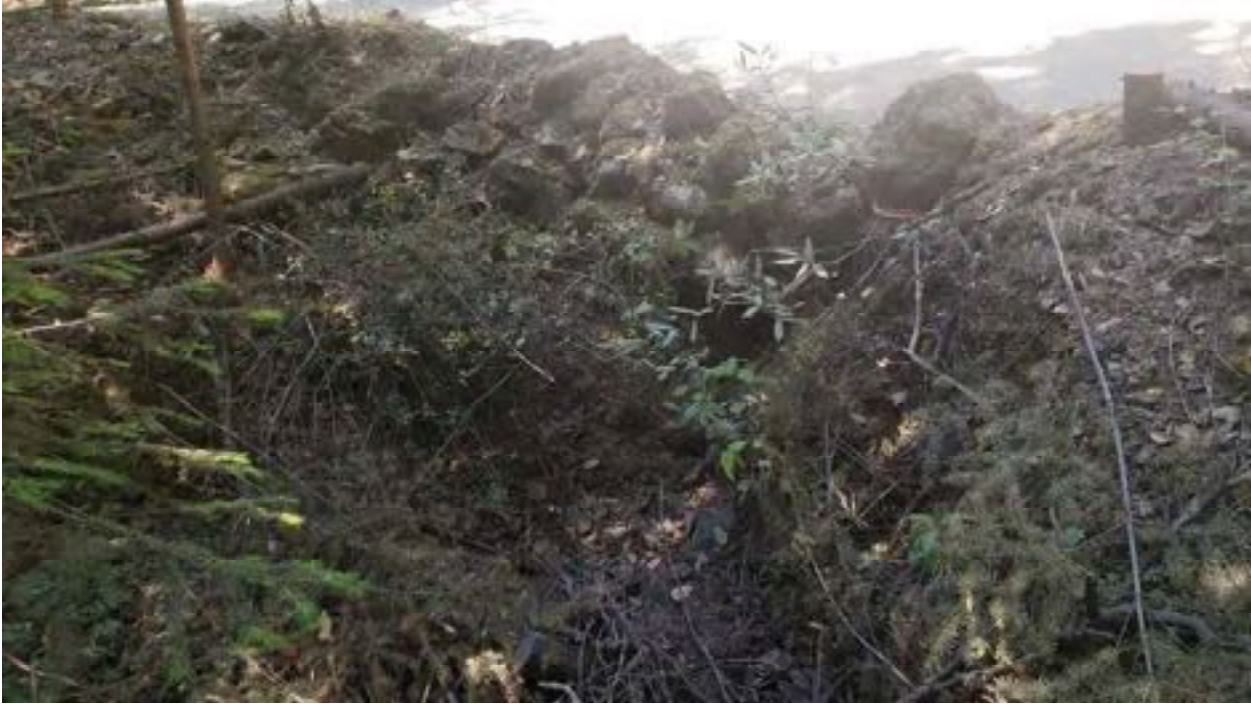
Site 26. Outlet of the watercourse crossing.

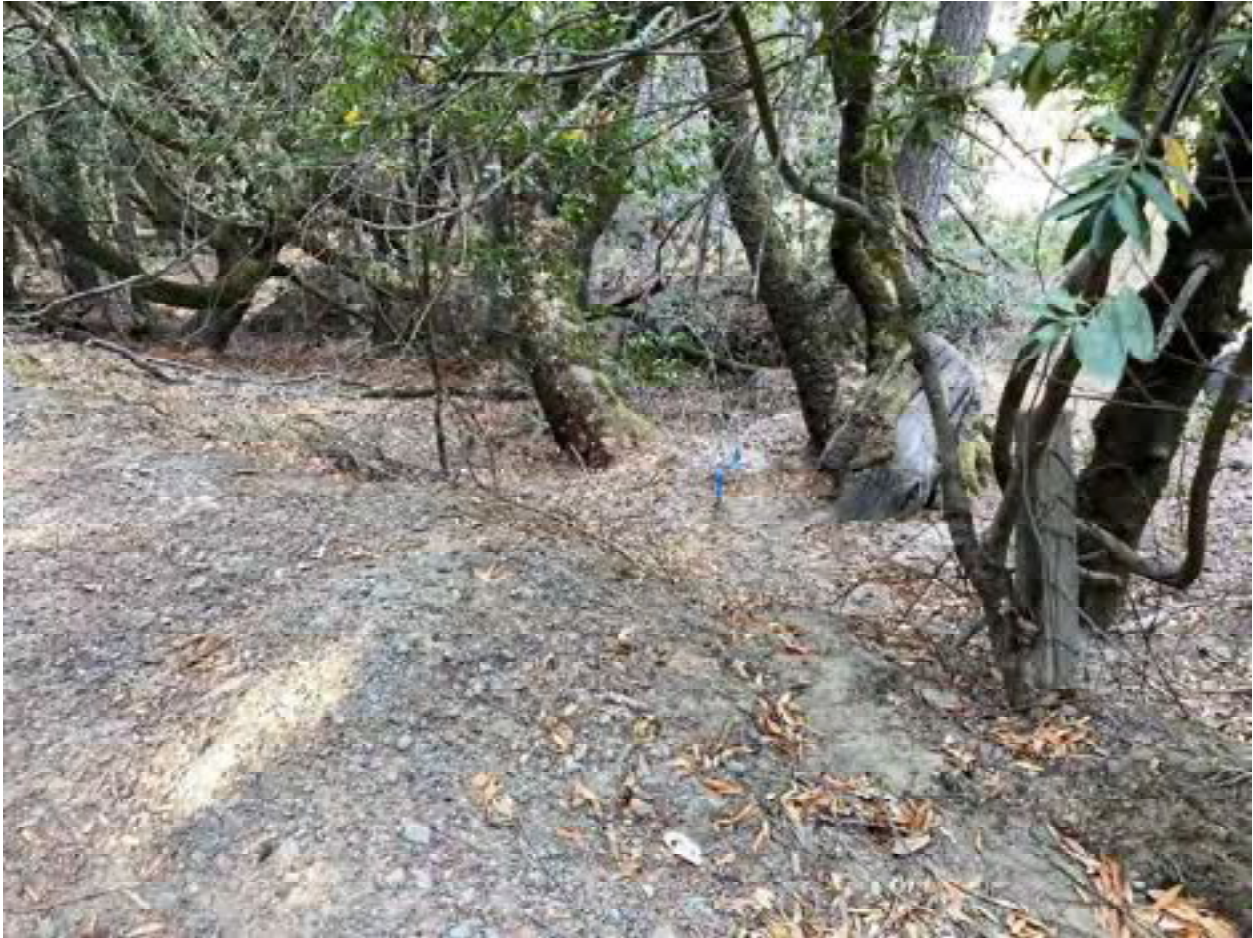
**Photo 41:** Stream Crossing 13. Looking downstream from the road where the outlet of stream crossing 13 is proposed. Photo date 9-1-2021.
